BUILDING AND TIMBER PEST REPORT

12/17 Hilltop Ct
Carina, QLD 4152

BYB
12/02/2024

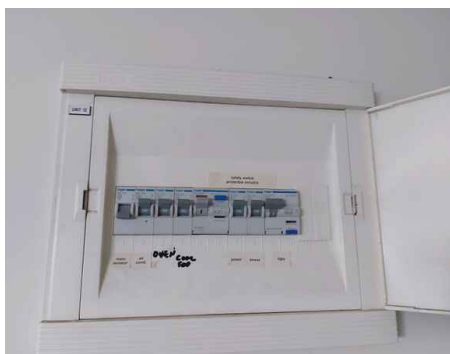
Electrical : Safety Switch Observed

A safety switch was observed, but not tested. It is recommended that the electrical system is fully inspected by a qualified electrician prior to use

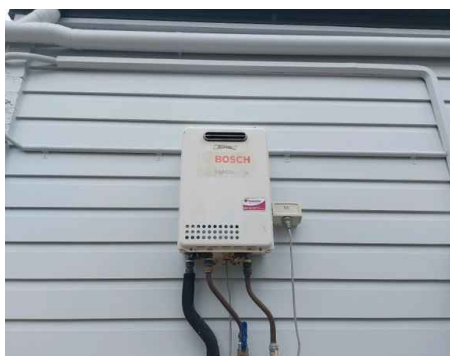
Hot Water Service: Hot water provided by:

Gas hotwater system

No specific tests were carried out. No determination has been made as to the compliance, suitability or adequacy of the hot water system in relation to capacity, function or lifespan.

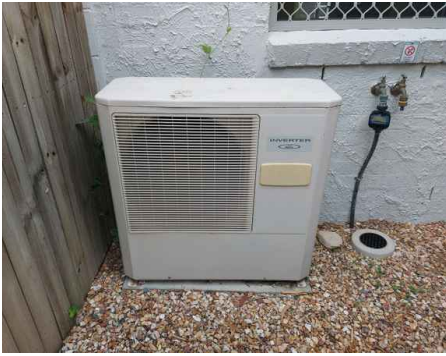
Air Conditioning: Air Conditioning Installed

Air-conditioning is installed to the property but has not been tested/inspected. We recommend a licensed air conditioning specialist to determine the status of the units.

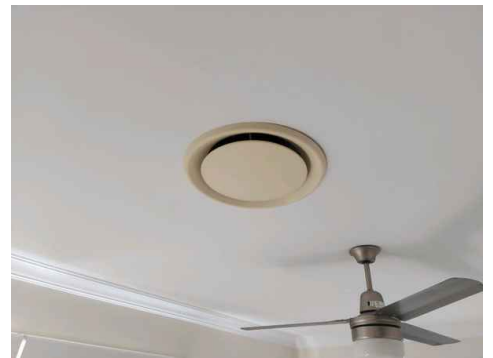
5.3.1 Air Conditioning

Type of air-condition installed is a fully ducted system. Refer to pictures in roof void section showing visible ducting.

Contact a qualified professional.

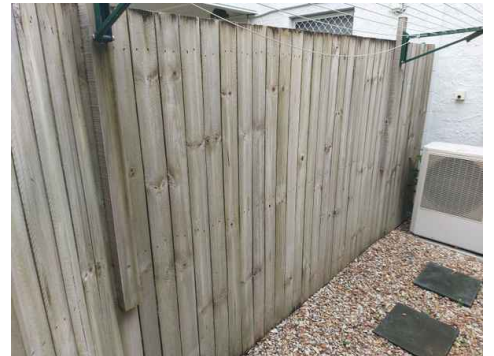
Fences/Gates: The condition of the fences appeared to be commensurate with their age.

It should be stated that timber fences do have a finite service life. Timber and treatment to timber deteriorate over time, and require regular maintenance and replacement. Maintaining the bases of the fence posts and palings free and clear of soil, rotting leaves, and occasional treatment with a wood preservative will be most effective in prolonging service life.

Contact a qualified professional.

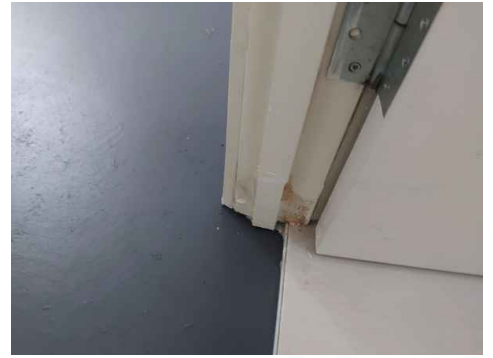
Minor-Moderate Attention Recommended**MOISTURE
DAMAGE/MINOR DECAY**

Minor damage observed, no current high moisture observed at the time of inspection. There may be hidden damage that could not be observed. The cause was not determined.

Further evaluation and correction recommended.

Contact a qualified professional.

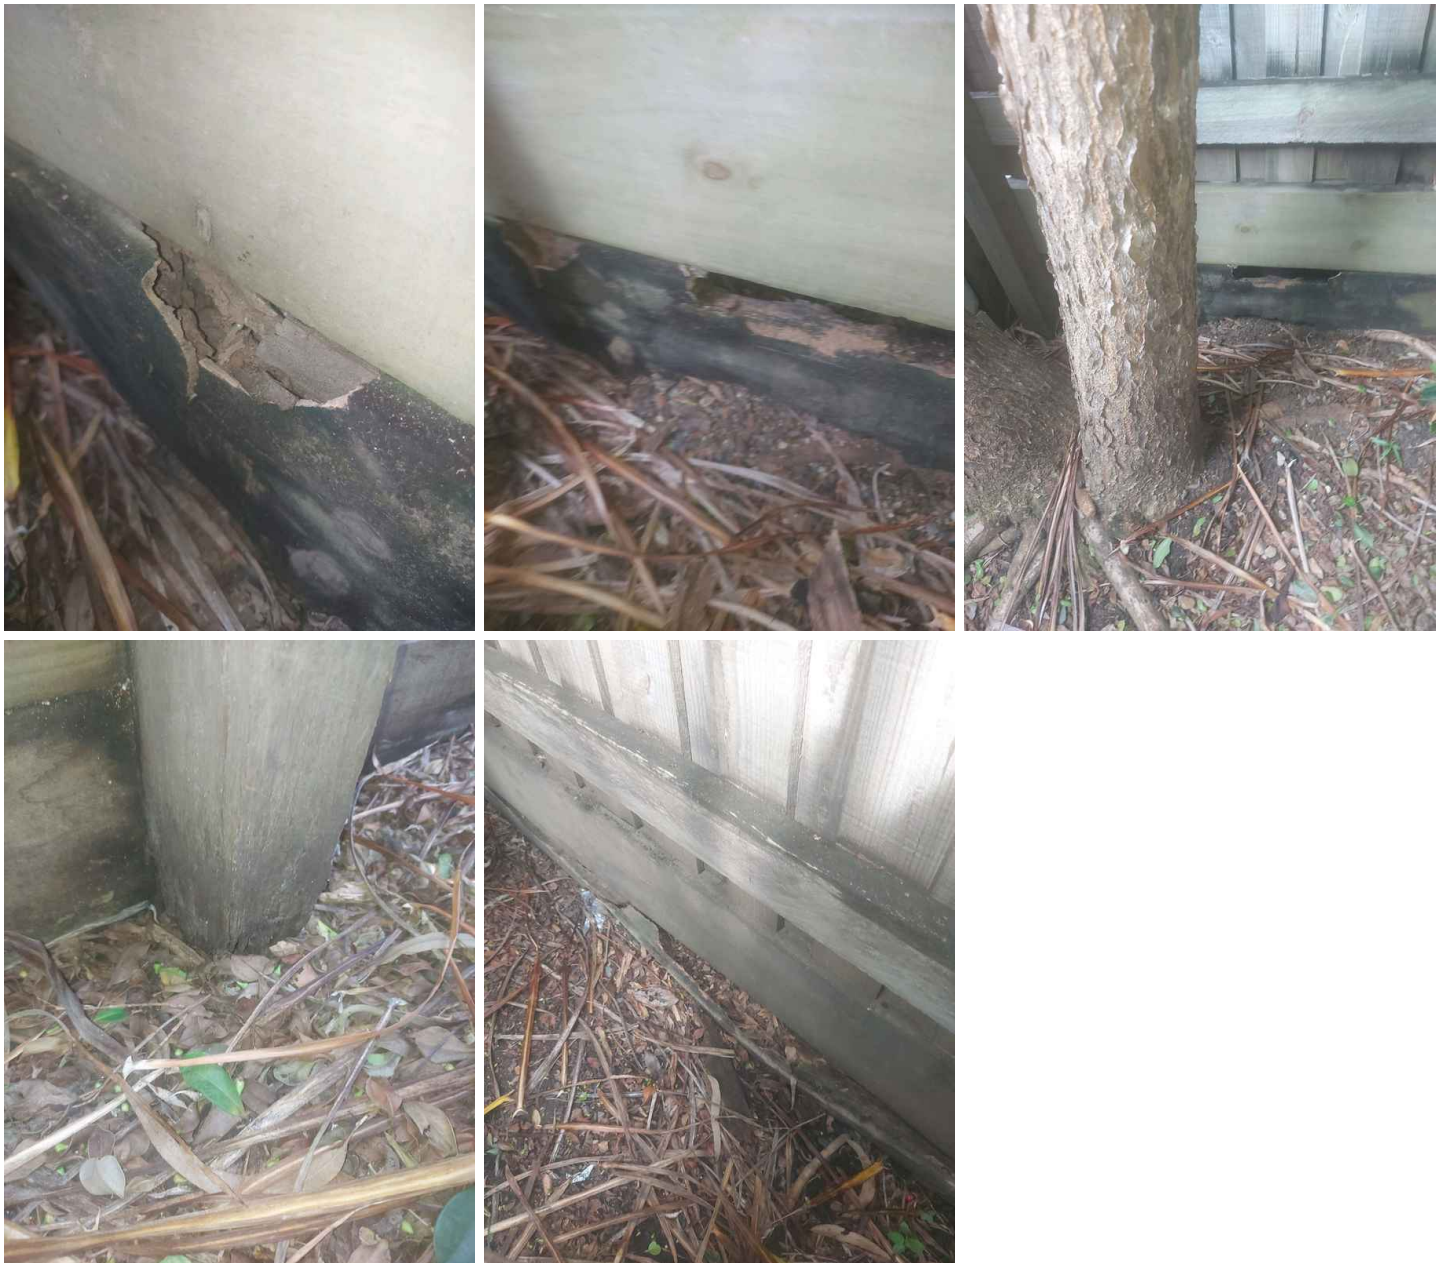
17.5.1 Termite Workings or Damage

**TERMITE DAMAGE OR WORKINGS FOUND**

Observations consistent with subterranean termite workings such as mud packing and/or damage was found at the time of the inspection

Where visual evidence of termite workings and/or damage is reported above, but no live termites were present at the time of inspection, it is possible that termites are still active in the immediate vicinity and the termites may continue to cause further damage. It is not possible, without the benefit of further investigation and a number of inspections over a period of time, to ascertain whether any infestation is active or inactive. Active termites may simply have not been present at the time of the inspection due to a prior disturbance, climatic conditions, or they may have been utilising an alternative feeding source. Invasive inspections are recommended to determine the full extent of damage. Continued, regular, inspections are essential. Unless written evidence of a termite protection program in accord with "Australian Standard 3660" with ongoing inspections is provided, arrange for a treatment in accord with "Australian Standard 3660" to be carried out to reduce the risk of further attack

Contact a qualified pest control specialist.

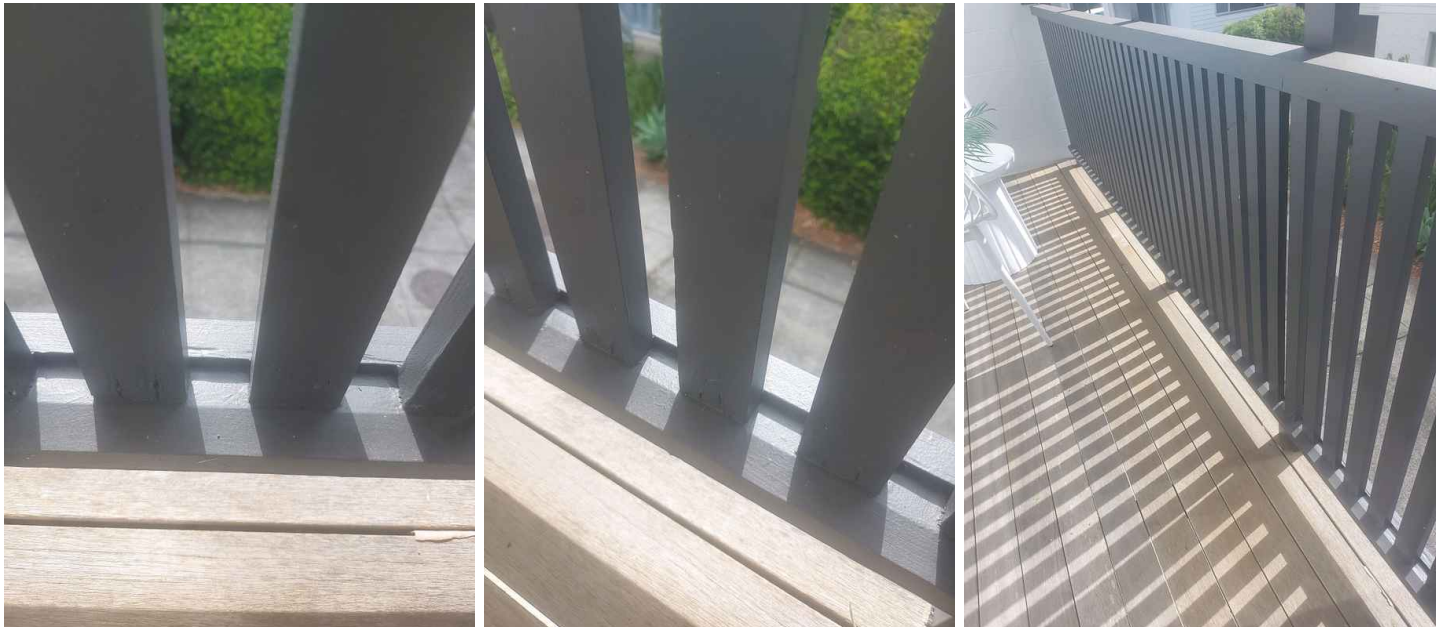
17.8.1 Fungal Decay (Wood Rot)

MINOR TO MODERATE FUNGAL DECAY DAMAGE

Minor to Moderate fungal decay damage was observed in various sections of timber, the decay did not appear to be structurally significant at time of the inspection. Further evaluation and repair or replacement recommended.

Contact a qualified professional.

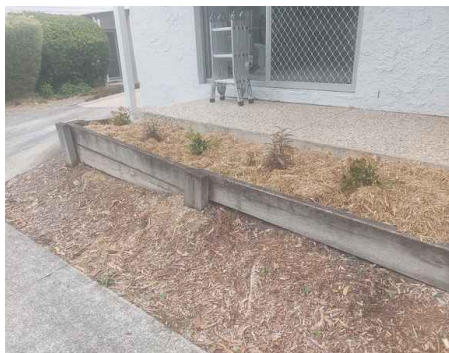
Site and Exterior: Landscaping Timbers

Timber in direct contact with the ground and or soil produces are ready food source for termites. Susceptible Timbers used in a hazardous environment are prone to fungal decay. It is recommended that you remove this condition order to prevent timber pest activity.

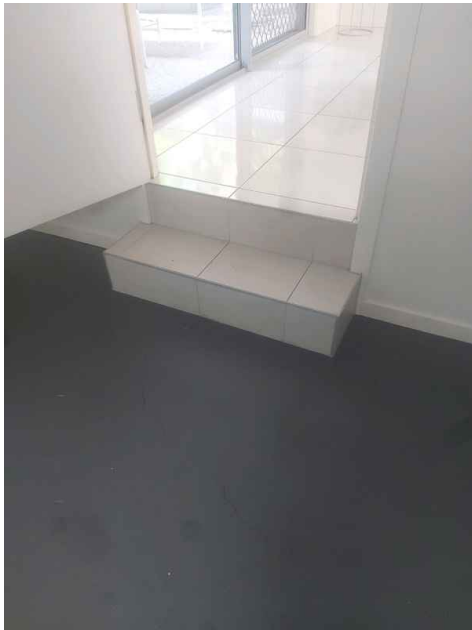
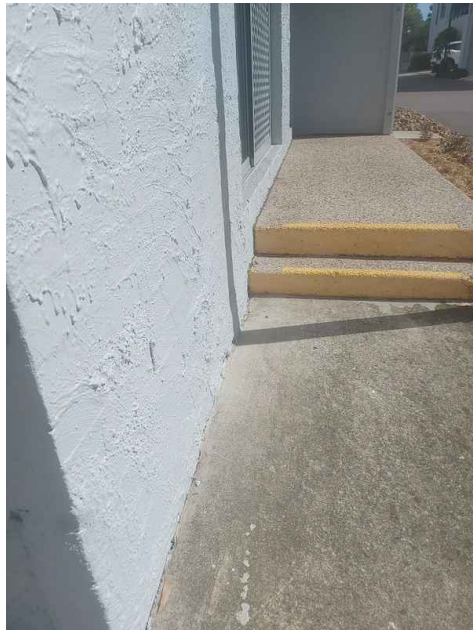
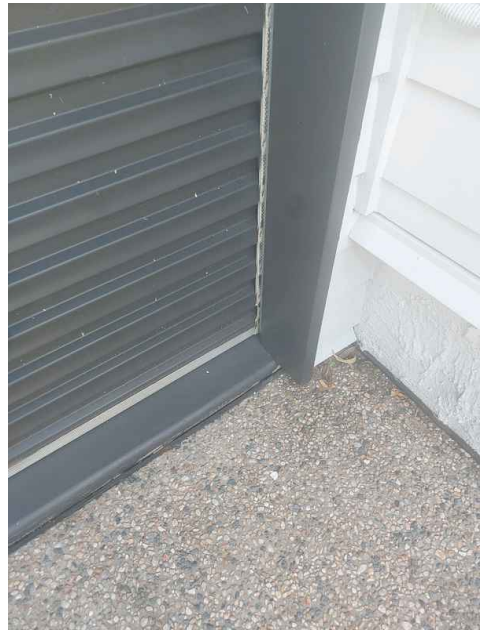
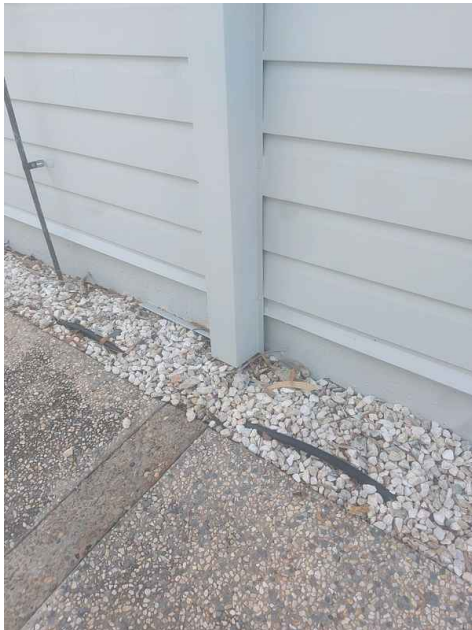
Minor-Moderate Attention Recommended

Rectify this condition, Reinspect, and maintain a clear inspection zone around the building

Contact a qualified professional.

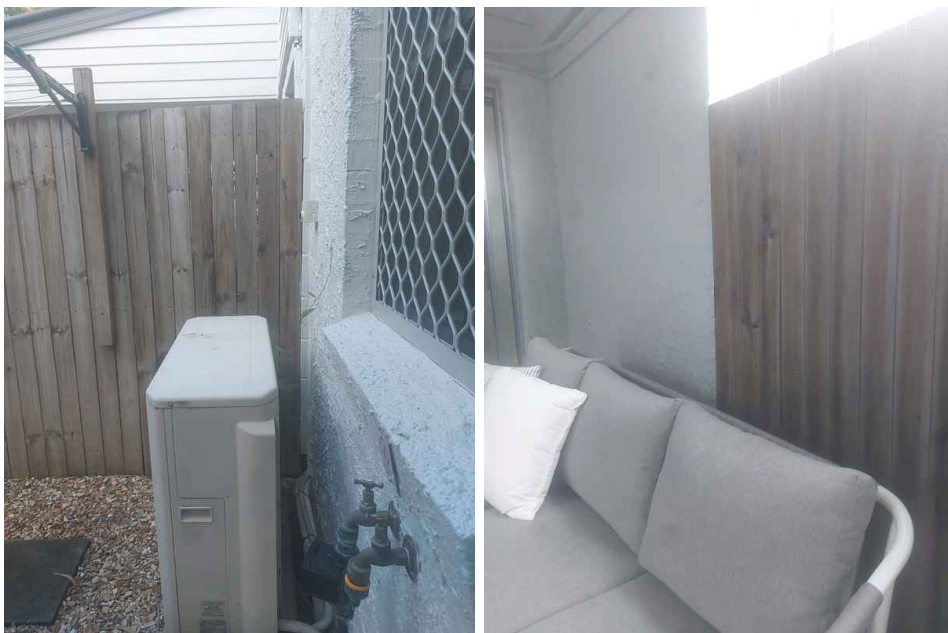
18.4.2 Bridging and Breaching of Termite Barriers and Inspection Zones

Minor-Moderate Attention Recommended

Further evaluation and correction recommended

Contact a qualified professional.

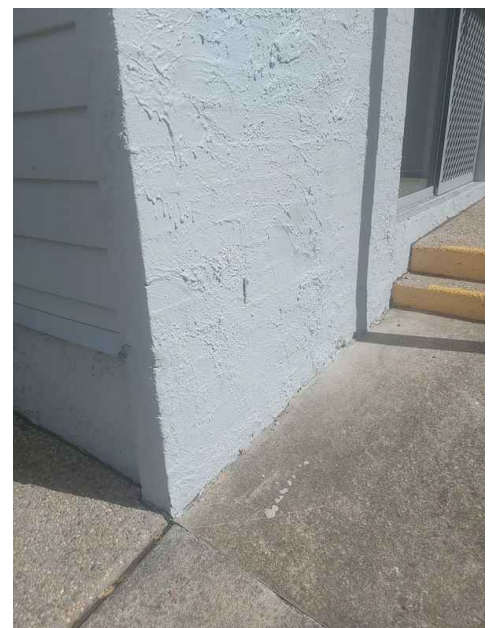
18.4.3 Bridging and Breaching of Termite Barriers and Inspection Zones

Minor-Moderate Attention Recommended

Further evaluation and correction recommended

Contact a qualified professional.
