BUILDING AND TIMBER PEST REPORT

508/455 Brunswick St
New Farm, QLD 4005

BYB
04/04/2024

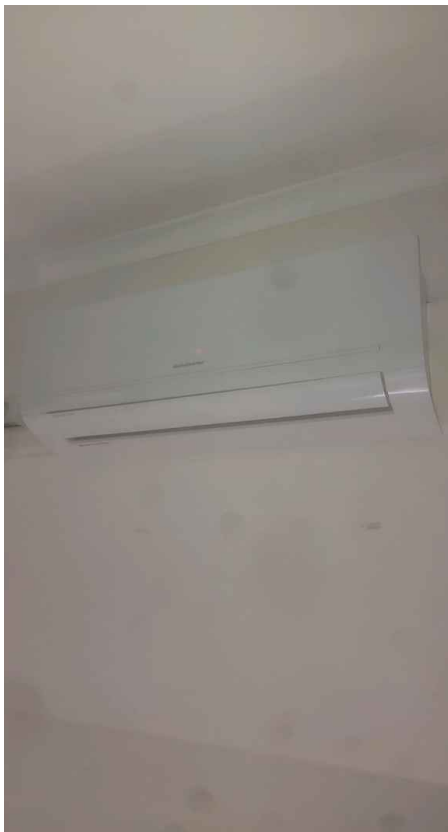
Air-conditioning is installed to the property but has not been tested/inspected. We recommend a licensed air conditioning specialist to determine the status of the units.

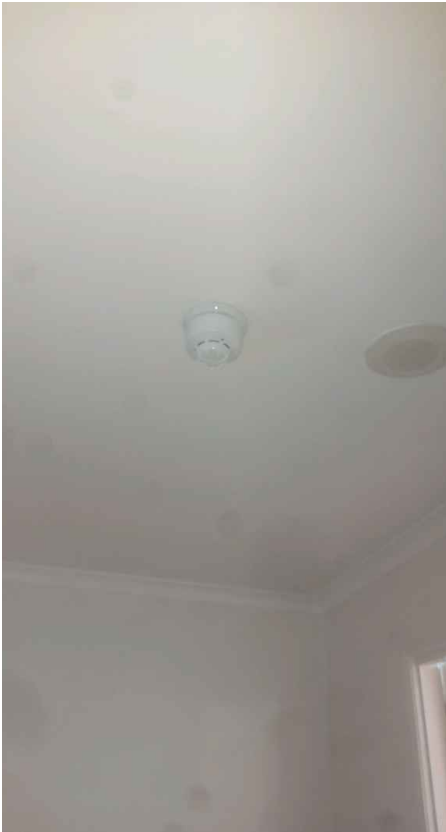
Smoke alarm(s) are fitted however the operation or adequacy was not tested and is not commented on.

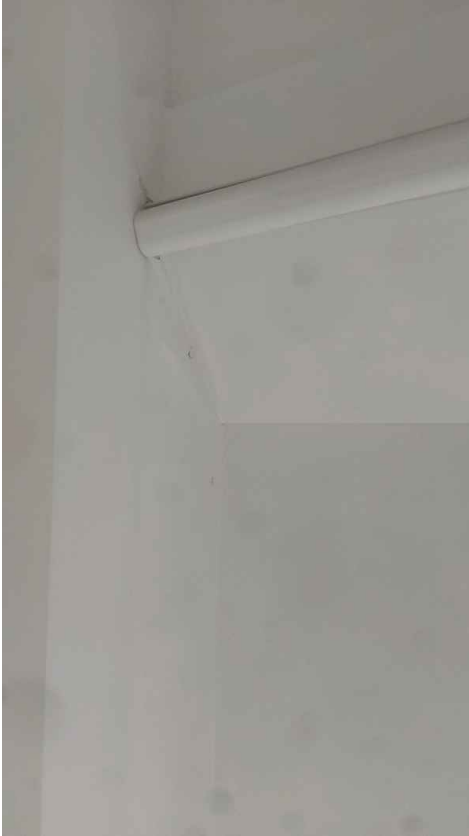
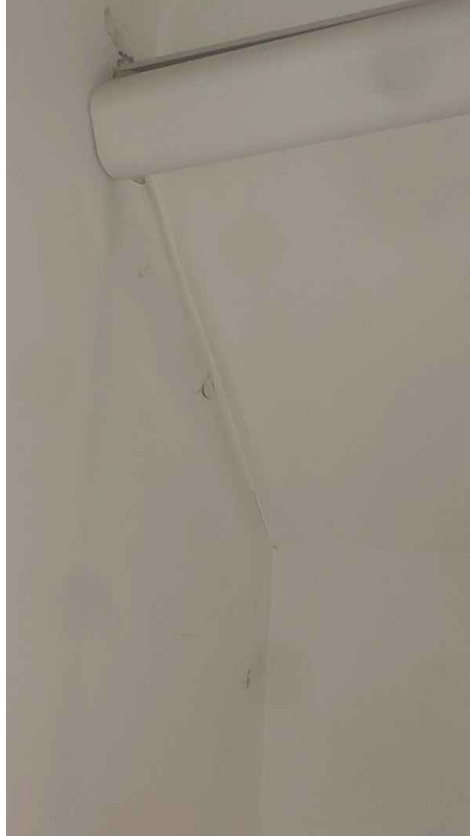
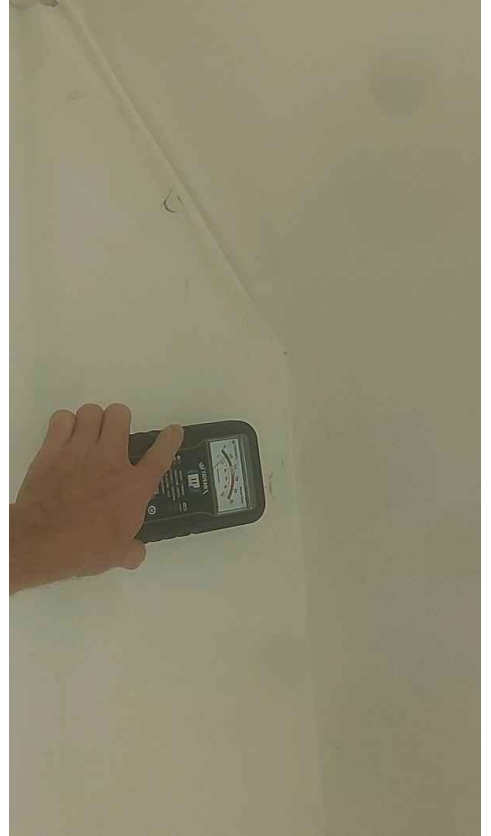
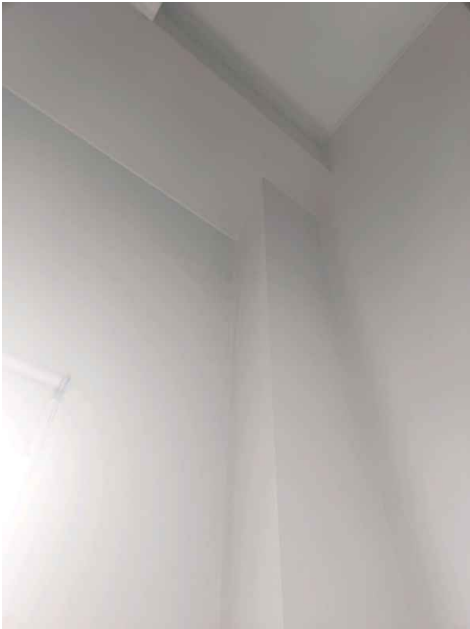
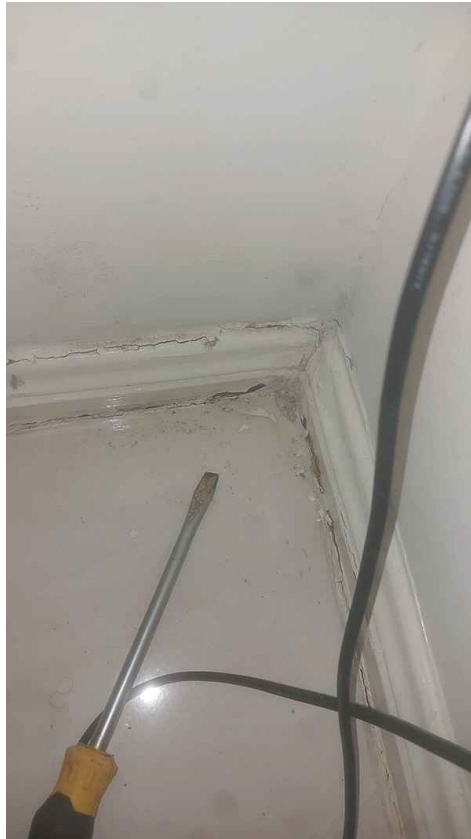
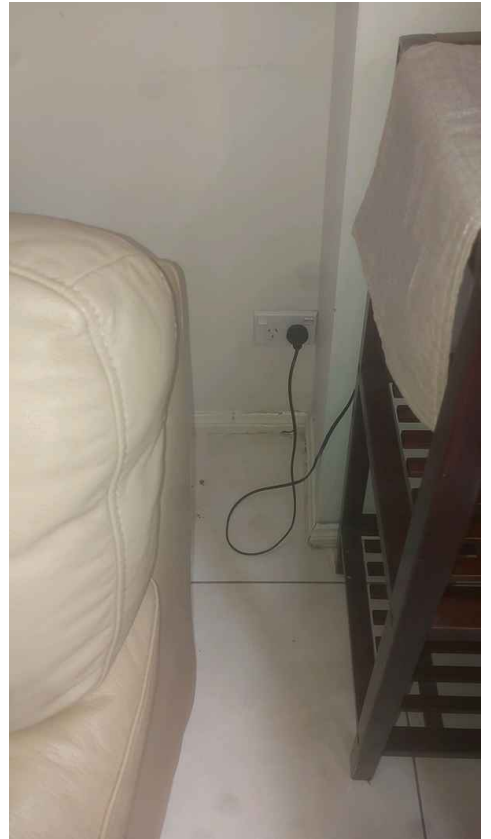
TOP LEVEL AIR-CONDITIONING PIPES

MOISTURE STAINS/DAMAGE - NO MOISTURE OBSERVED

Stains/damage on the walls visible at the time of the inspection appeared to be the result of moisture. The moisture meter showed no elevated moisture levels in the affected areas at the time of the inspection. Although this condition indicated that the source of moisture may have been corrected, further examination by a qualified contractor would be required to provide confirmation

Contact a qualified professional.

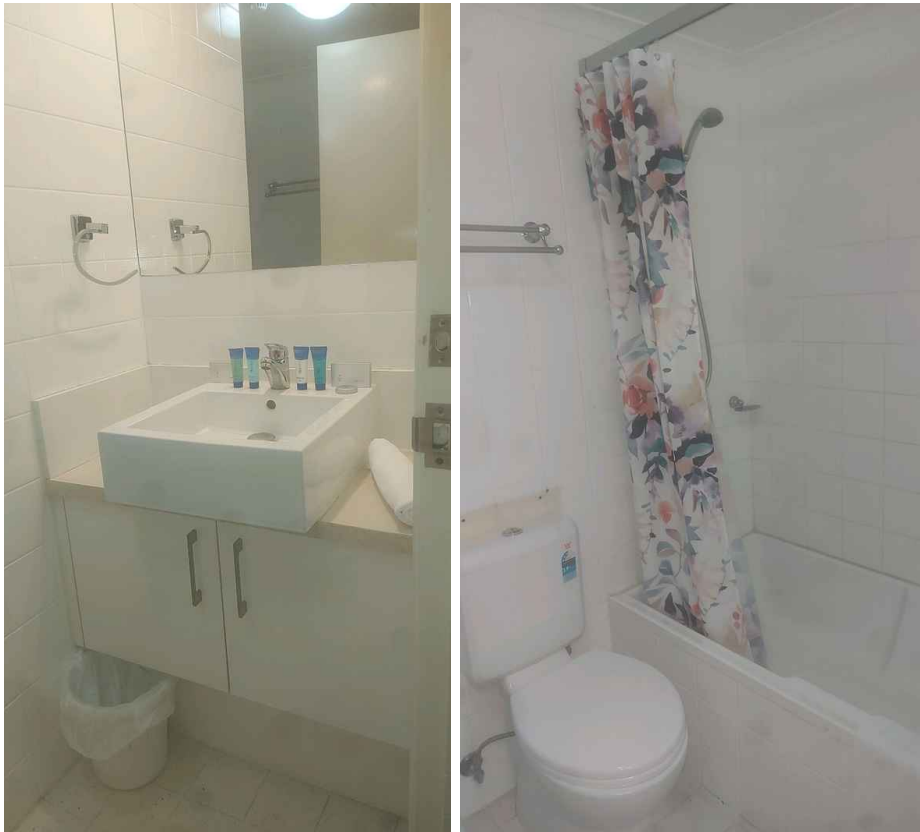
12.1.1 General

Although functioning, the bathroom/s are older and toward the end of useful life, and recommend consideration of replacement/renovation of the bathroom in the near future.

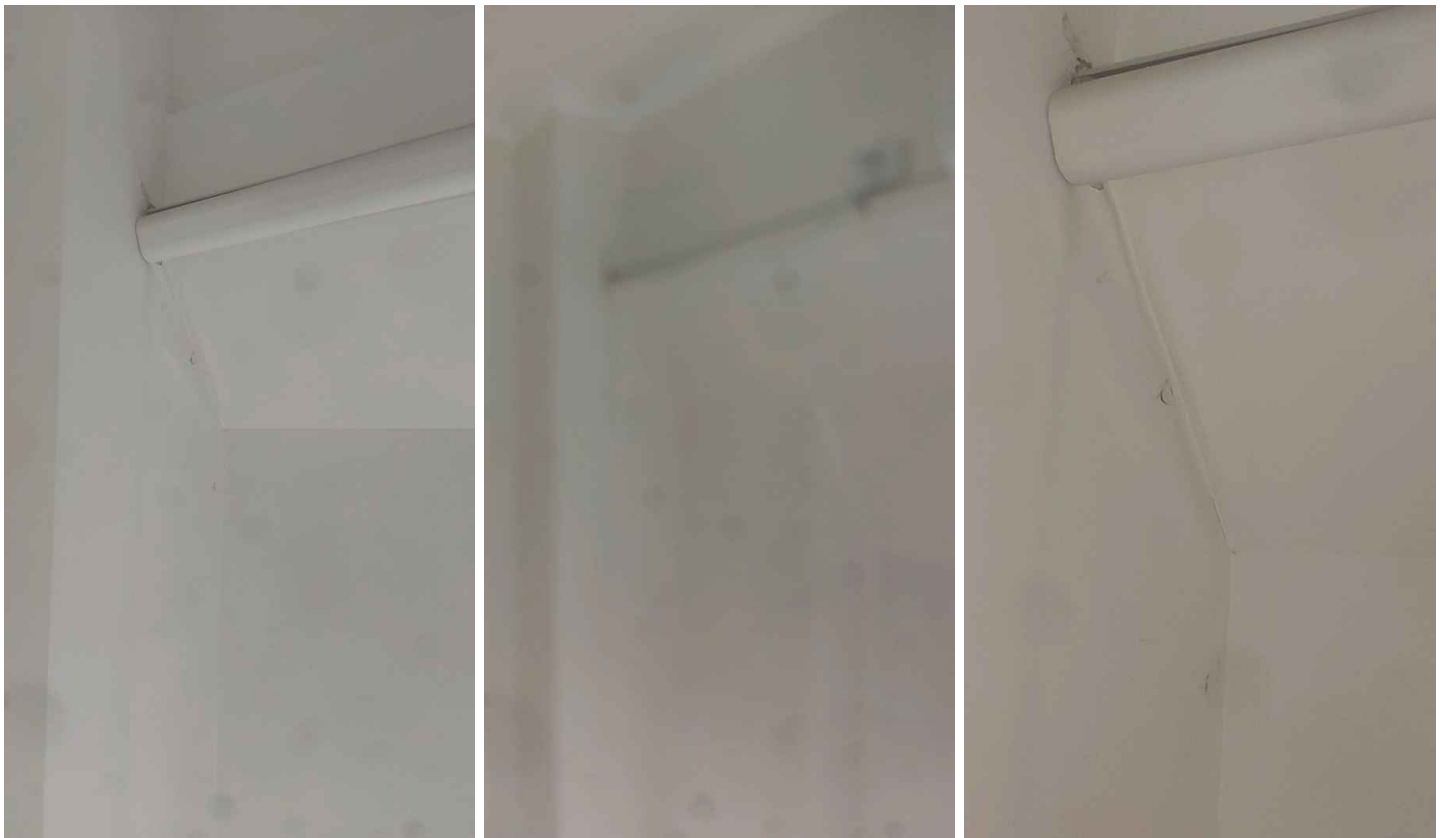
17.3.1 Presence of Excessive Moisture

EVIDENCE OF MOISTURE INTRUSION FOUND

The source of moisture should be identified and corrected to avoid continuing damage, and if there is any current damage. Further evaluation and correction are recommended.

Contact a qualified professional.
