BUILDING AND TIMBER PEST REPORT

13 Albert St
Camp Hill, QLD 4152

10/01/2024

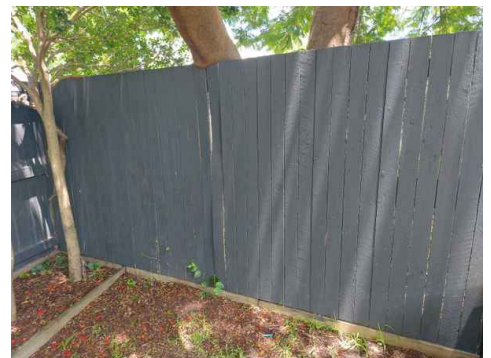
It should be stated that timber fences do have a finite service life. Timber and treatment to timber deteriorate over time, and require regular maintenance and replacement. Maintaining the bases of the fence posts and palings free and clear of soil, rotting leaves, and occasional treatment with a wood preservative will be most effective in prolonging service life.

Contact a qualified professional.

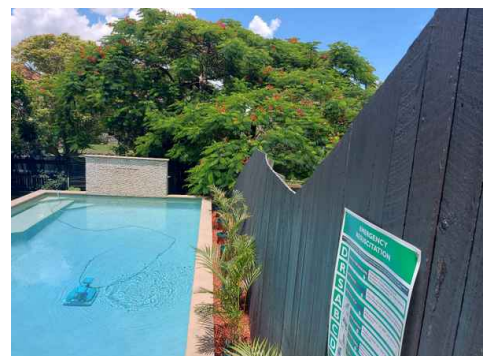
6.5.2 Fences/Gates

Fence leaning in areas. A qualified contractor should evaluate and make repairs or replace sections as necessary.

Contact a qualified fencing contractor

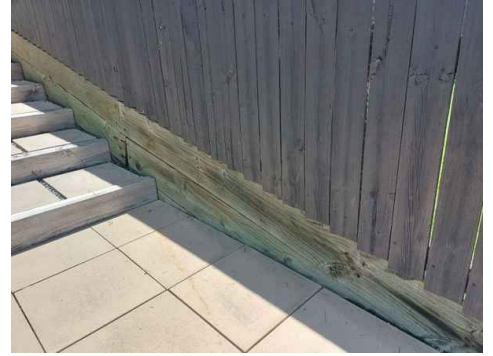
6.6.1 Retaining Walls

It should be stated that timber retaining have a finite service life. Maintaining and occasional treatment with a wood preservative may prolong service life. Timber retaining walls will require maintenance and replacement once deteriorated.

Contact a qualified professional.

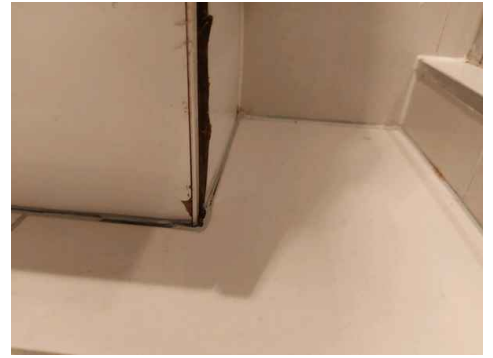
13.1.1 General

**MOISTURE
DAMAGE BELOW VANITY**

Further investigation and repairs recommended

Note: no current moisture observed

Contact a qualified professional.

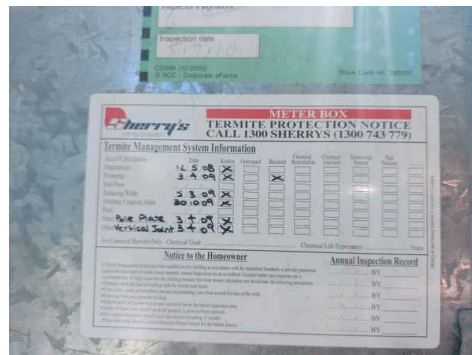
Observations/a notice indicates that the property has had a "Kordon" termite management system installed during construction in respect to protection against subterranean termite attack. We strongly recommend any prospective purchaser attempt to verify this information and obtain copies of all relevant documentation.

Contact a qualified professional.

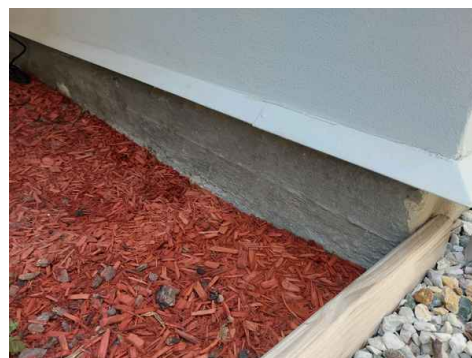
17.3.2 Termite Management Systems

The chosen method of termite protection for this property includes either a full or partial exposed slab edge to the perimeter of the house. This method relies heavily upon regular professional and homeowner inspection of the slab edge. This method does not prevent termite entry, it relies upon making a termite attack more easily detected and then taking action once termite activity has been observed.

Contact a qualified professional.
