## BUILDING AND TIMBER PEST REPORT

14 Lloyd St  
Camp Hill, QLD 4152

BYB  
04/04/2024

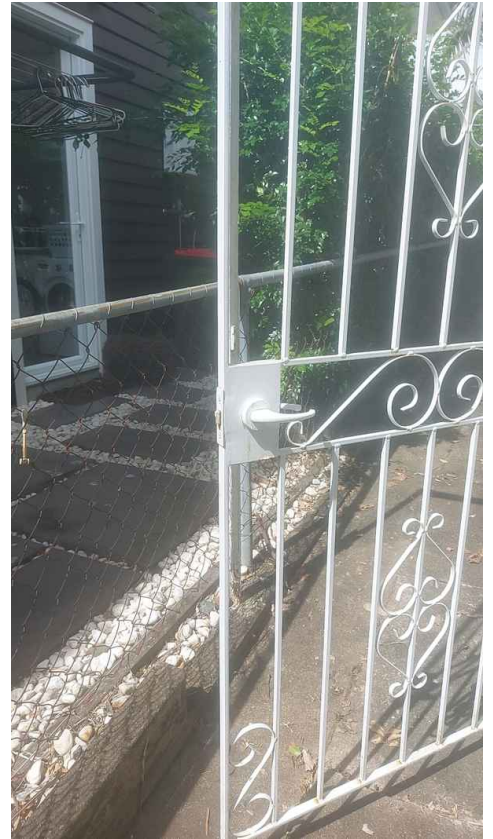
Minor-Moderate Attention Recommended
**GATE DIFFICULT TO OPEN / CLOSE**

Contact a qualified fencing contractor

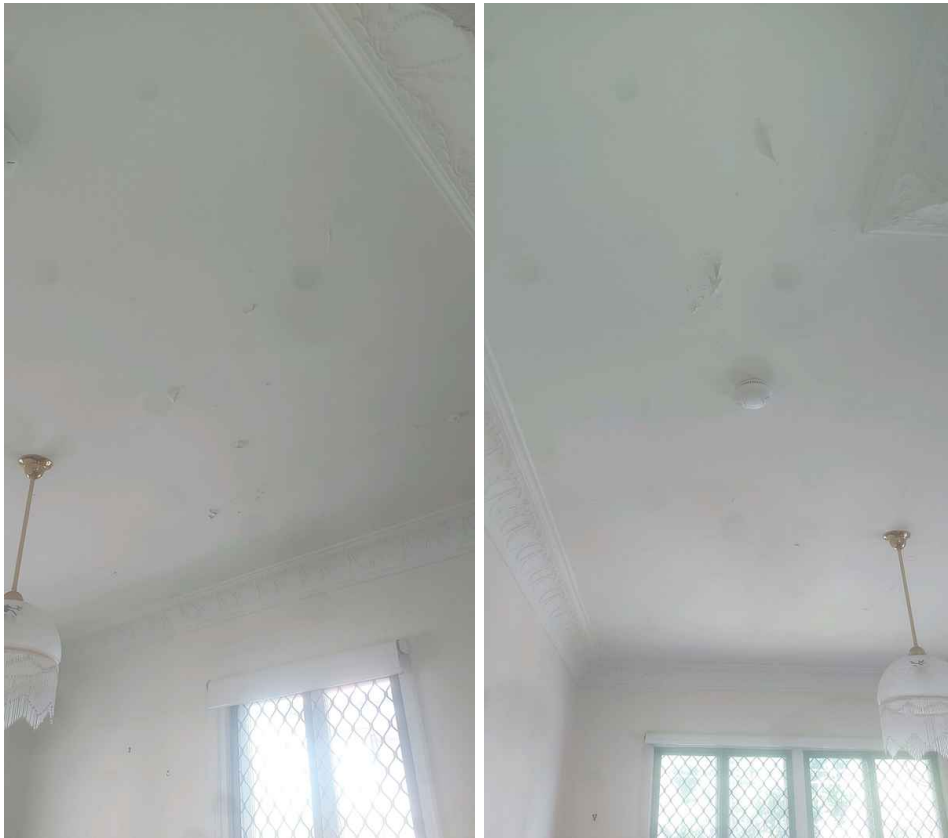
Repainting/regular maintenance recommended

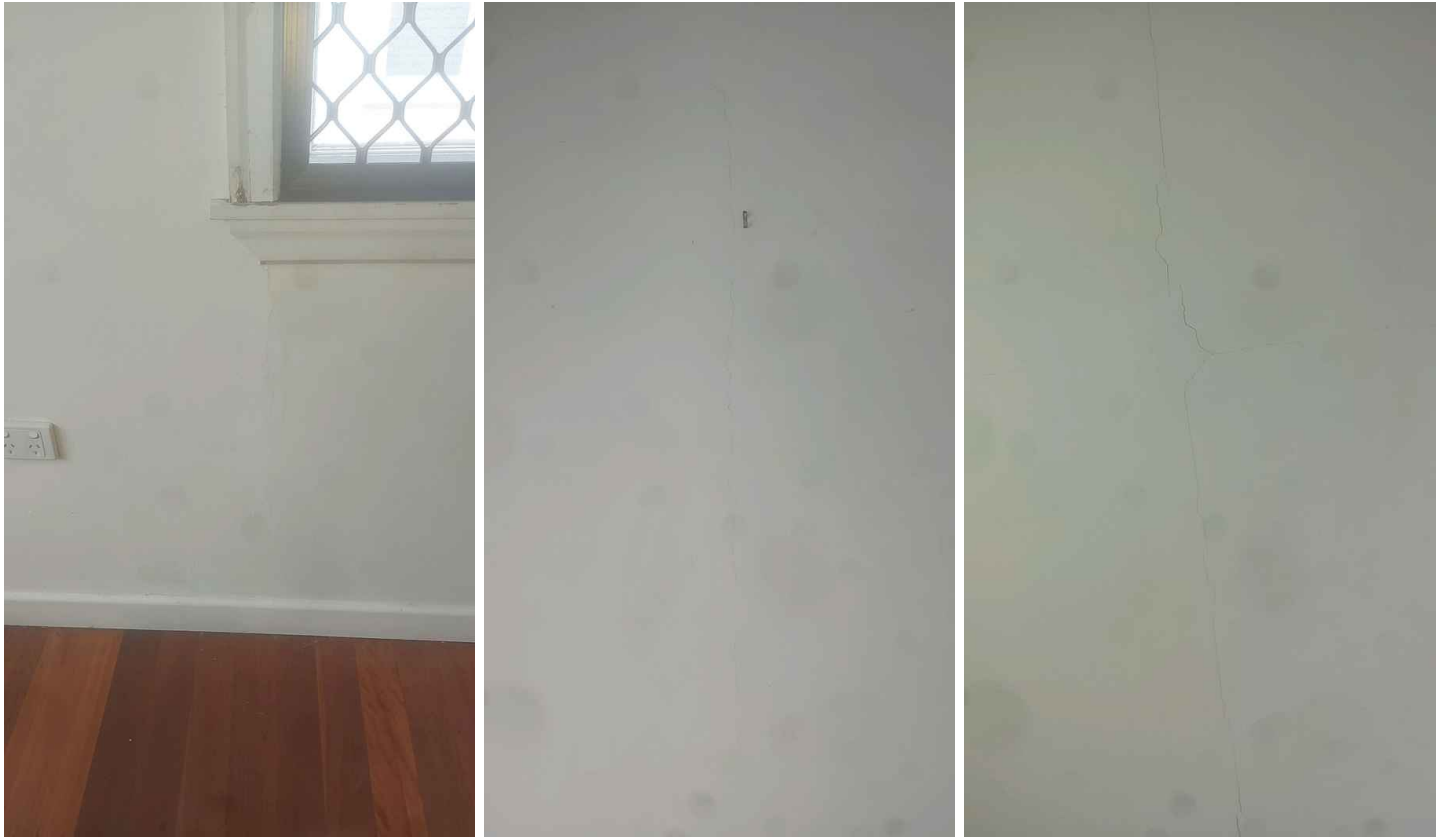
## 11.5.1 Walls

**MINOR CRACKS**

There are minor cracks in the walls. This is a common condition with this type of construction and at the time of inspection appeared to be slight and appearance defect. The cracks can be repaired or painted, and expansion joints installed where appropriate. We recommend repair by a qualified plasterer.

Note: if the condition worsens/deteriorates, further evaluation and correction recommended by a structural engineer.

Contact a qualified professional.

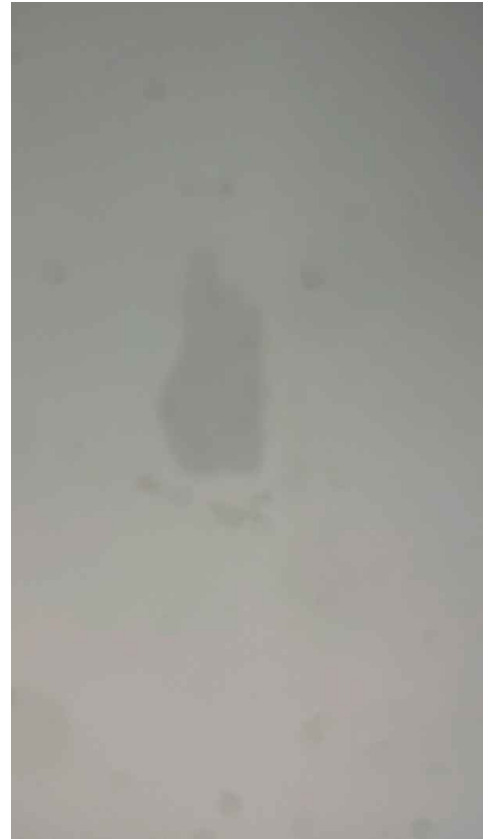
## 11.5.3 Walls

Repair patches installed in the were poorly finished.

Recommend further evaluation and correction by a plasterer.

Contact a qualified professional.

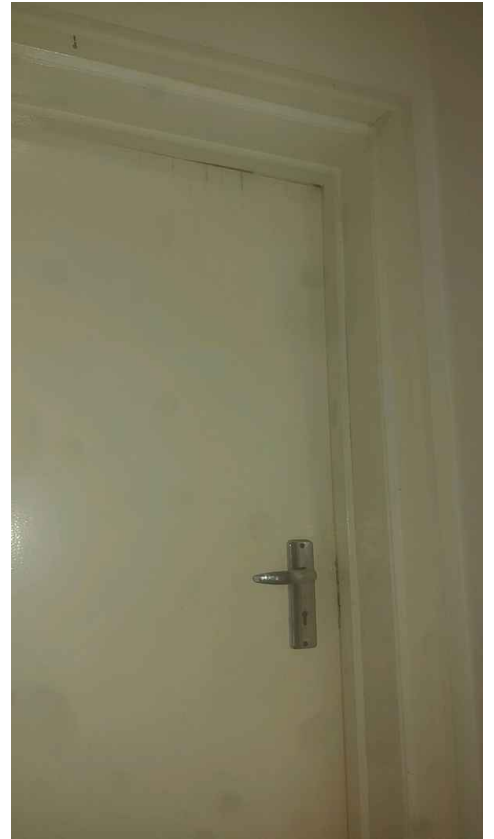
## 11.6.1 Doors

Minor-Moderate Attention Recommended
**BINDING/RUBBING**

Further evaluation and correction recommended.

Contact a qualified professional.

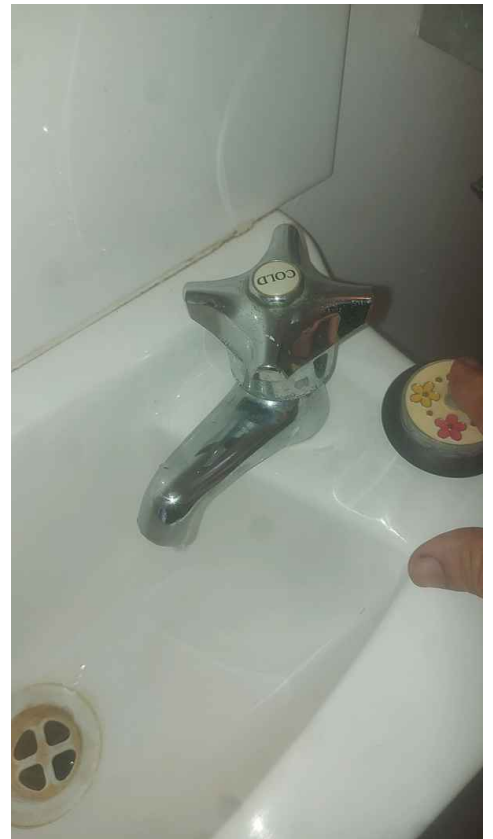
13.1.1 General

### **DAMAGED FIXTURES AND FITTINGS**

Further evaluation and correction recommended

Contact a qualified professional.

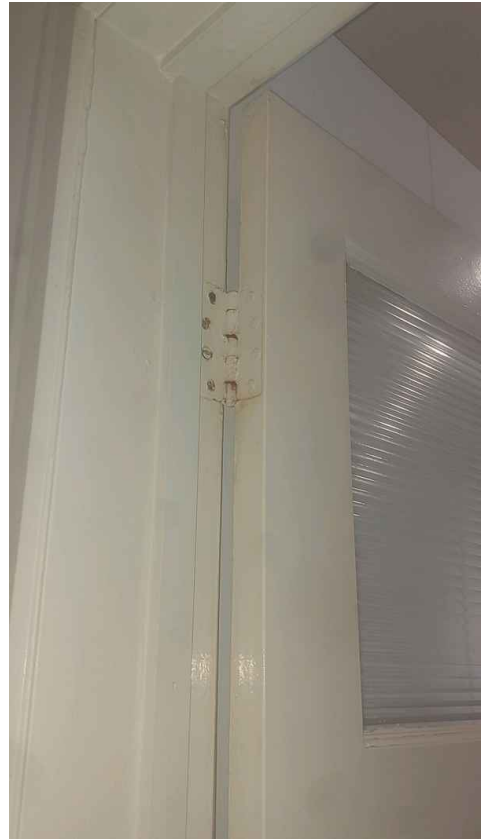
## 13.2.1 Doors

**NO LIFT OFF  
HINGES**

For safety lift off hinges should be installed to the toilet door.

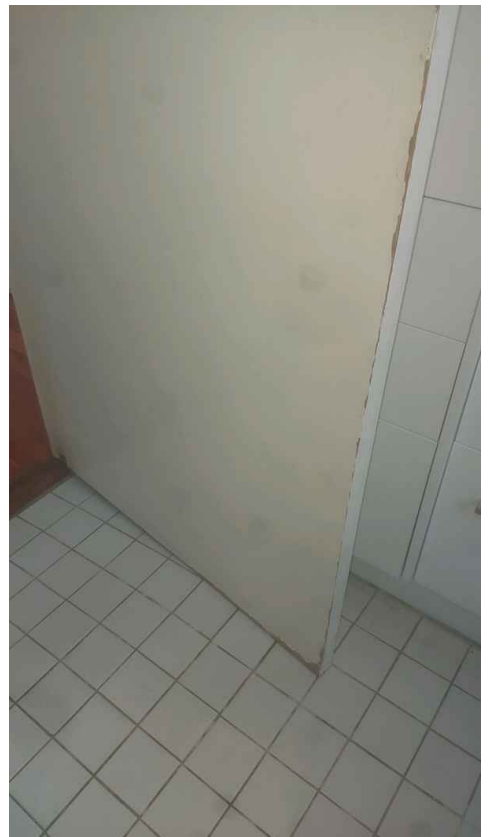
## 13.2.2 Doors

**MINOR  
DAMAGE/DETERIORATION**

An interior door exhibited minor damage or deterioration commensurate with the age of the home.

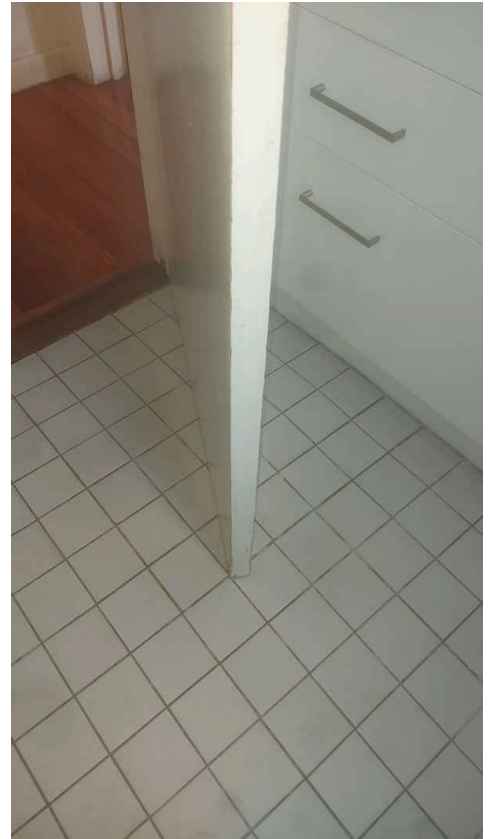
## 13.2.3 Doors

Minor-Moderate Attention Recommended**DIFFICULT TO CLOSE, JAMB BINDING- QC**

The door to the exterior in the \*Bathroom Location\* was binding on the jamb and was difficult to close. The Inspector recommends service by a qualified contractor.

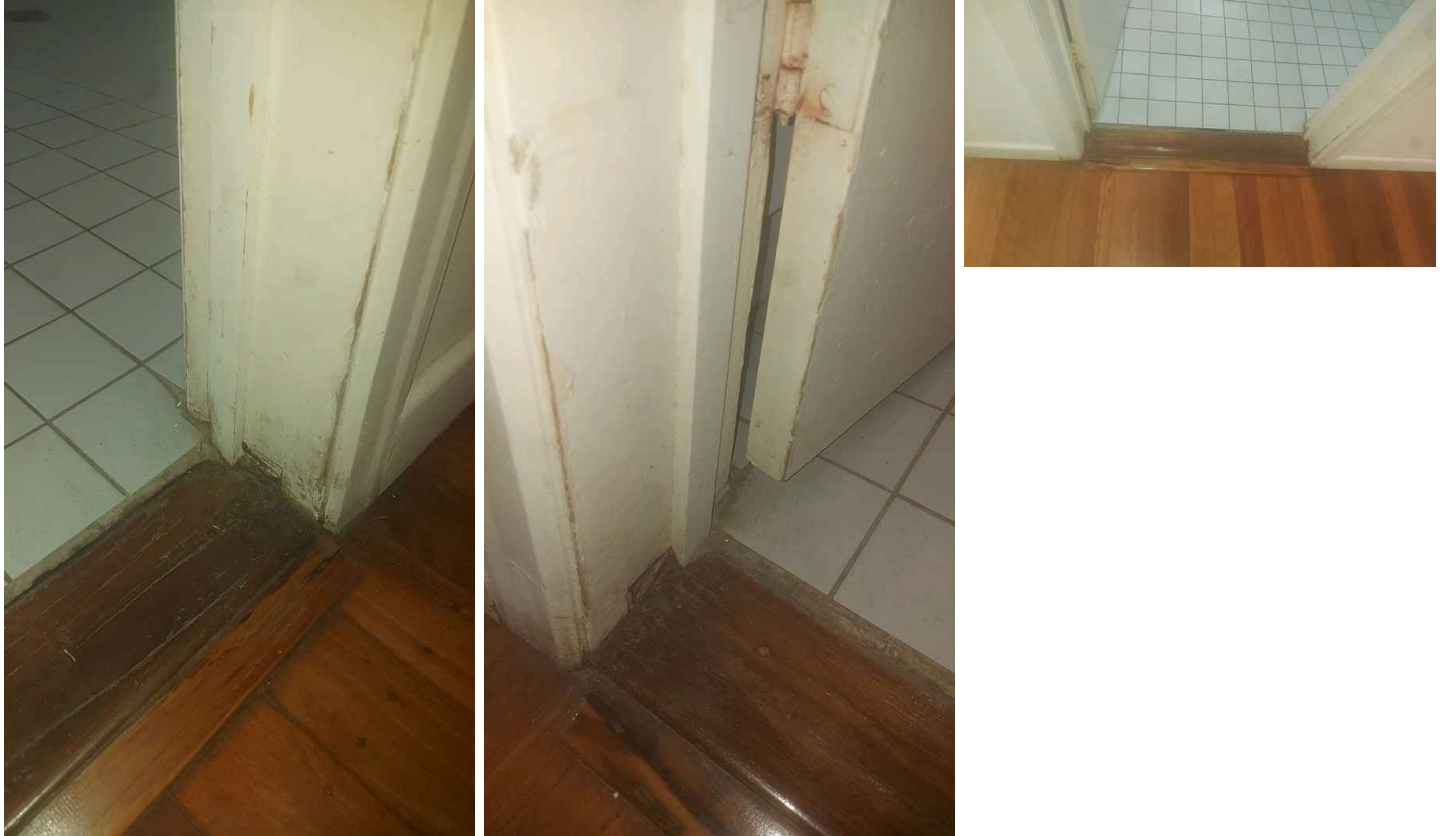
## 17.8.1 Fungal Decay (Wood Rot)

**MINOR TO MODERATE FUNGAL DECAY DAMAGE**

Minor to Moderate fungal decay damage was observed in various sections of timber, the decay did not appear to be structurally significant at time of the inspection. Further evaluation and repair or replacement recommended.

Contact a qualified professional.

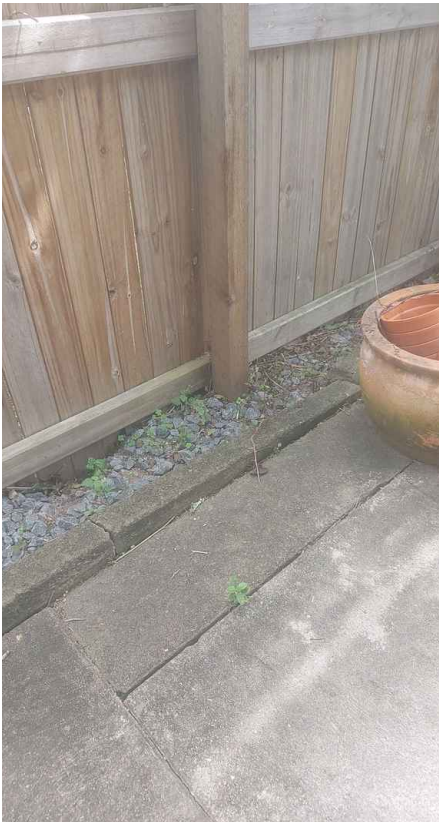
**Site and Exterior: Fence Palings in contact with the ground**

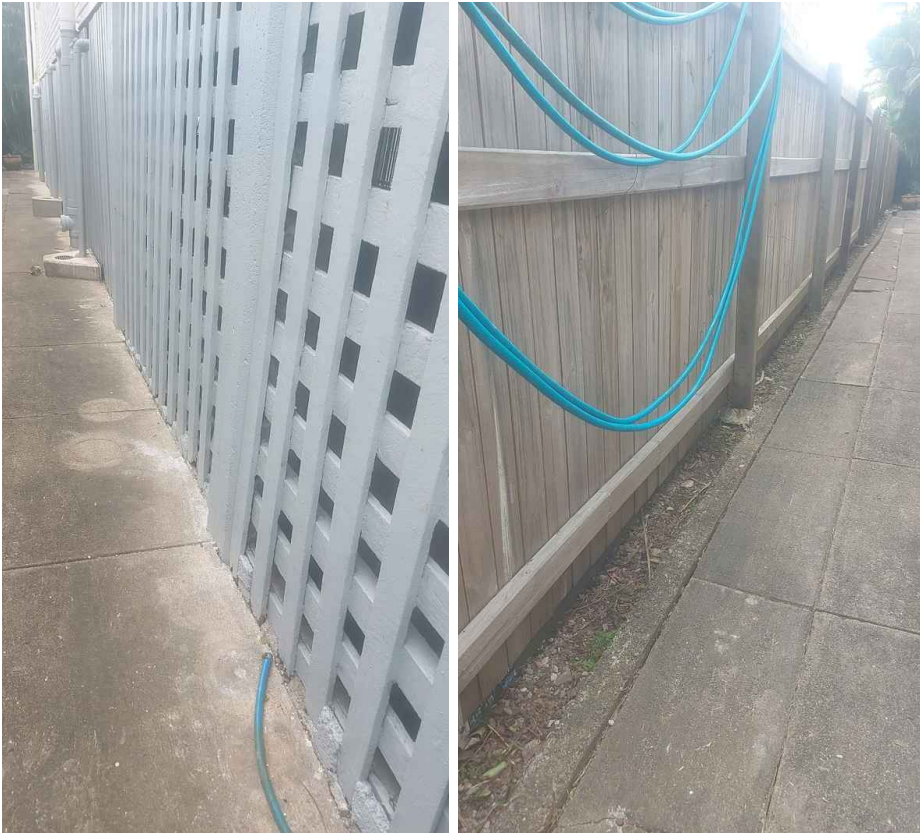
**Site and Exterior: Timber in ground contact**

Timber in contact with the ground will raise the moisture content of timber creating conditions conducive to fungal decay. Action is required to remove this condition in order to prevent timber pest activity and structural damage occurring.

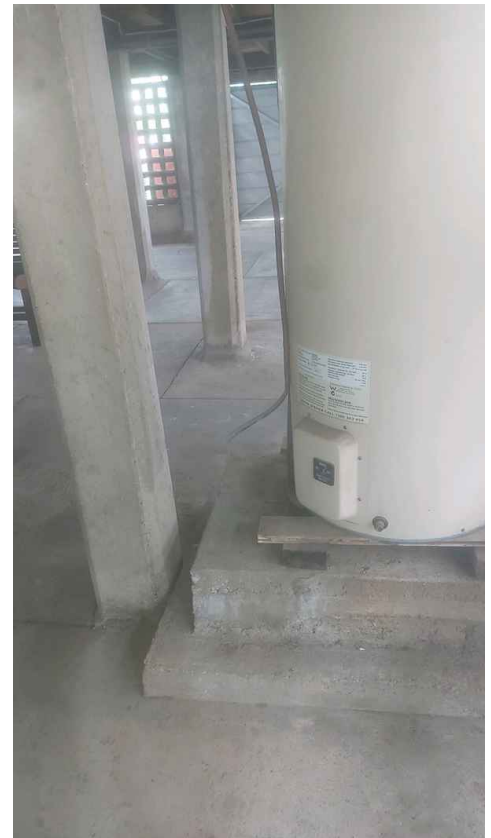
## 18.5.1 Site and Exterior

Minor-Moderate Attention Recommended

Contact a qualified professional.
