BUILDING AND PEST XL2

24 Fryar St
Camp Hill, QLD 4152

Before You Bid (BYB)
10/11/2023

Pre-Purchase Inspection - Residential Building Report

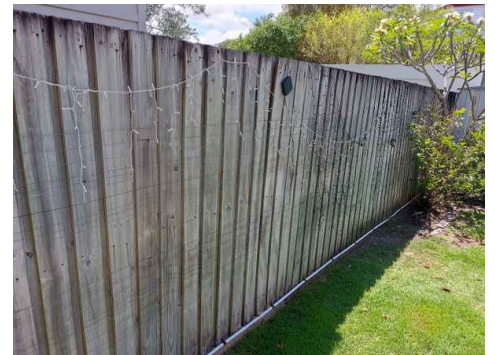
Fences/Gates: The condition of the fences appeared to be commensurate with their age.

It should be stated that timber fences do have a finite service life. Timber and treatment to timber deteriorate over time, and require regular maintenance and replacement. Maintaining the bases of the fence posts and palings free and clear of soil, rotting leaves, and occasional treatment with a wood preservative will be most effective in prolonging service life.

Contact a qualified professional.

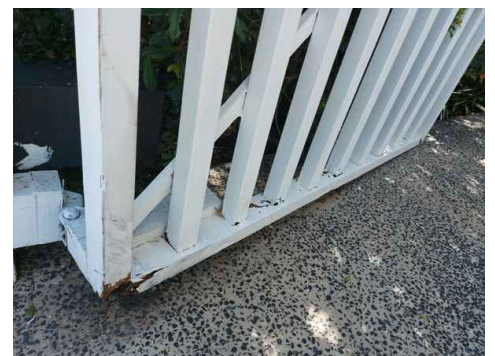
GATE REPAIR - MINOR

One or more gates had some damage and/or deterioration. Recommend repairs made.

Contact a handyman or DIY project

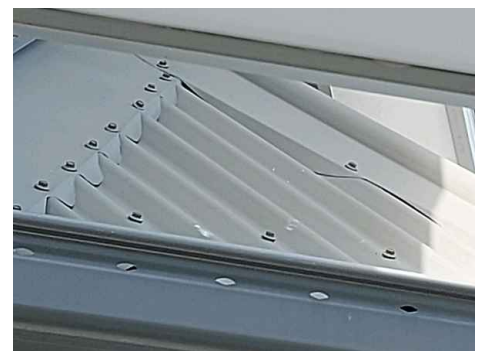
General: Primary roof-covering type:

Metal sheet corrugated

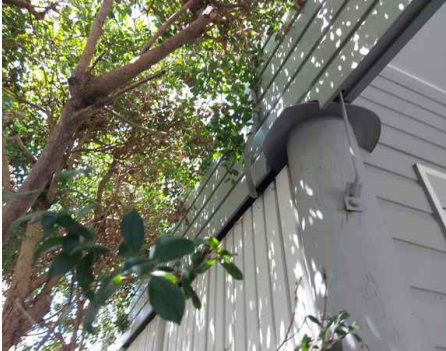
Left side of the building

Access to inspect external walls was partially restricted by vegetation / foliage

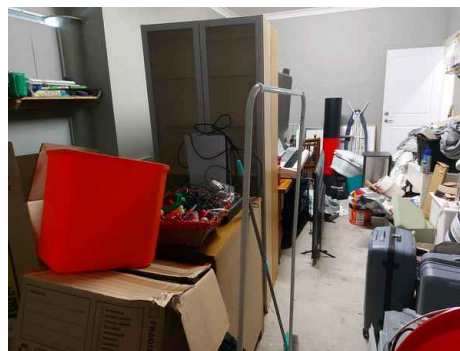
Access, Restrictions, and Limitations: Garage/Shed - Stored items

Stored items restricted inspection to the areas

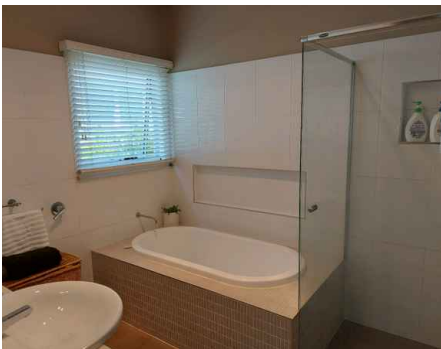
Bathroom

No Major Defects Were Observed. Normal ongoing maintenance is required.

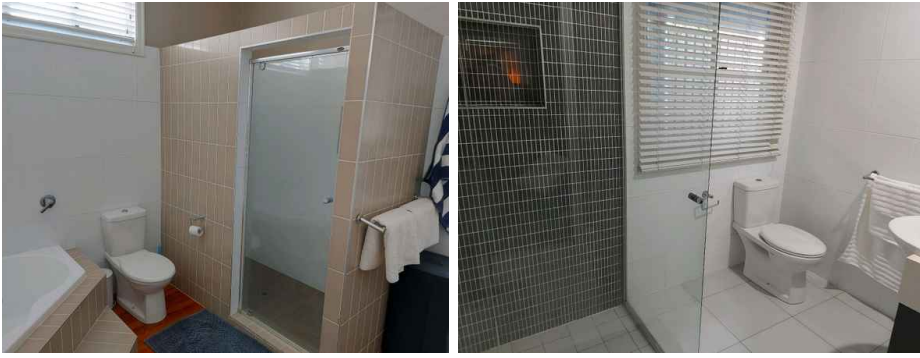
Ensuite

No Major Defects Were Observed. Normal ongoing maintenance is required.

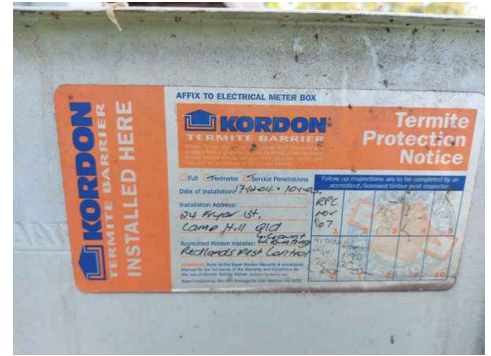
A notice indicates that the property may have had a termite management system during construction in respect to protection against subterranean termite attack. We strongly recommend any prospective purchaser attempt to verify this information and obtain copies of all relevant documentation.

Contact a qualified professional.
