BUILDING AND TIMBER PEST REPORT

24 Goulburn St
Hawthorne, QLD 4171

BYB
28/03/2024

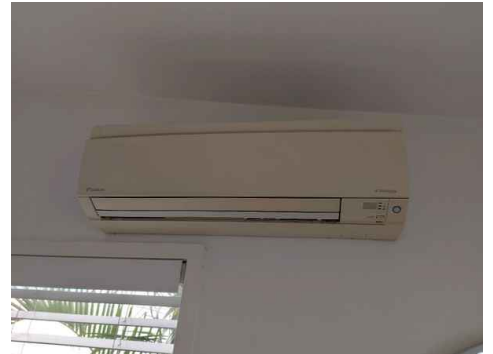
5.3.1 Air Conditioning

Minor-Moderate Attention Recommended

DAMAGED

Further evaluation and correction recommended

Contact a qualified HVAC professional.

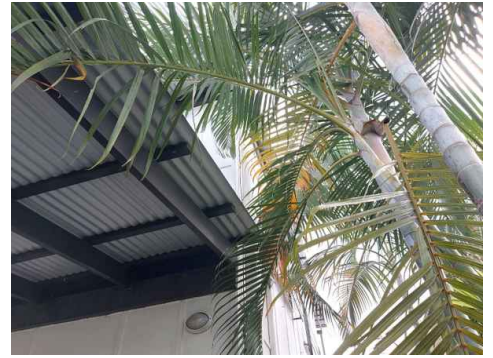
Minor-Moderate Attention Recommended

We consider this a potential threat to the structure. To eliminate the potential for damage, we recommend modification of the structure to accommodate the tree or removal of the tree.

Contact a qualified professional.

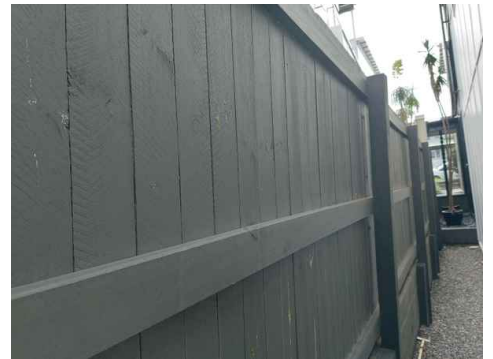
6.5.1 Fences/Gates

It should be stated that timber fences do have a finite service life. Timber and treatment to timber deteriorate over time, and require regular maintenance and replacement. Maintaining the bases of the fence posts and palings free and clear of soil, rotting leaves, and occasional treatment with a wood preservative will be most effective in prolonging service life.

Contact a qualified professional.

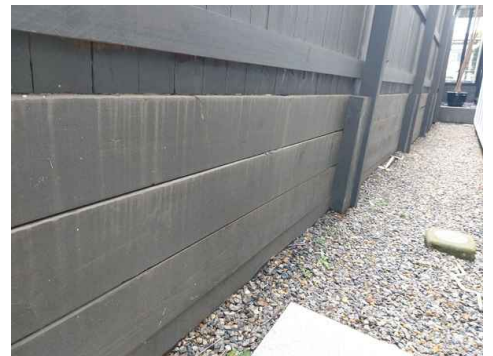
6.6.1 Retaining Walls

It should be stated that timber retaining have a finite service life. Maintaining and occasional treatment with a wood preservative may prolong service life. Timber retaining walls will require maintenance and replacement once deteriorated.

Contact a qualified professional.

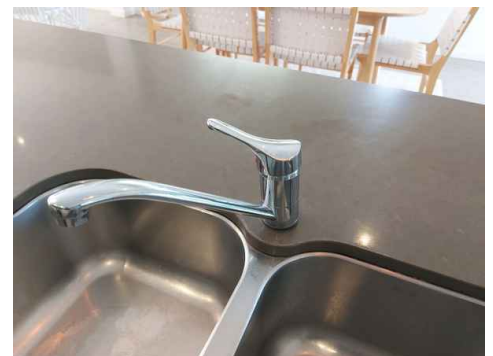
12.1.1 Cabinets

LOOSE SPOUT

The spout of the kitchen faucet was loose.

Contact a qualified professional.

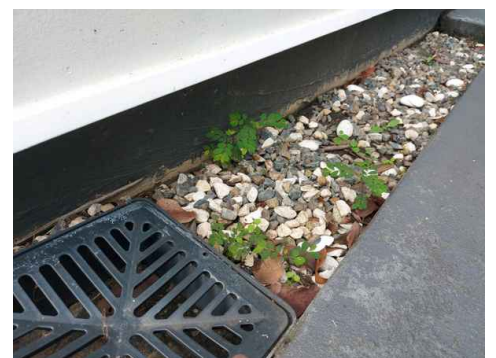
17.3.1 Termite Management Systems

KORDON

Observations/a notice indicates that the property has had a "Kordon" termite management system installed during construction in respect to protection against subterranean termite attack. We strongly recommend any prospective purchaser attempt to verify this information and obtain copies of all relevant documentation.
