BUILDING AND TIMBER PEST REPORT

24 Lindisfarne St
Carindale, QLD 4152

26/03/2024

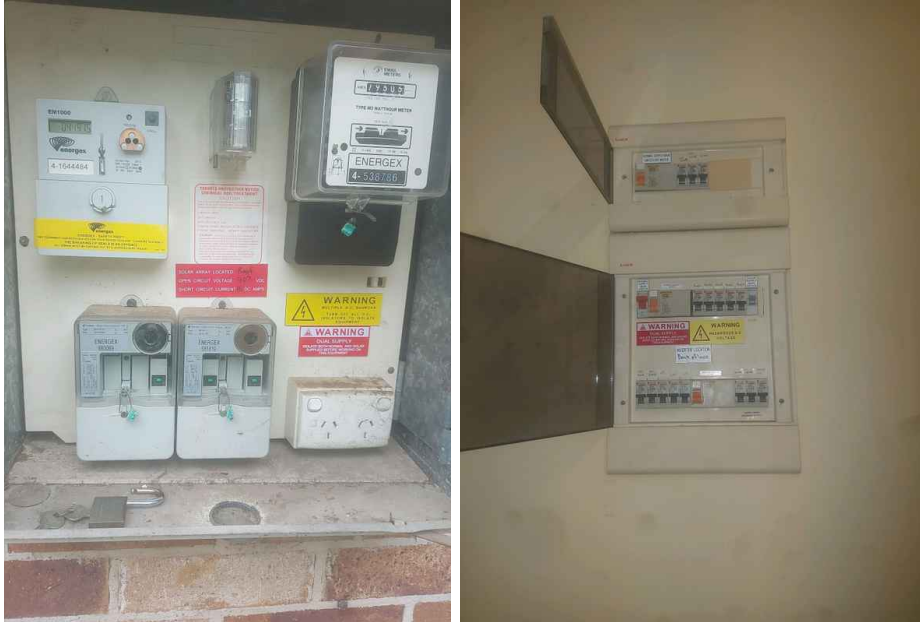
Electrical : Solar Power System Installed

A solar power system including Panels and/or Inverter was observed, but no testing was conducted. Consult a Qualified Electrician to determine the adequacy and current status.

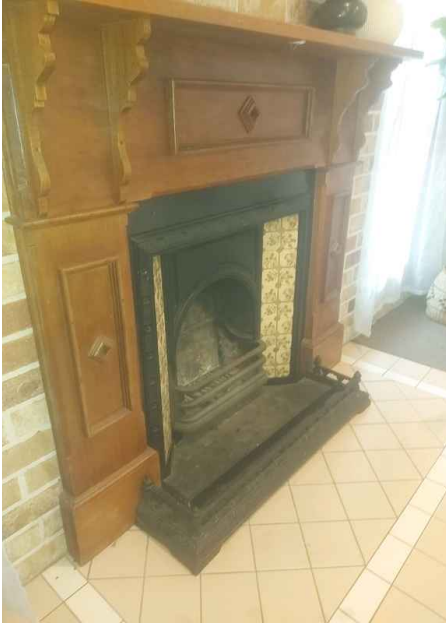
Combustion heater : Fire place/ heater - Not tested

There is a solid fuel combustion heater appliance installed. The inspection of this appliance is not included in the scope of this report. I recommend that you ensure that this appliance is correctly installed and the chimney/fireplaces should be professionally tested for safety and cleaned prior to being put into use.

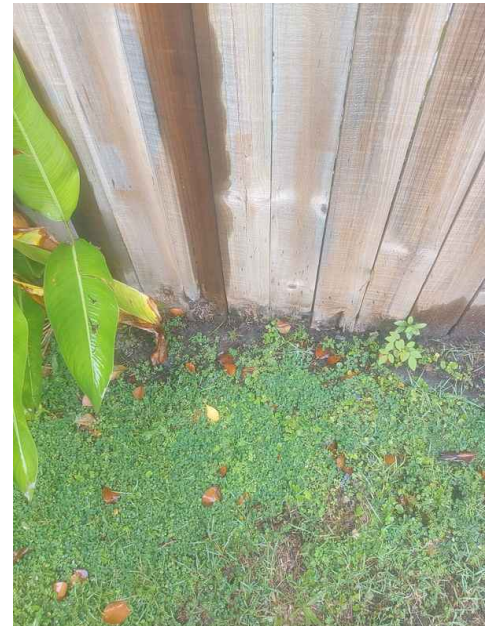
**FENCE REPAIR - MINOR**

Fences and/or gates are damaged and/or deteriorated in some areas. Make repairs or replace sections as necessary.

Contact a qualified fencing contractor

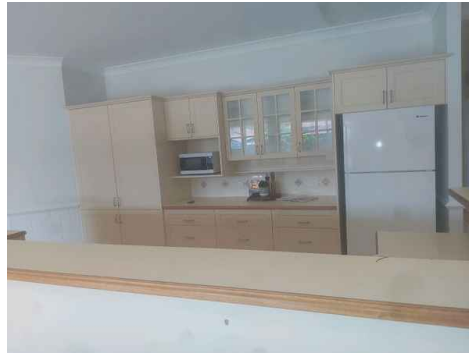
13.1.1 Cabinets

EXTERIOR DAMAGE

The kitchen cabinets exhibited damage.

Further evaluation and correction recommended.

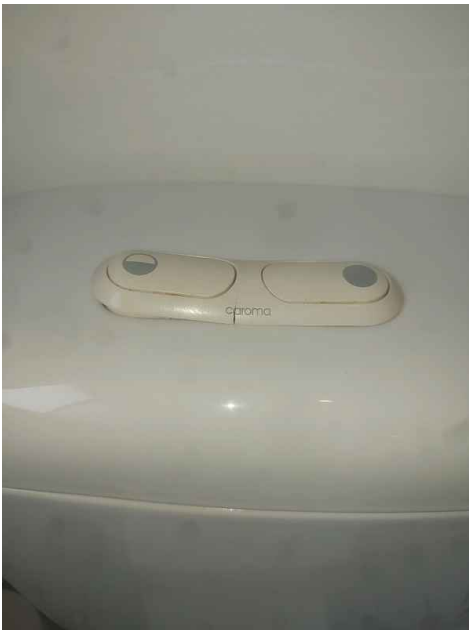
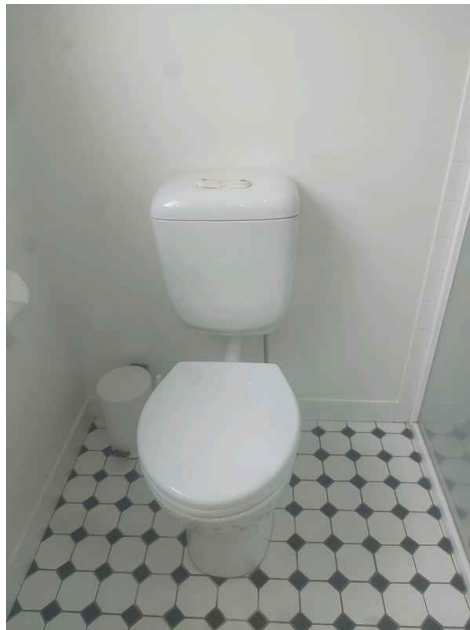
14.2.1 Toilet

FLUSH NOT OPERATING PROPERLY/DAMAGED

Further evaluation and correction recommended

Minor-Moderate Attention Recommended

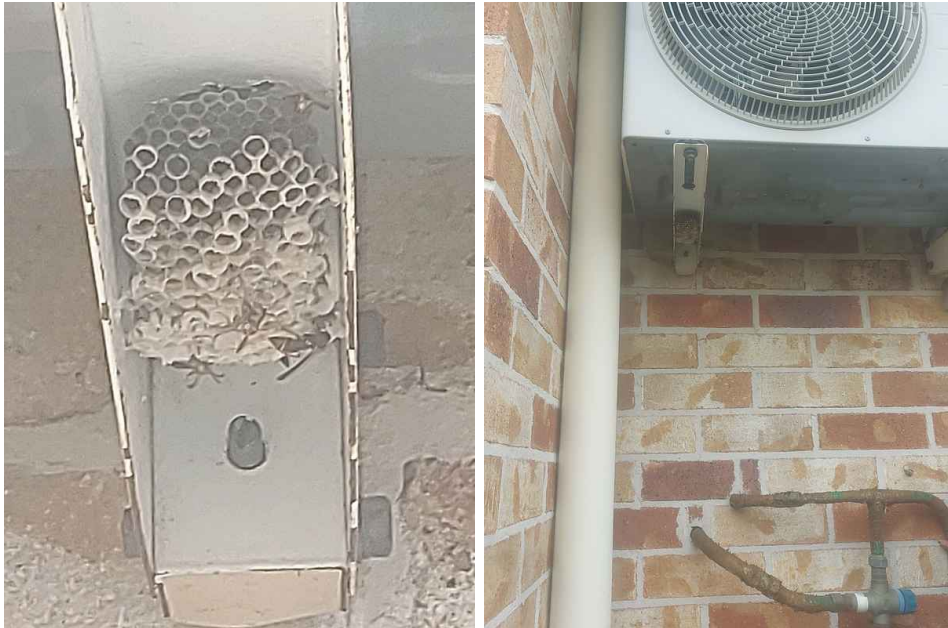
One or more hornet, bee or wasp nests were found. These can pose a safety hazard. A qualified person should remove nests or exterminate as necessary.

Contact a qualified pest control specialist.

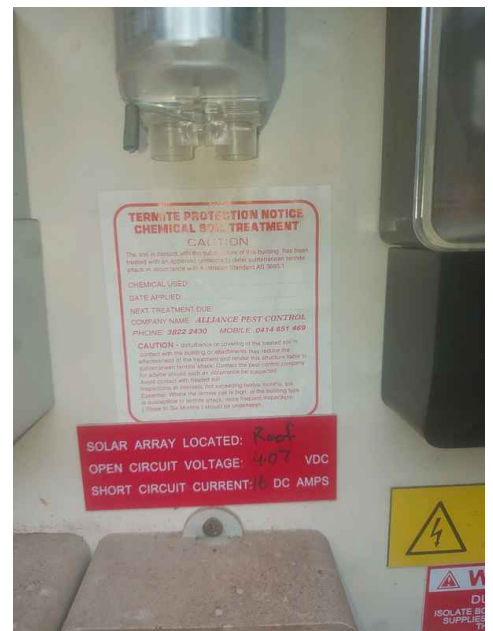
I recommend assuming the associated treatment is past its effective lifespan.

Contact a qualified professional.

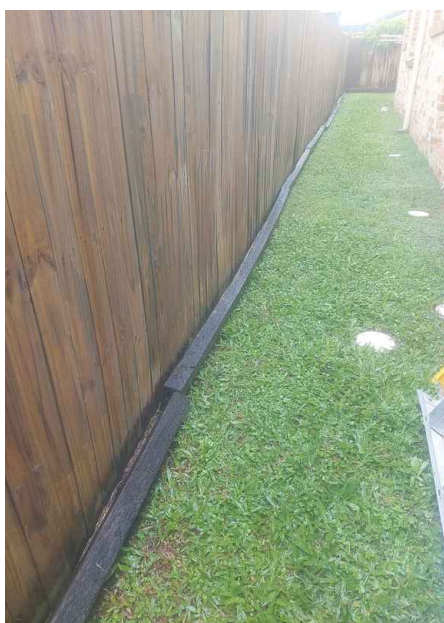
Site and Exterior: Fence Palings in contact with the ground

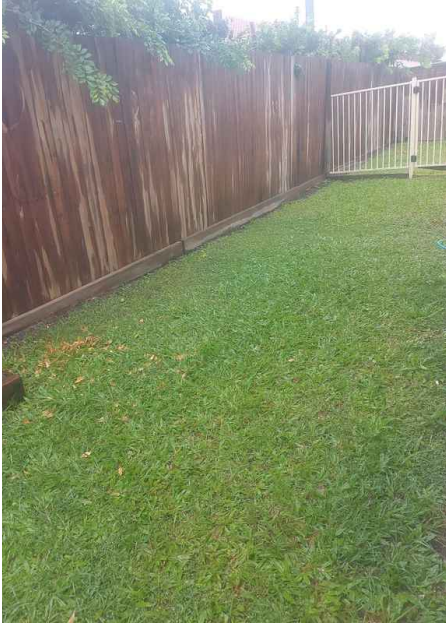
Site and Exterior: Landscaping Timbers

Timber in direct contact with the ground and or soil produces are ready food source for termites. Susceptible Timbers used in a hazardous environment are prone to fungal decay. It is recommended that you remove this condition order to prevent timber pest activity.

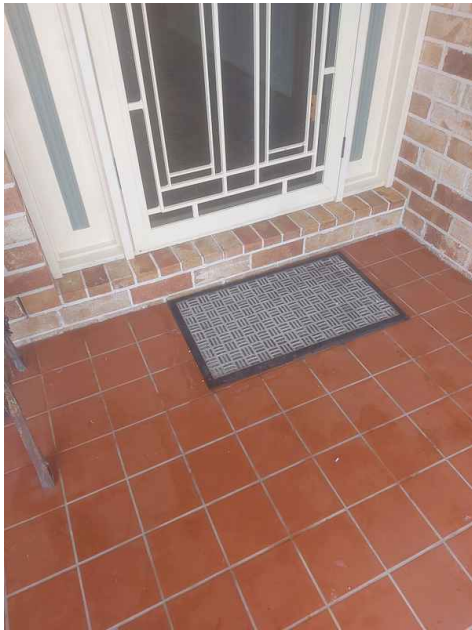
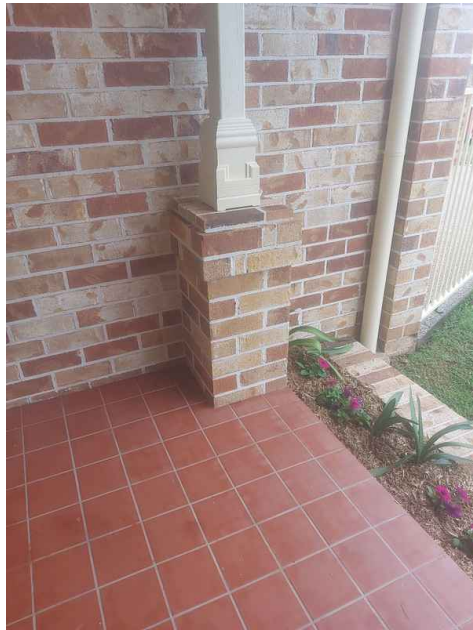
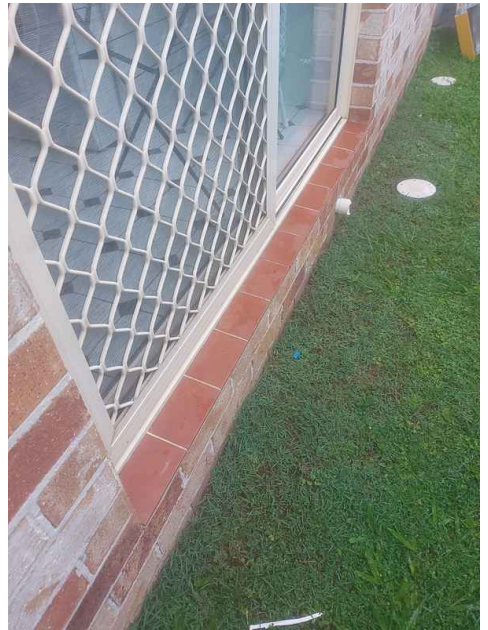
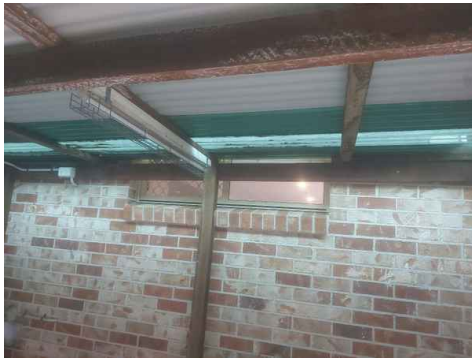
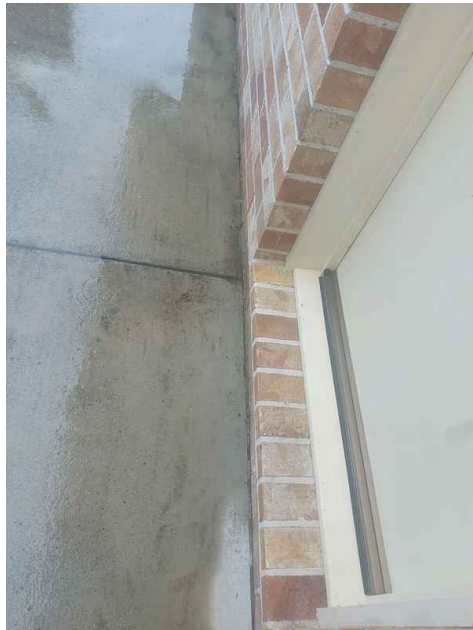
19.4.1 Bridging and Breaching of Termite Barriers and Inspection Zones

Minor-Moderate Attention Recommended

Rectify this condition, Reinspect, and maintain a clear inspection zone around the building

Contact a qualified professional.

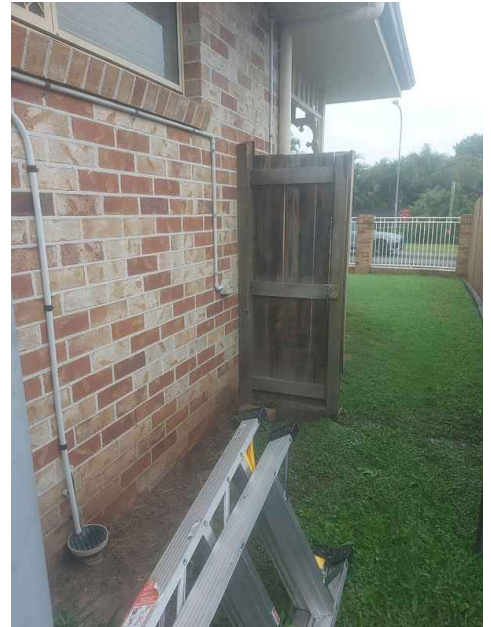
19.4.2 Bridging and Breaching of Termite Barriers and Inspection Zones

Minor-Moderate Attention Recommended

Further evaluation and correction recommended

Contact a qualified professional.
