BUILDING AND TIMBER PEST REPORT

25 Love St
Holland Park, QLD 4121

Before You Bid (BYB)
07/03/2024

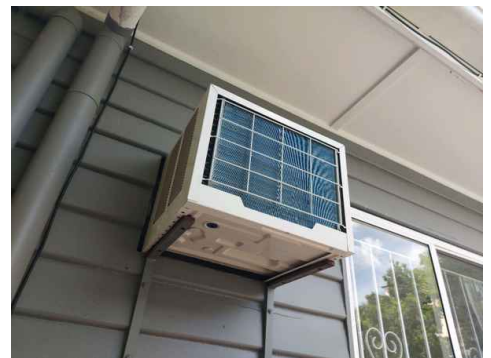
5.3.1 Air Conditioning

OLD AIR CONDITIONING SYSTEM

Although Air conditioners are excluded from the inspection, air conditioners observed appeared old.

Air conditioning units have a service life, and units observed appeared to be past their life or deteriorated, and may not be operating, operating efficiently, or require replacement in the near future.

Recommend further evaluation by an air conditioning specialist.

Contact a qualified professional.

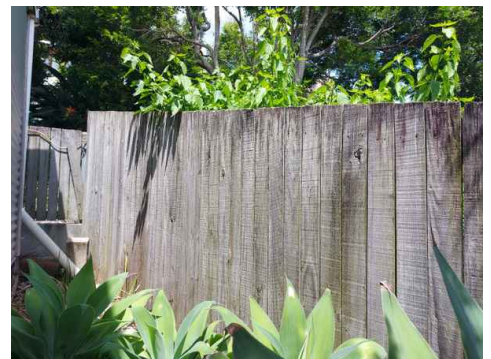
6.5.1 Fences/Gates

It should be stated that timber fences do have a finite service life. Timber and treatment to timber deteriorate over time, and require regular maintenance and replacement. Maintaining the bases of the fence posts and palings free and clear of soil, rotting leaves, and occasional treatment with a wood preservative will be most effective in prolonging service life.

Contact a qualified professional.

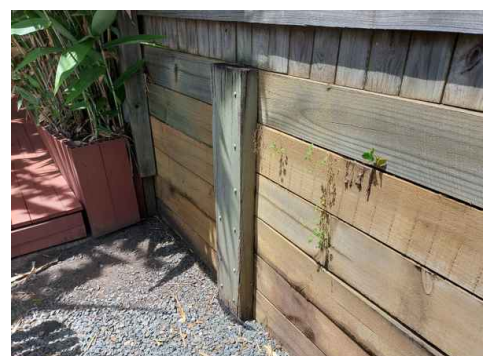
6.6.1 Retaining Walls

It should be stated that timber retaining have a finite service life. Maintaining and occasional treatment with a wood preservative may prolong service life. Timber retaining walls will require maintenance and replacement once deteriorated.

Contact a qualified professional.

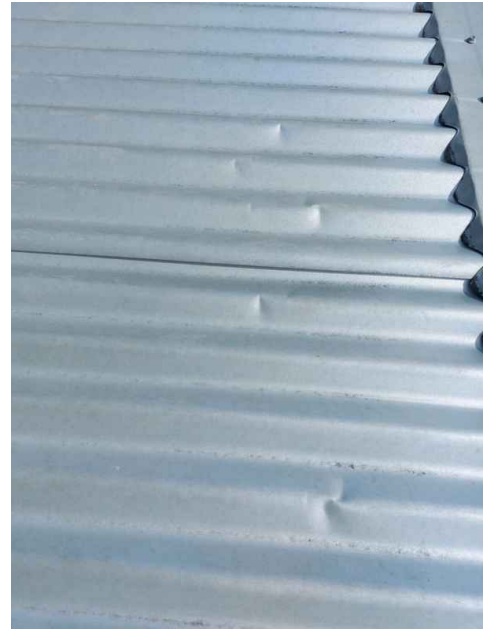
HAIL DAMAGE-MODERATE

The metal roof exhibited moderate damage that appeared to be from hail. This type of damage is cosmetic and will not affect the ability of the metal roof to protect the underlying structure.

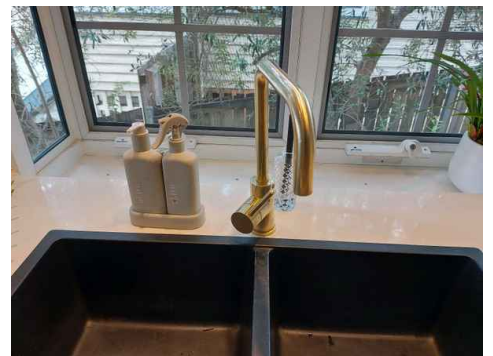
12.2.1 Sink / Plumbing

MIXER LOOSE

Further evaluation and correction recommended

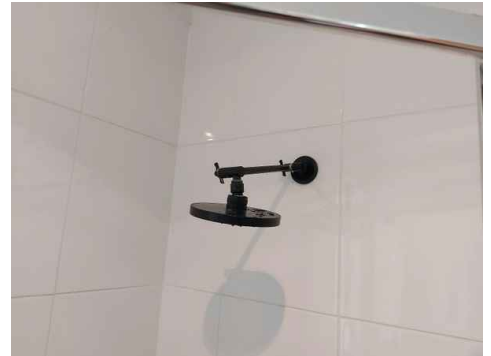
13.2.1 Shower

SHOWER HEAD/HOSE LEAKING

The shower head/ hose is leaking. This is may due to deterioration. It may simply require a new seal or tightening. Replacement is relatively inexpensive.
