BUILDING AND TIMBER PEST REPORT

38 Brisbane Ave
Camp Hill, QLD 4152

Before You Bid (BYB)
07/03/2024

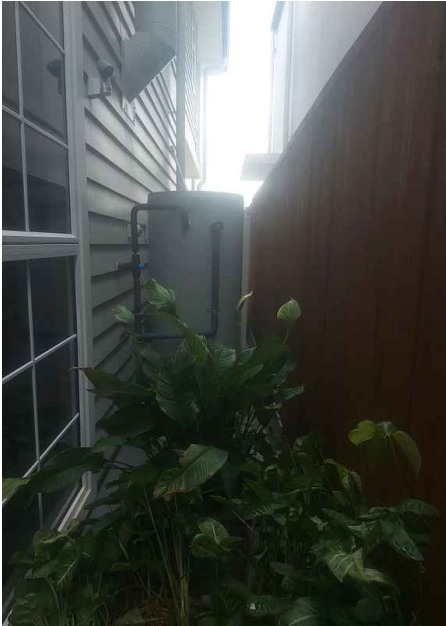
Electric Water Heater (Tank)

No specific tests were carried out. No determination has been made as to the compliance, suitability or adequacy of the hot water system in relation to capacity, function or lifespan.

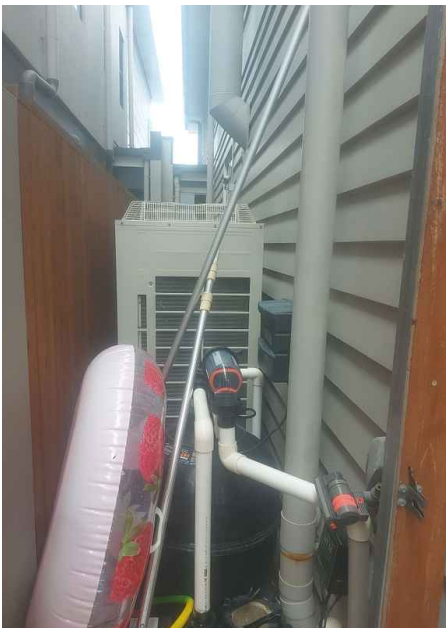
Air Conditioning: Air Conditioning Installed

Air-conditioning is installed to the property but has not been tested/inspected. We recommend a licensed air conditioning specialist to determine the status of the units.

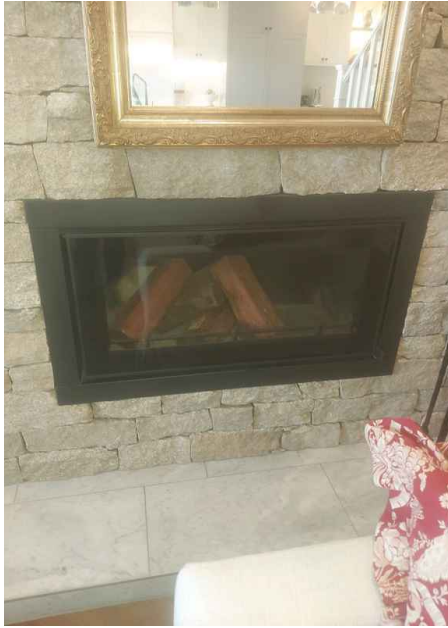
Combustion heater : Fire place/ heater - Not tested

There is a solid fuel combustion heater appliance installed. The inspection of this appliance is not included in the scope of this report. I recommend that you ensure that this appliance is correctly installed and the chimney/fireplaces should be professionally tested for safety and cleaned prior to being put into use.

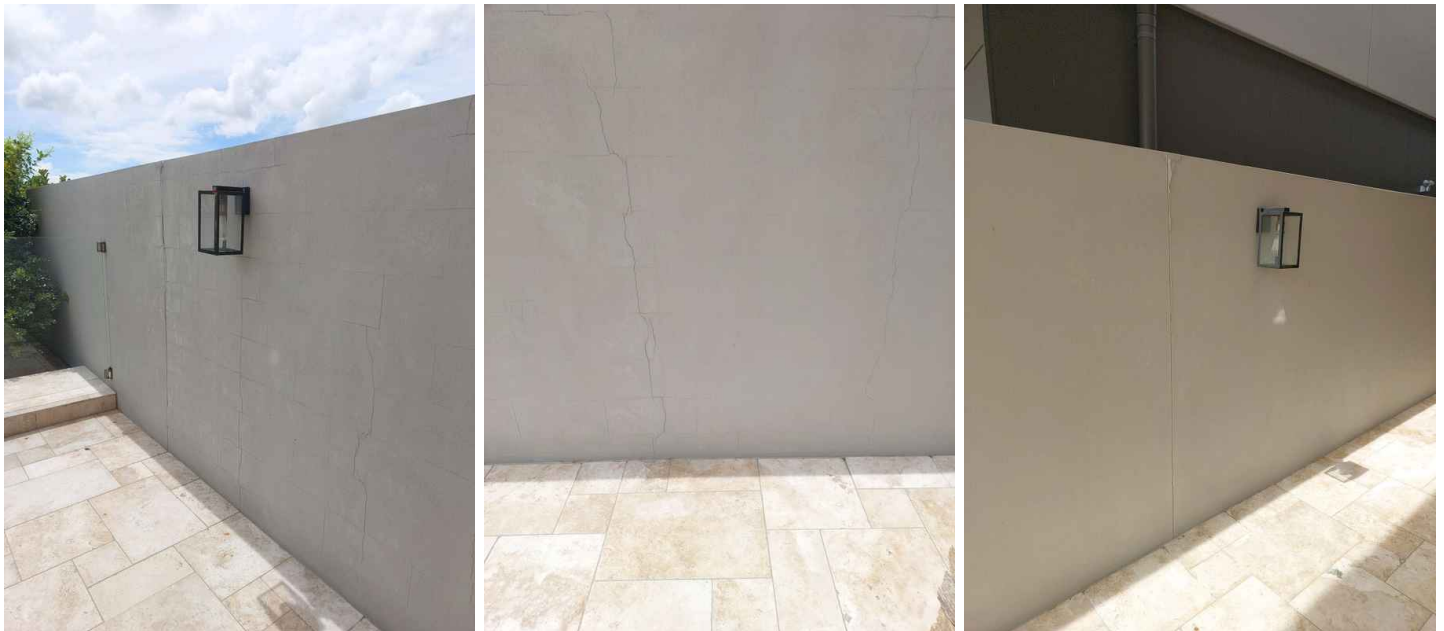
MODERATE DETERIORATION

Areas of the fencing were damaged and/or deteriorated. A qualified contractor should evaluate and replace or make repairs as necessary.

Contact a qualified fencing contractor

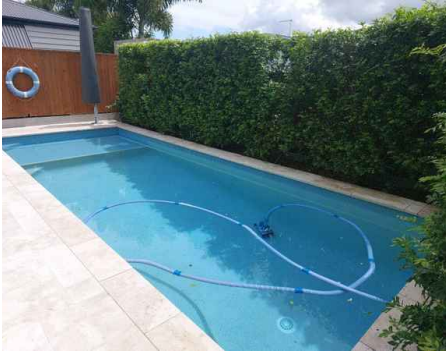
General: A swimming pool/spa is present.

This inspection specifically excludes any inspection of the pool, associated fencing, surrounds and safety elements. We recommend you obtain an inspection from a specialist pool inspector to determine the condition of the pool, pool equipment, safety barriers and surrounds.

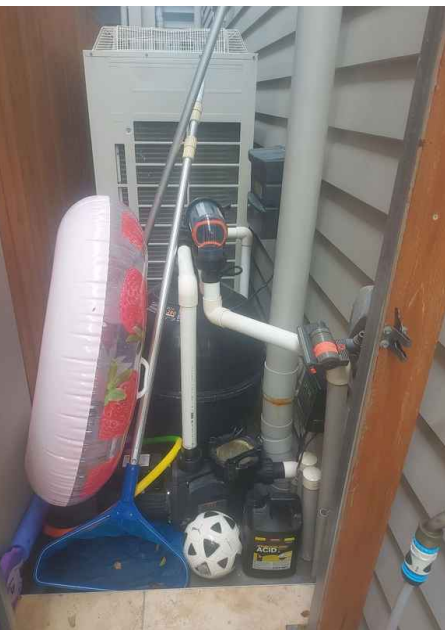
Goods stored close to external elements obstructed inspection of areas at the time of the inspection

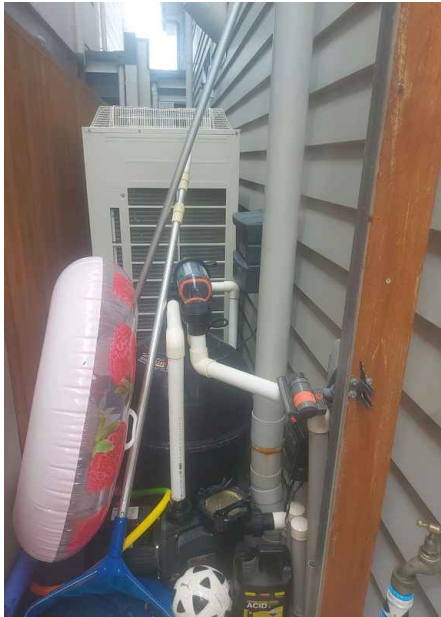
Restricted access/obstruction due to position of the unit/s

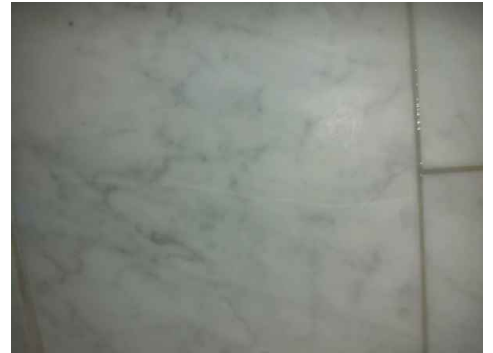
**CRACKS- APPEARS
COSMETIC**

Minor-Moderate Attention Recommended

Replace as required. If the situation worsens, further investigation is required.

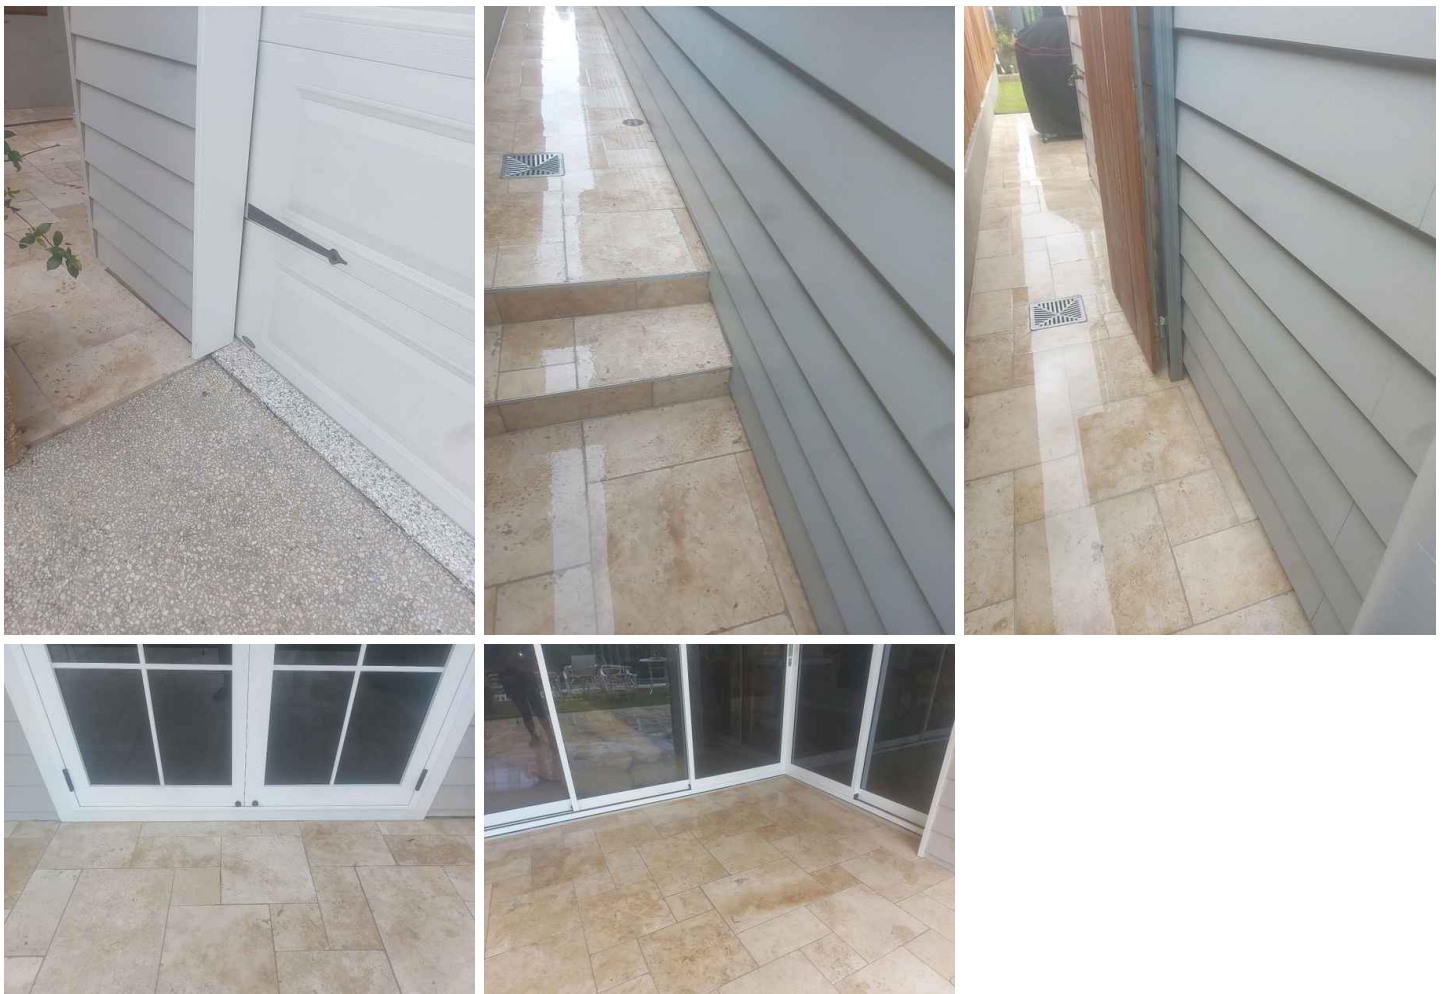
Minor-Moderate Attention Recommended

Rectify this condition, Reinspect, and maintain a clear inspection zone around the building

Contact a qualified professional.

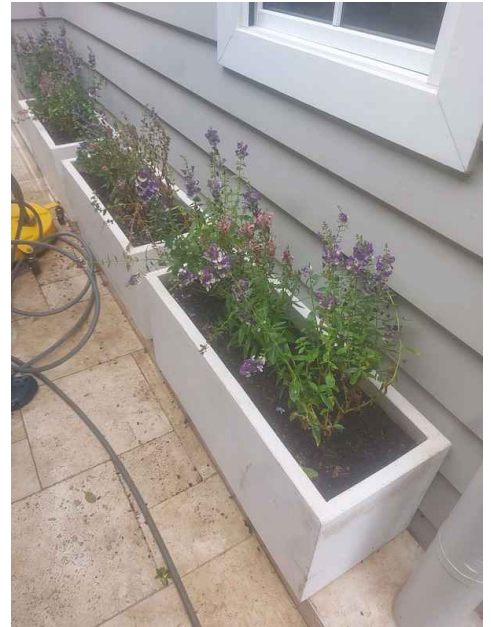
19.4.2 Bridging and Breaching of Termite Barriers and Inspection Zones

Minor-Moderate Attention Recommended

The level of some external paths, paved areas or soil is either higher than, or at a similar level, as that of the internal floors. This situation could allow concealed termite entry. We strongly recommend the lowering of these (150mm lower for gardens/lawns and 75mm lower for paths) below the internal floor level to reduce the risk of concealed termite entry.

Rectify this condition, Reinspect, and maintain a clear inspection zone around the building

Contact a qualified professional.
