BUILDING AND TIMBER PEST REPORT

43 Brinawa St
Camp Hill, QLD 4152

26/03/2024

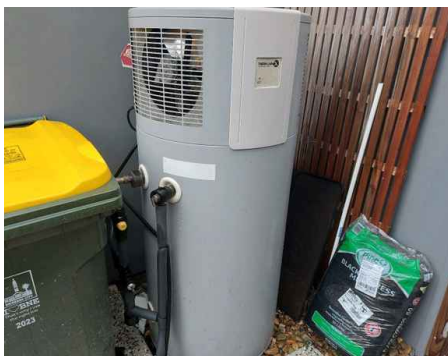
Hot Water Service: Hot water provided by:

Heat Pump type Water HEATER

No specific tests were carried out. No determination has been made as to the compliance, suitability or adequacy of the hot water system in relation to capacity, function or lifespan.

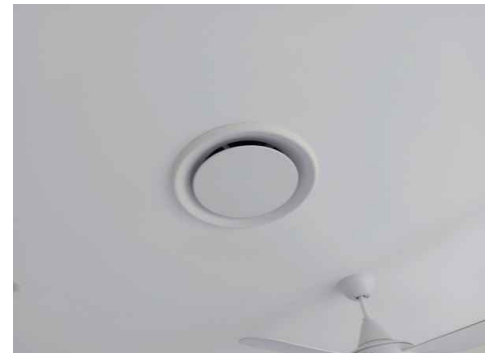
5.3.1 Air Conditioning

Type of air-condition installed is a fully ducted system. Refer to pictures in roof void section showing visible ducting.

Contact a qualified professional.

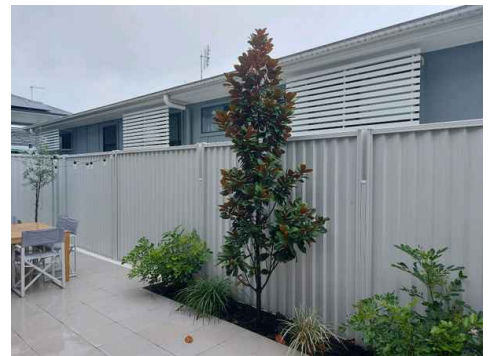
6.5.2 Fences/Gates

It should be stated that timber fences do have a finite service life. Timber and treatment to timber deteriorate over time, and require regular maintenance and replacement. Maintaining the bases of the fence posts and palings free and clear of soil, rotting leaves, and occasional treatment with a wood preservative will be most effective in prolonging service life.

Contact a qualified professional.

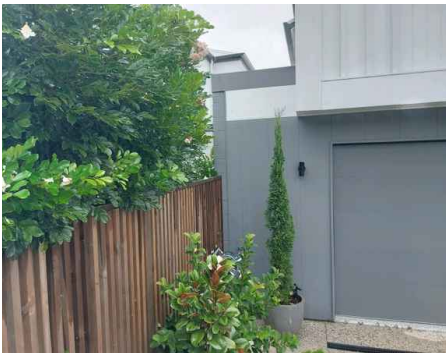
Left side of the building

The ability to inspect external walls located in close proximity to title boundaries was limited due to insufficient access.

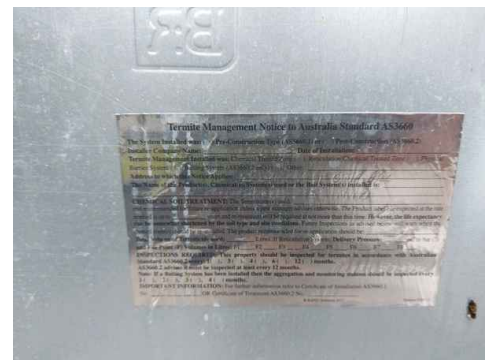
17.3.1 Termite Management Systems

Minor-Moderate Attention Recommended

I recommend assuming the associated treatment is past its effective lifespan.

Contact a qualified professional.
