BUILDING AND TIMBER PEST REPORT

4/47 East St
Camp Hill, QLD 4152

BYB
04/04/2024

Pre-Purchase Inspection - Residential Building Report

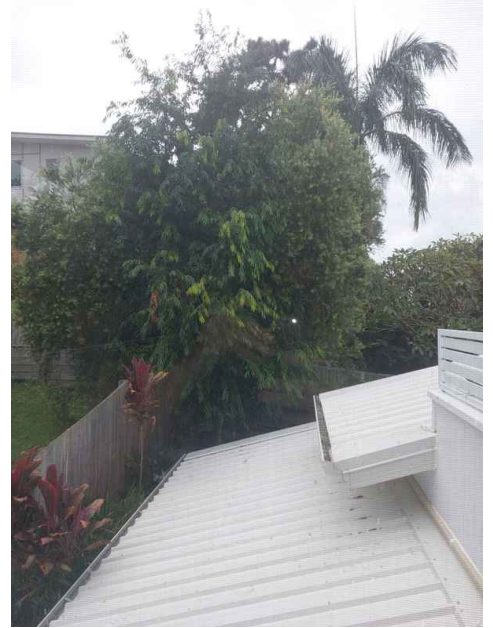
6.5.1 Fences/Gates

It should be stated that timber fences do have a finite service life. Timber and treatment to timber deteriorate over time, and require regular maintenance and replacement. Maintaining the bases of the fence posts and palings free and clear of soil, rotting leaves, and occasional treatment with a wood preservative will be most effective in prolonging service life.

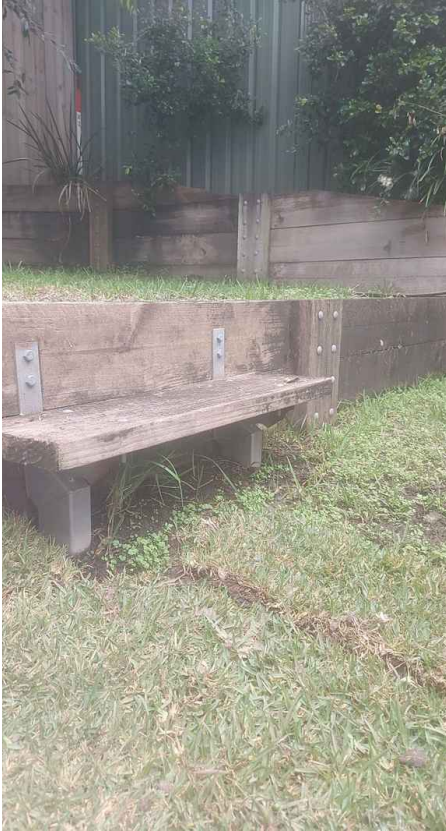
Site and Exterior: Landscaping Timbers

Timber in direct contact with the ground and or soil produces are ready food source for termites. Susceptible Timbers used in a hazardous environment are prone to fungal decay. It is recommended that you remove this condition order to prevent timber pest activity.

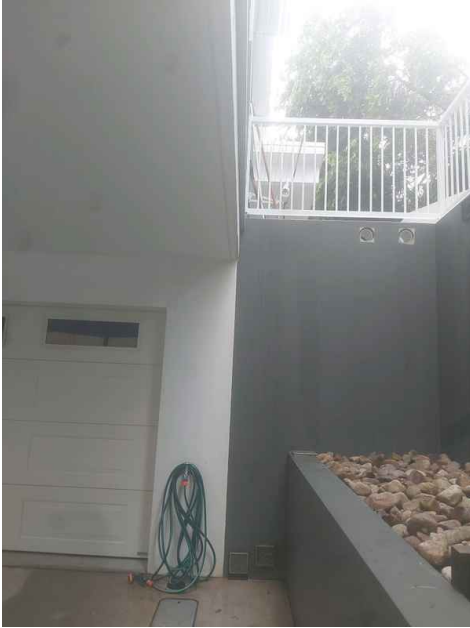
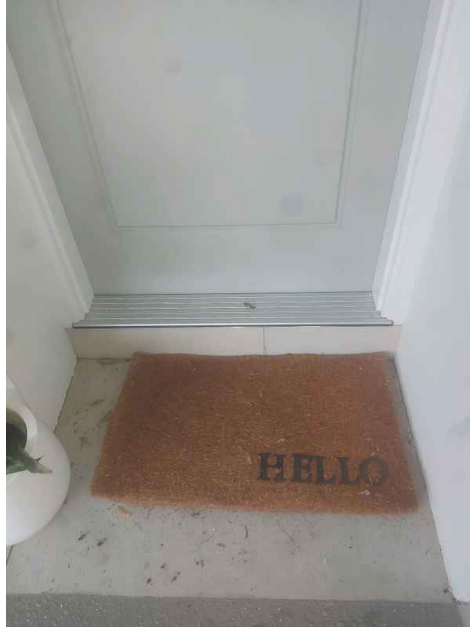
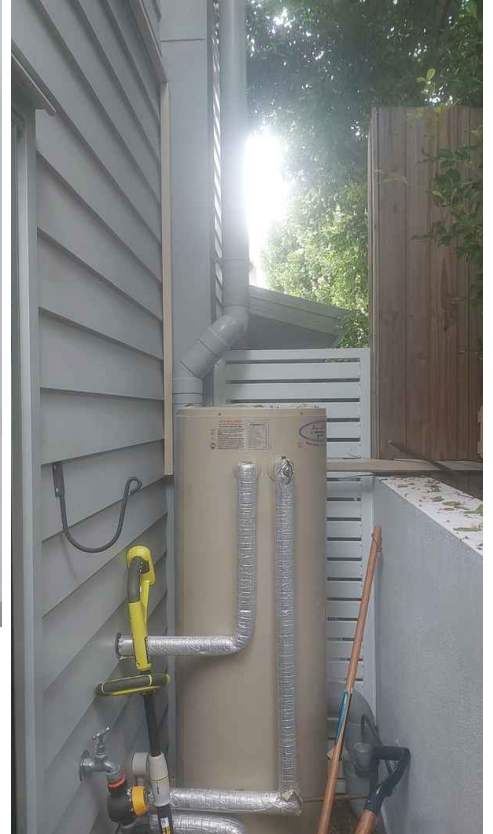
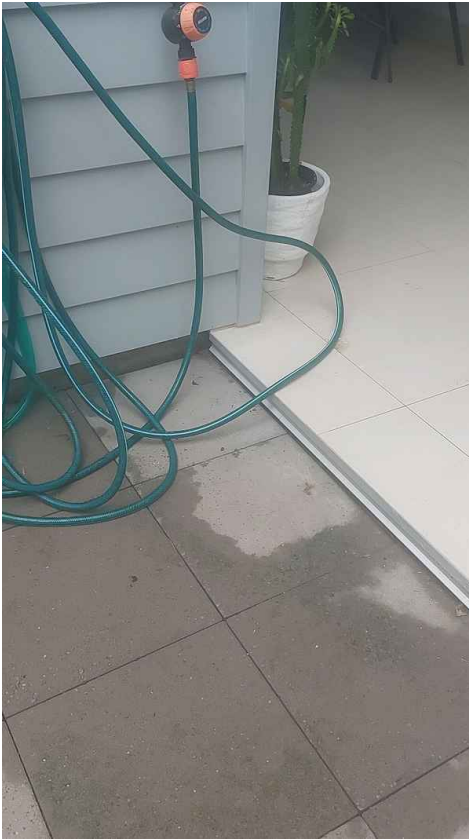
18.4.1 Bridging and Breaching of Termite Barriers and Inspection Zones

Minor-Moderate Attention Recommended

Rectify this condition, Reinspect, and maintain a clear inspection zone around the building
