BUILDING AND TIMBER PEST REPORT

49 Pavo St
Camp Hill, QLD 4152

Before You Bid (BYB)
27/11/2023

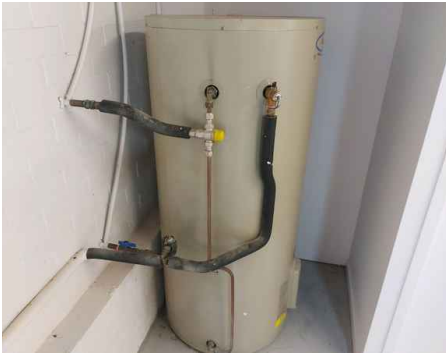
Hot Water Service: Hot water provided by:
Electric Water Heater (Tank)

No specific tests were carried out. No determination has been made as to the compliance, suitability or adequacy of the hot water system in relation to capacity, function or lifespan.

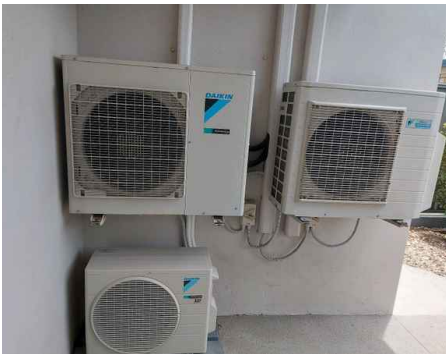
Air Conditioning: Air Conditioning Installed

Air-conditioning is installed to the property but has not been tested/inspected. We recommend a licensed air conditioning specialist to determine the status of the units.

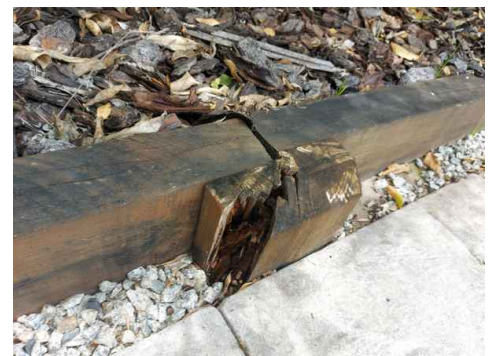
6.6.1 Retaining Walls

MINOR DECAY

Minor fungal decay damage was noted. Replacement of damaged timbers is required. Refer also to the Timber Pest Report.

Further evaluation and correction recommended.

Contact a qualified fencing contractor

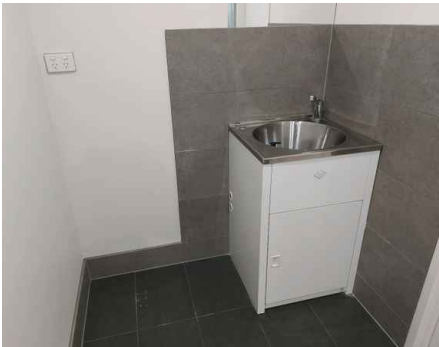
**General: Renovated bathroom**

We cannot determine the adequacy of bathroom renovations, especially hidden elements, for example, waterproofing membranes.

We recommend you request any documentation, approvals and warranty if available.
