BUILDING AND TIMBER PEST REPORT

55 Mackay St
Coorparoo, QLD 4151

BYB
14/02/2024

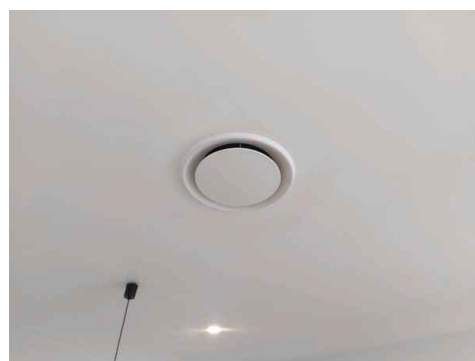
5.3.1 Air Conditioning

Type of air-condition installed is a fully ducted system. Refer to pictures in roof void section showing visible ducting.

Contact a qualified professional.

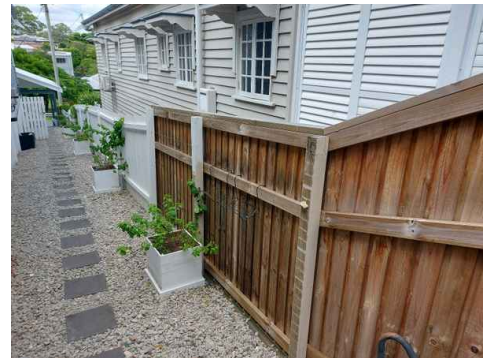
It should be stated that timber fences do have a finite service life. Timber and treatment to timber deteriorate over time, and require regular maintenance and replacement. Maintaining the bases of the fence posts and palings free and clear of soil, rotting leaves, and occasional treatment with a wood preservative will be most effective in prolonging service life.

Contact a qualified professional.

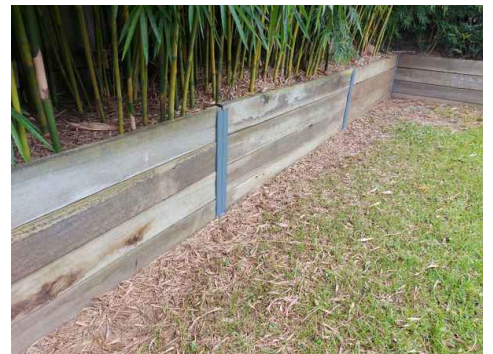
6.6.1 Retaining Walls

The inspector observed no major deficiencies in the retaining walls at the time of the inspection.

Contact a qualified professional.

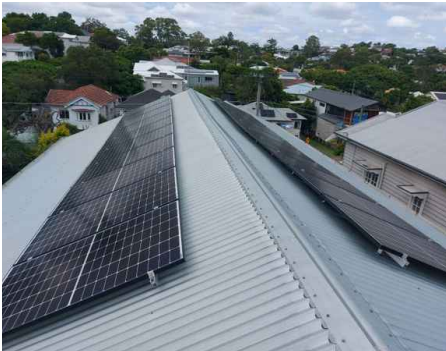
Solar panels or other fixtures obstructed some areas of the roof surfaces from being inspected.
