BUILDING AND TIMBER PEST REPORT

**58 Arrol Street
Camp Hill, QLD 4152**

Before You Bid (BYB)

15/03/2024

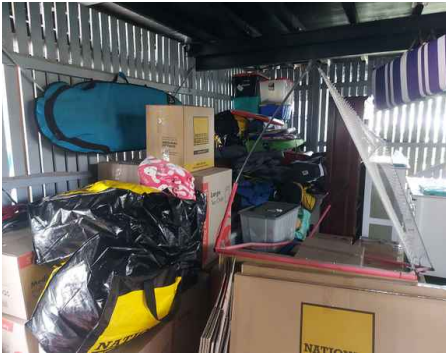
Access, Restrictions And Limitations: Stored Goods

Stored goods restricted access to inspect this area. Once goods have been removed a reinspection of the subfloor is recommended

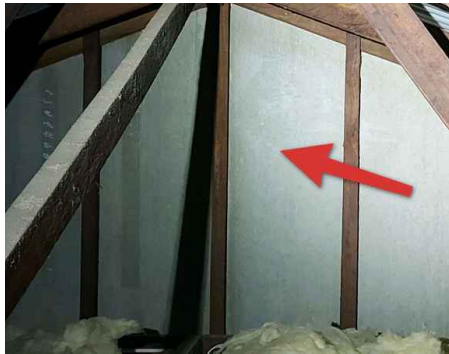
Access, Restrictions and Limitations: Asbestos

There is presence of items which potentially contain Asbestos. Only a limited inspection was performed from the access hatch. We recommend that you arrange to have an Asbestos audit of the property for the presence or absence of Asbestos, and a further roof space inspection performed when deemed safe.

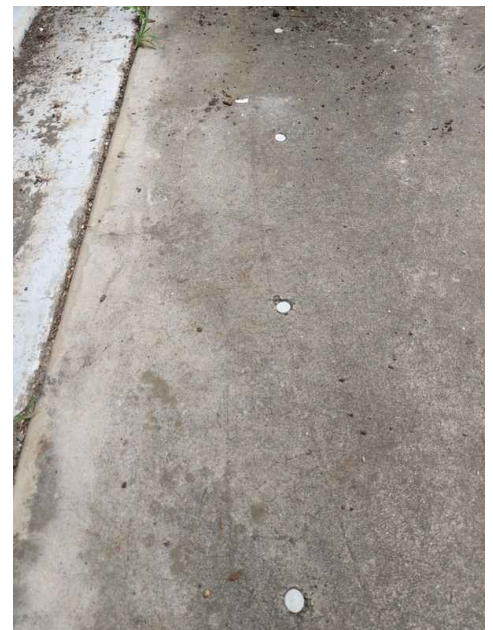
Patched/plugged drill holes were noted to concrete/paved areas. Drill holes are an indicator that part or all of the building may have been treated by chemical injection in respect to termite control or protection. We are not able to determine if the treatment was preventative or due to termite activity. We strongly recommend any prospective purchaser attempt to verify this information and obtain copies of all relevant documentation.

Contact a qualified professional.

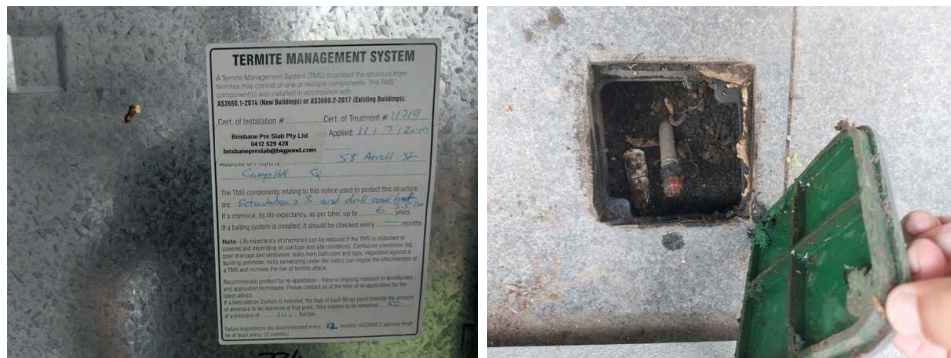
17.3.2 Termite Management Systems

A reticulation system may be present as there are pipes present (with inspection points) located in the path around the perimeter of the house. Termite reticulation systems installed during or after construction to assist in the protection of the structure against subterranean termite attack. We strongly recommend any prospective purchaser attempt to verify these findings and ask the seller for full details of this system. It is important to verify the extent of this system as some reticulation systems cover only part of the property.

Contact a qualified professional.
