## BUILDING AND TIMBER PEST REPORT

**58 Capella St  
Coorparoo, QLD 4151**

Before You Bid (BYB)  
10/04/2024

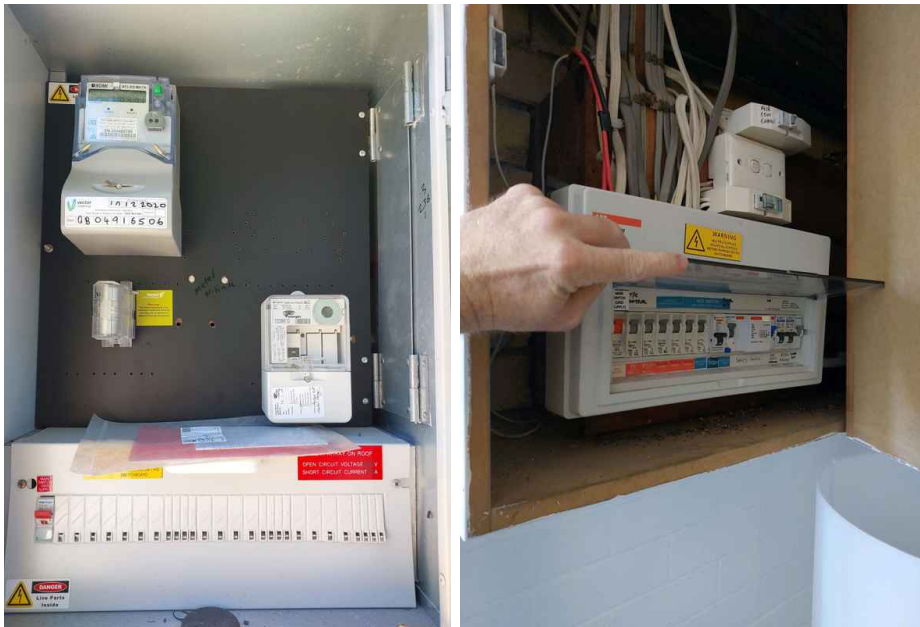
#### Electrical : Safety Switch Observed

A safety switch was observed, but not tested. It is recommended that the electrical system is fully inspected by a qualified electrician prior to use

#### Electrical : Solar Power System Installed

A solar power system including Panels and/or Inverter was observed, but no testing was conducted. Consult a Qualified Electrician to determine the adequacy and current status.

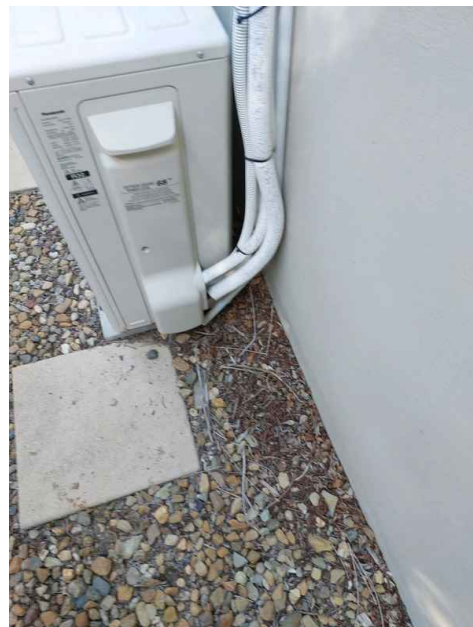
## 5.3.1 Air Conditioning

Minor-Moderate Attention Recommended

**DRAINS NEAR FOUNDATIONS**

Excess moisture near the buildings can cause structural issues and encourage timber pest activity.

Best practice is to drain into stormwater (downpipe or other surface drainage) to prevent excess moisture near the building.

Contact a qualified professional.

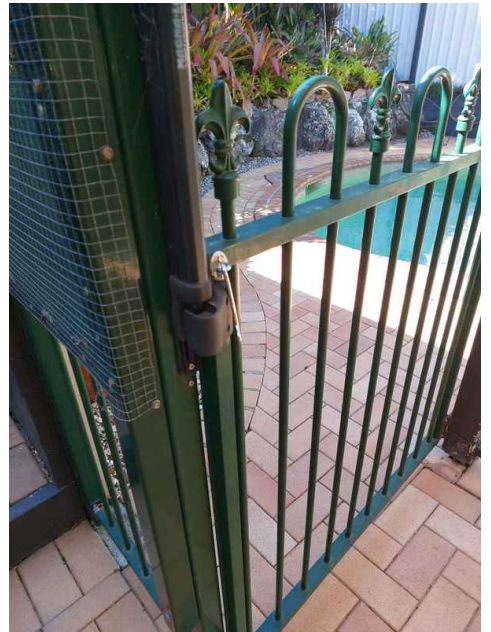
7.2.1 Fences / Gates / Barriers

Safety / Major

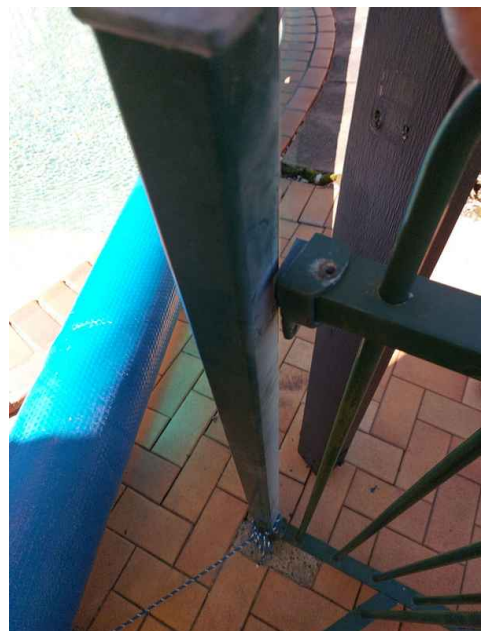
7.2.2 Fences / Gates / Barriers

### **DOES NOT APPEAR TO COMPLY**

Safety / Major

Recommend further evaluation and correction

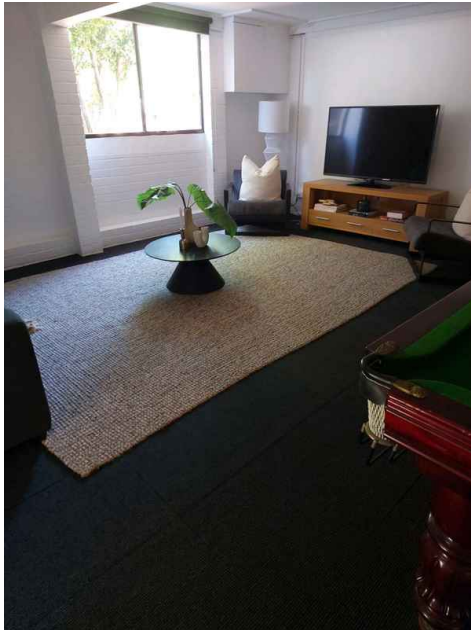
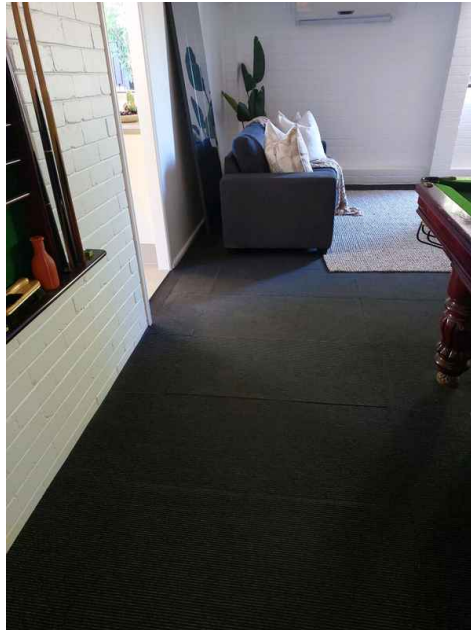
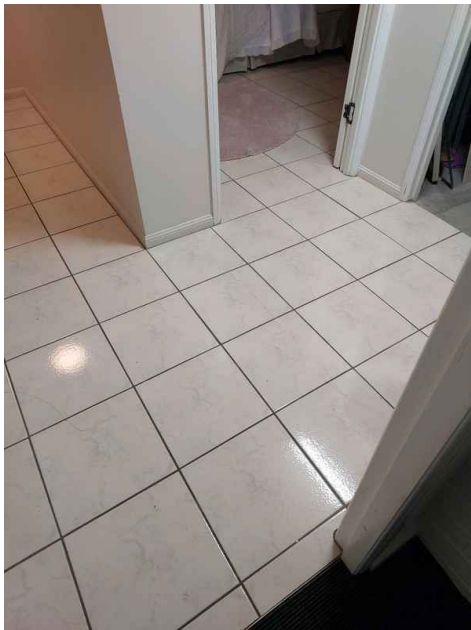
The concrete floor slab was not flat or level. This appeared to be the result of poor building practices at the time of construction. These areas may be a trip hazard.

Further evaluation and correction recommended

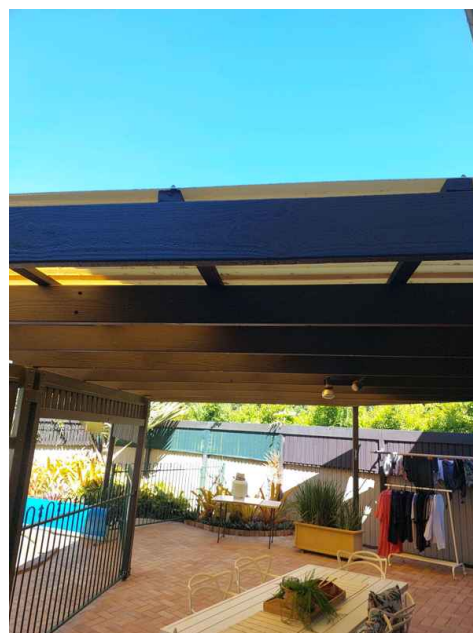
Minor-Moderate Attention Recommended

The roof sheeting was installed on a slope inadequate for the design of this type of roofing material. Manufacturers specify that their product be installed on roofs with a minimum roof pitch.

Determining adequate roof pitch for this particular metal roof would require research that exceeds the scope of the this Inspection and the Inspector disclaims responsibility for confirming proper installation. You may wish to have proper installation confirmed by a qualified roofing contractor.

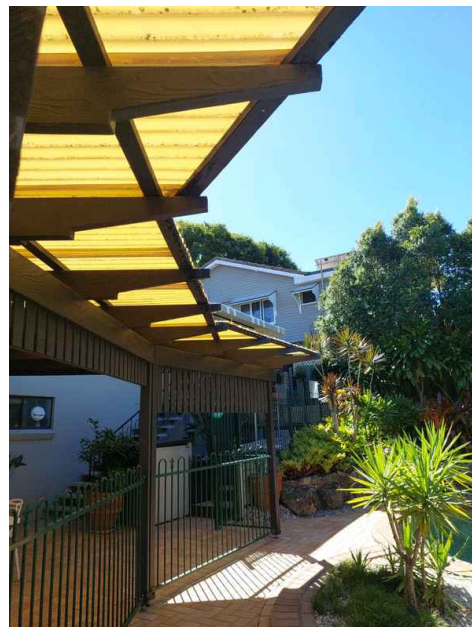
## 9.4.1 Roof Drainage Systems

**MISSING GUTTERS**

Areas were missing gutters. This condition can cause excessively high moisture levels in the soil next to the foundation that can cause damage related to soil/foundation movement and is a condition that encourages timber pest activity. The Inspector recommends the installation of gutters and stormwater systems as needed by a qualified contractor.

Contact a qualified gutter contractor

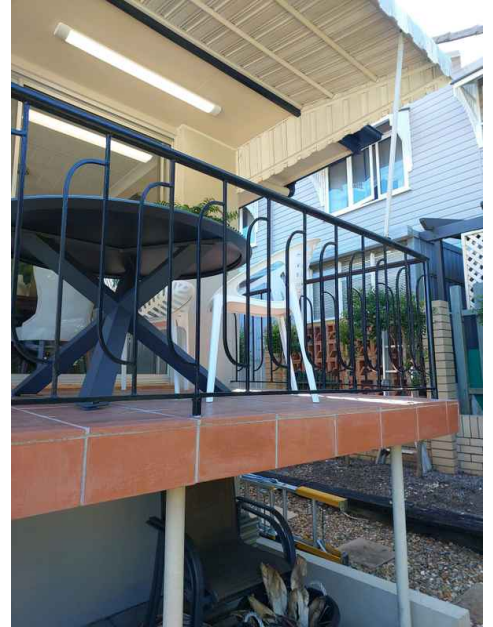
Minor-Moderate Attention Recommended**LOW GUARDRAIL**

The guardrails were lower than 1m above the walking surface. This condition is a safety concern. The Inspector recommends that this condition be updated to meet generally-accepted modern safety standards by a qualified contractor.

*Please Note: The deck/balcony guardrails may have complied with the building safety standards in effect at the time of original construction, and it is not a requirement to upgrade these to current codes but is a recommended to be considered for safety reasons.*

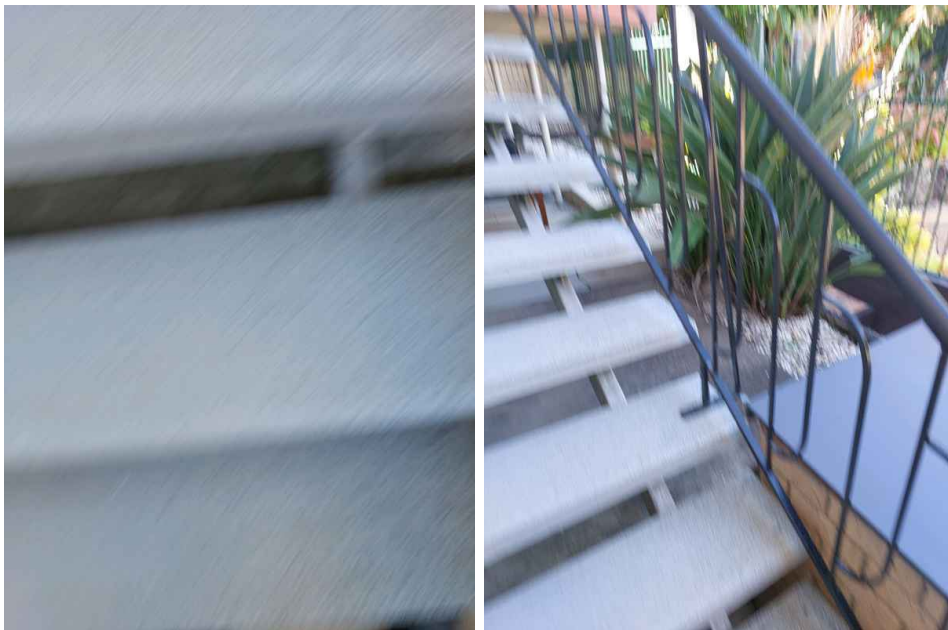
## 12.1.2 Safety

Safety / Major**LOOSE BALUSTRADE**

Further evaluation and correction recommended

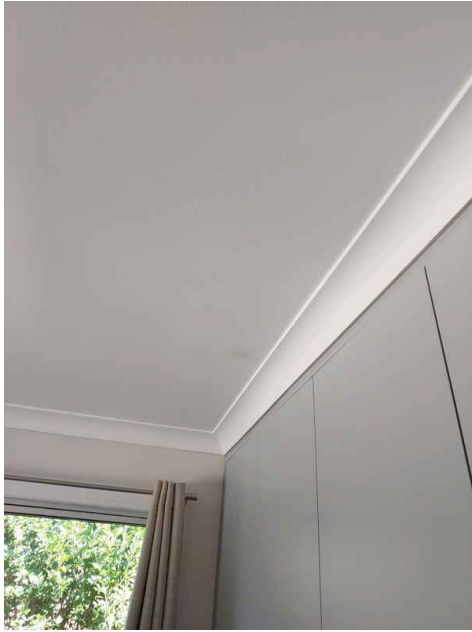
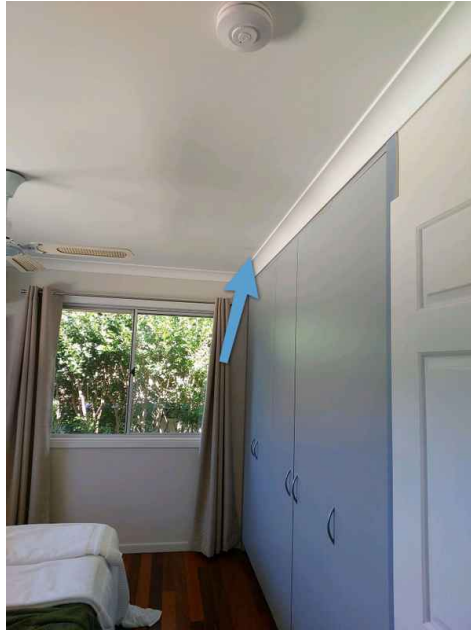
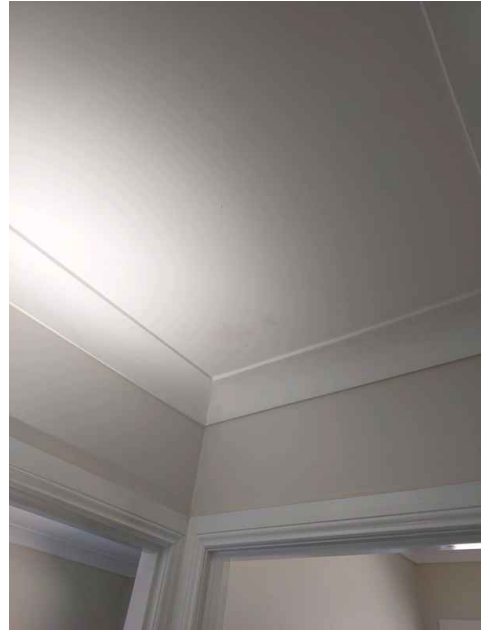
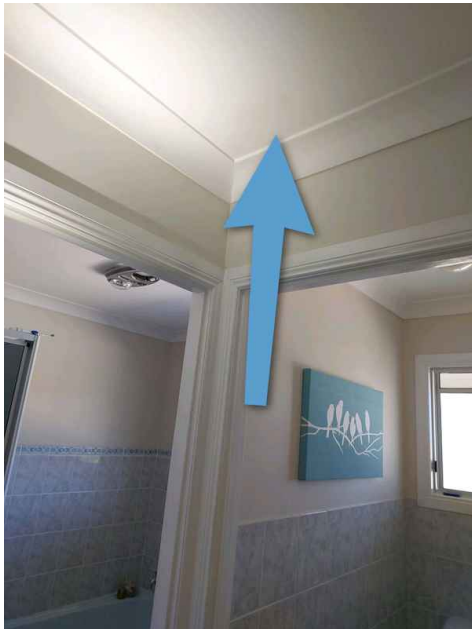
#### **MOISTURE STAINS - NO MOISTURE DETECTED**

Stains on the ceiling observed at the time of the inspection. The moisture meter showed no elevated levels of moisture present in the stained areas at the time of the inspection, indicating that the source of moisture may have been corrected, or may be intermittent.

Further evaluation and correction recommended.

Contact a qualified professional.

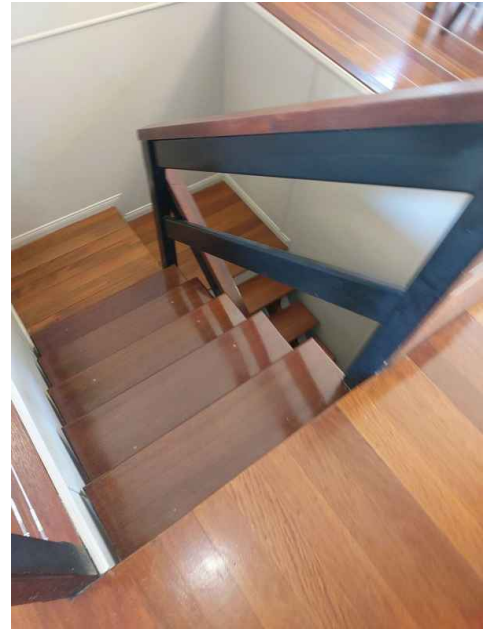
## 13.8.1 Stairs

At heights over 1m, spaces exceeded 125mm. Safe building practices dictate that a 125mm sphere may not pass spaces at any point. This condition is classed as hazardous, especially to small children. The Inspector recommends correction by a qualified contractor.

Note: If the structures were compliant at the time of construction, upgrades are not a requirement, but recommended due to safety concerns.

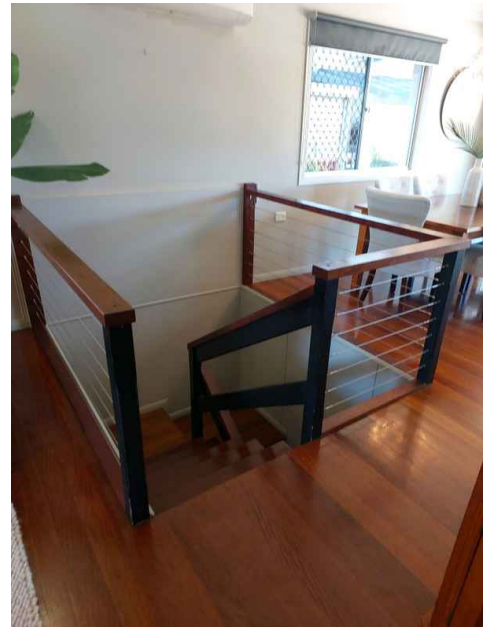
## 13.8.2 Stairs

**LOW GUARDRAILS, OLDER HOME**

The horizontal guardrails protecting this stairwell were less than 1 metre in height. Although this condition is now considered a potential fall hazard, it is not uncommon in older homes such as this one, built during a time period during which safety standards were different from generally-accepted current safety standards. Homes are not required to be updated to comply with newly enacted safety standards. Because this is a safety issue, the Inspector recommends having the guardrails altered or replaced with guardrails at least 1 metre in height to comply with modern safety standards.

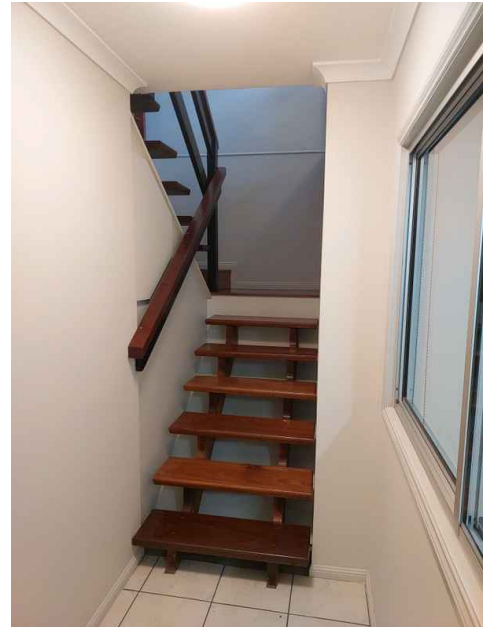
## 13.8.3 Stairs

**INADEQUATE  
HEADROOM**

Minor-Moderate Attention Recommended

This stairway did not comply with generally-accepted current standards for headroom.

Note: AS 4 3.2 Minimum vertical clearance (Head Height)  
Unless otherwise approved by the regulatory authority, the head clearance shall be not less than 2000 mm measured vertically from the nosing line.

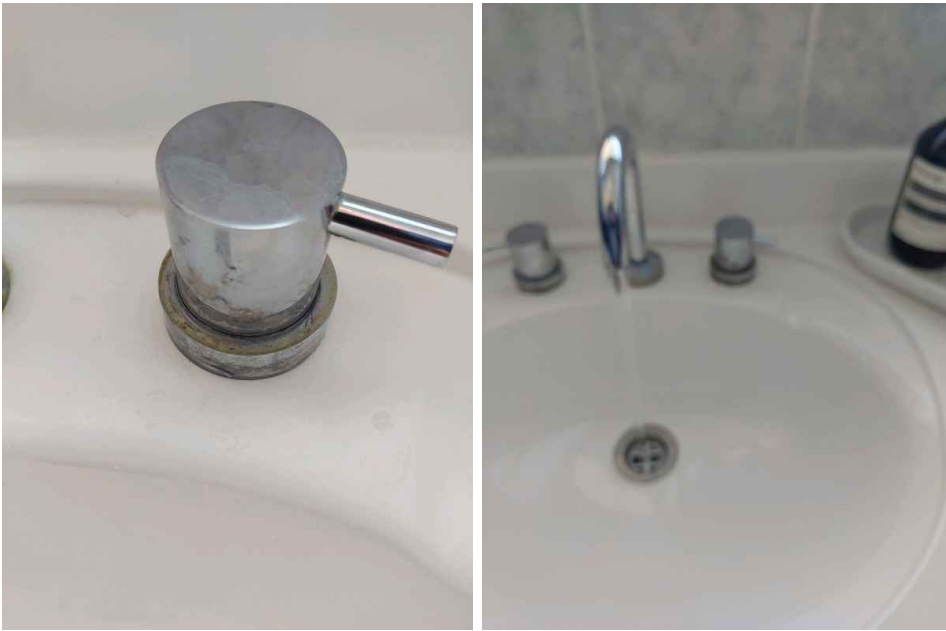
## 15.2.1 Plumbing

**LEAKING AT TAP/MIXER**

Further evaluation and correction recommended

Minor-Moderate Attention Recommended

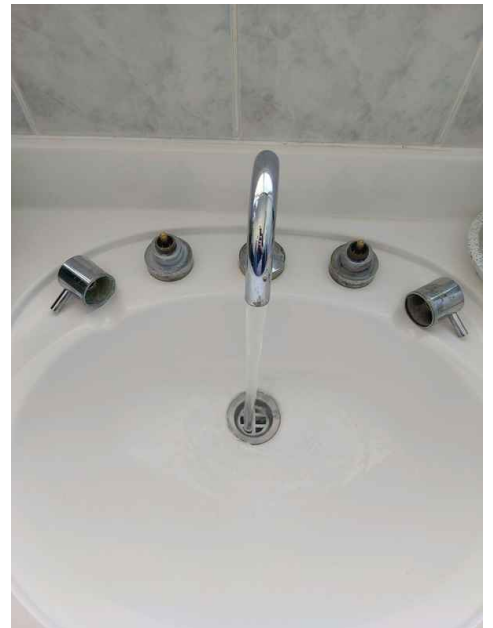
## 15.2.2 Plumbing

**LOOSE TAPWARE**

Minor-Moderate Attention Recommended

The tap ware is loose, and this can lead to further issues if not corrected. Further investigation by a Qualified Plumber is recommended. It is likely only tightening or adjusting is required, but replacement may be necessary.

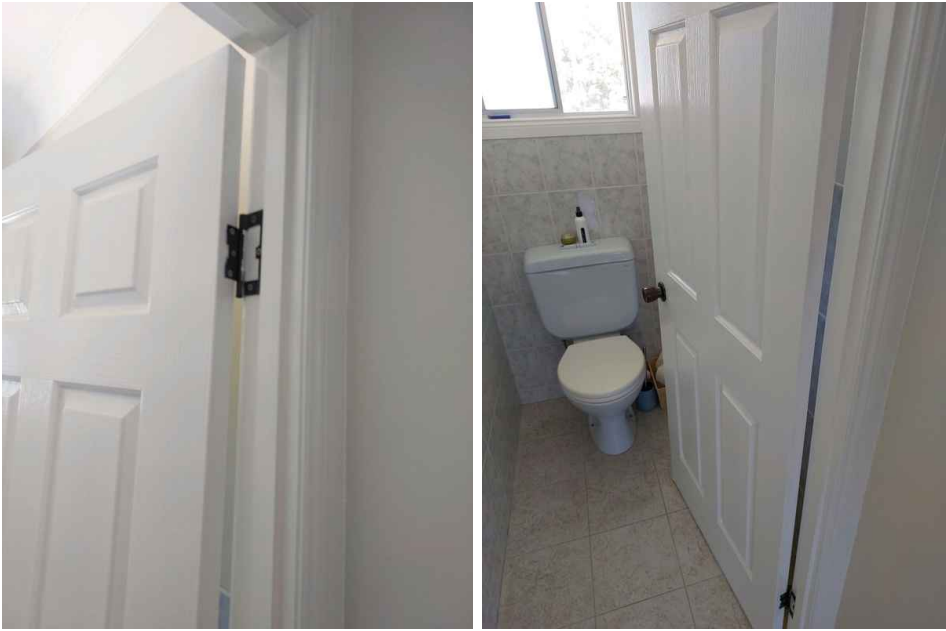
## 15.3.1 Doors

**NO LIFT OFF HINGES**

Minor-Moderate Attention Recommended

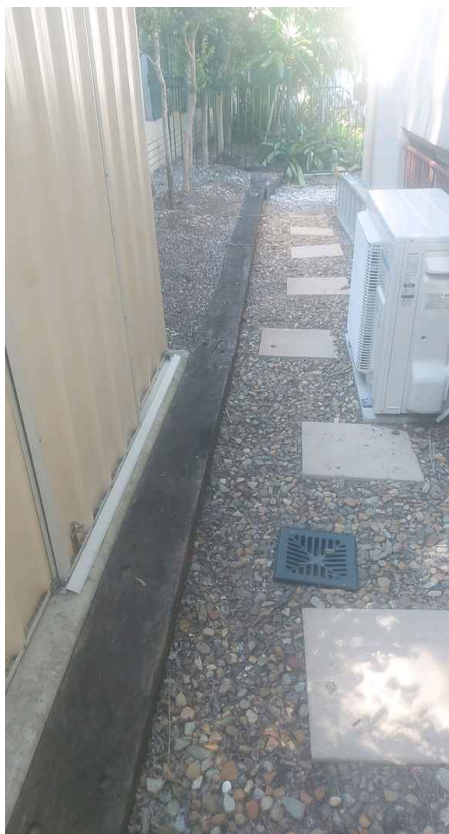
**Site and Exterior: Landscaping Timbers**

Timber in direct contact with the ground and or soil produces are ready food source for termites. Susceptible Timbers used in a hazardous environment are prone to fungal decay. It is recommended that you remove this condition order to prevent timber pest activity.

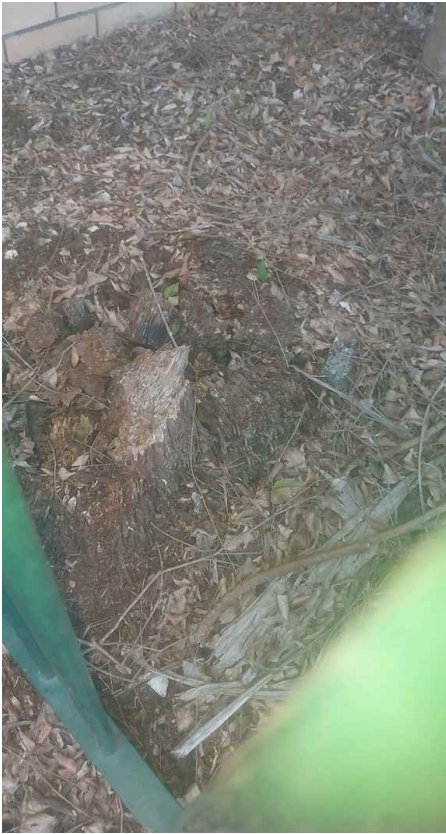
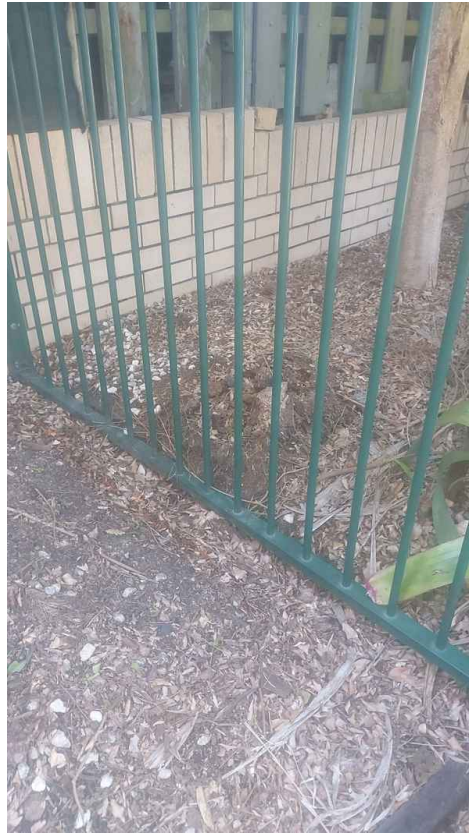
**Site and Exterior: Trees & Stumps**

Timber in direct contact with the ground and or soil produces are ready food source for termites. Susceptible Timbers used in a hazardous environment are prone to fungal decay. It is recommended that you remove this condition order to prevent timber pest activity.

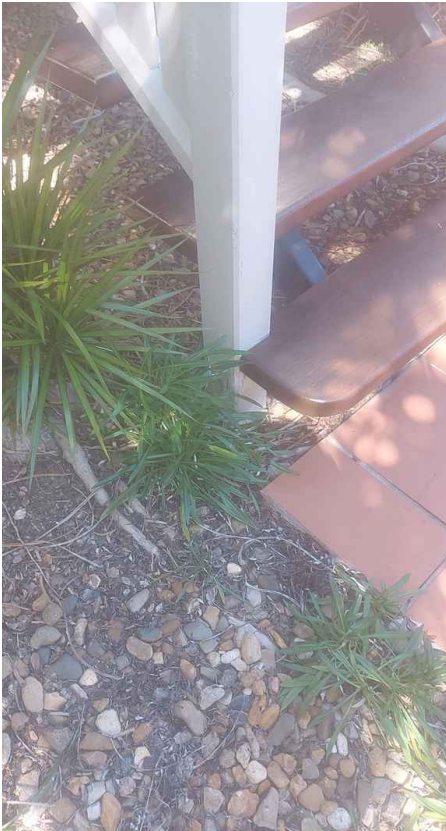
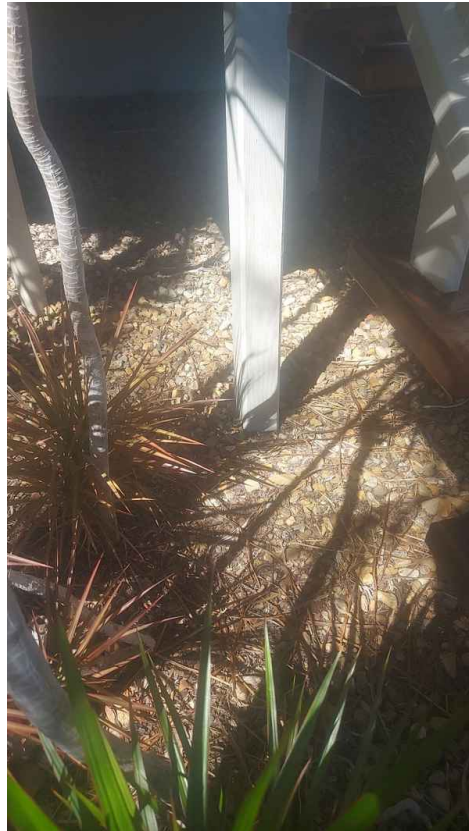
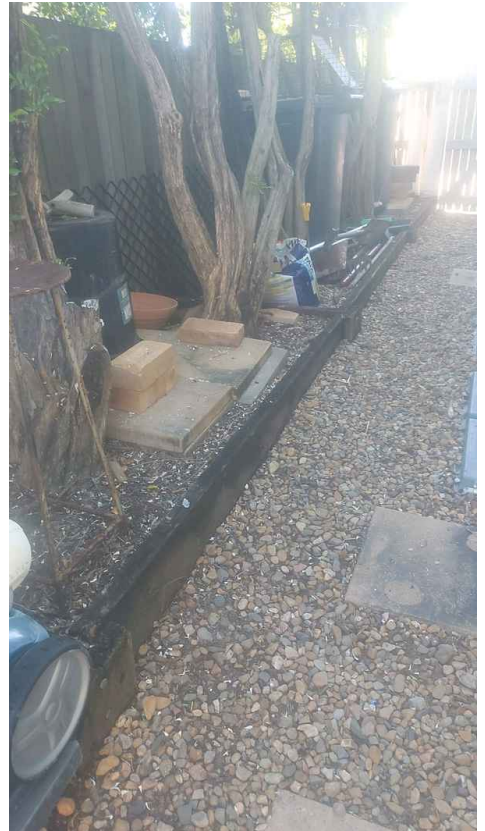
**Site and Exterior: Timber in ground contact**

Timber in contact with the ground will raise the moisture content of timber creating conditions conducive to fungal decay. Action is required to remove this condition in order to prevent timber pest activity and structural damage occurring.

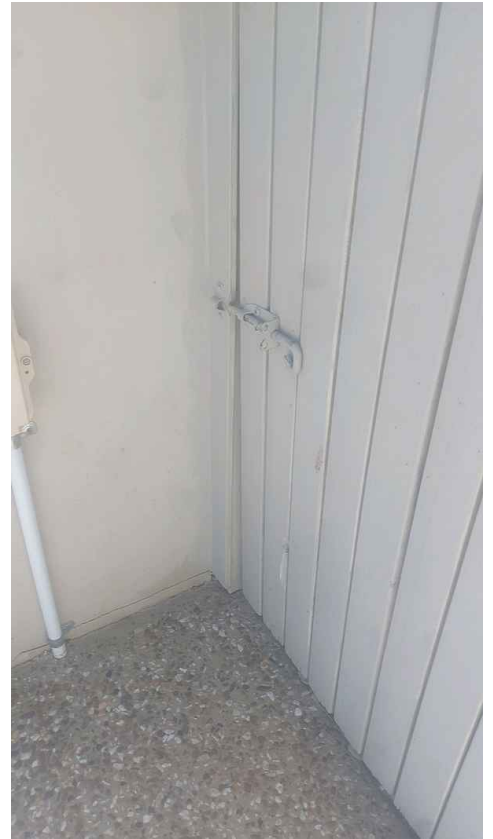
20.4.3 Bridging and Breaching of Termite Barriers and Inspection Zones

Minor-Moderate Attention Recommended

Contact a qualified professional.

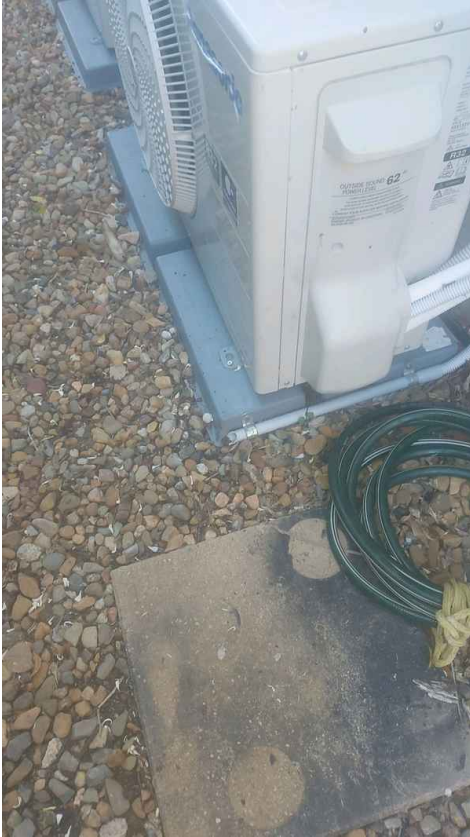
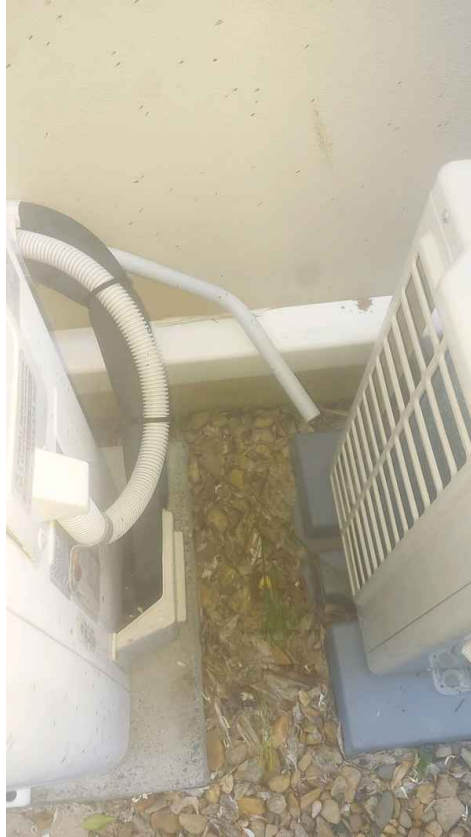
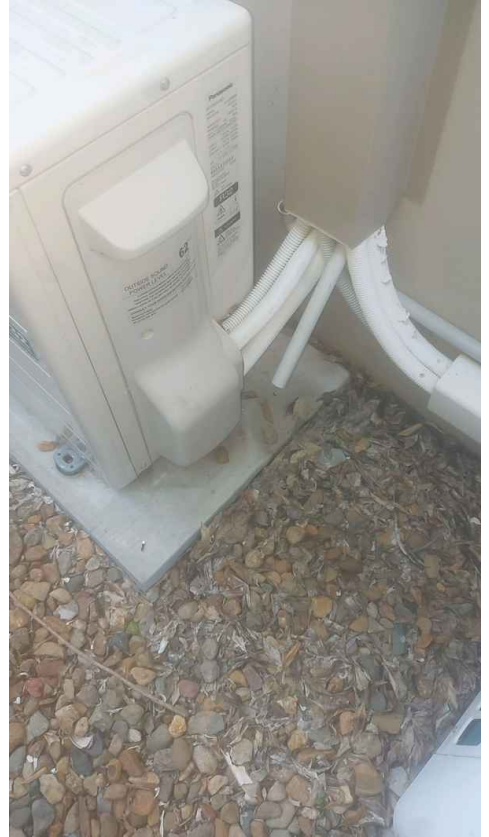
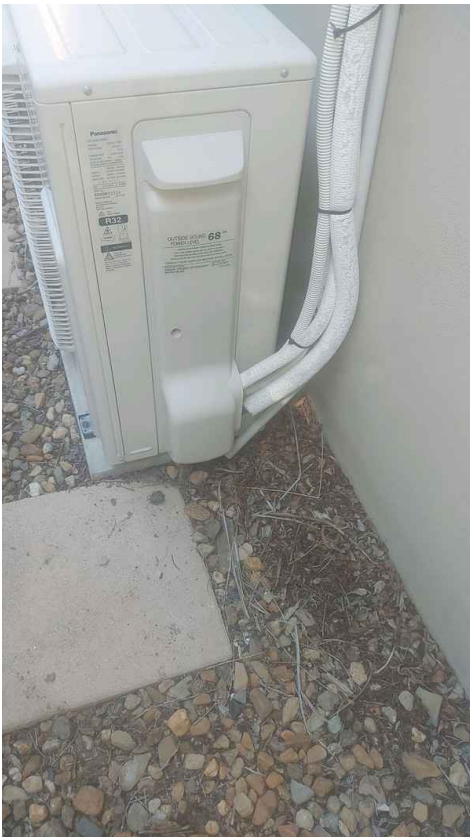
20.5.1 Site and Exterior

Minor-Moderate Attention Recommended

Contact a qualified professional.
