BUILDING AND TIMBER PEST REPORT

**64 Halland Terrace
Camp Hill, QLD 4152**

11/12/2023

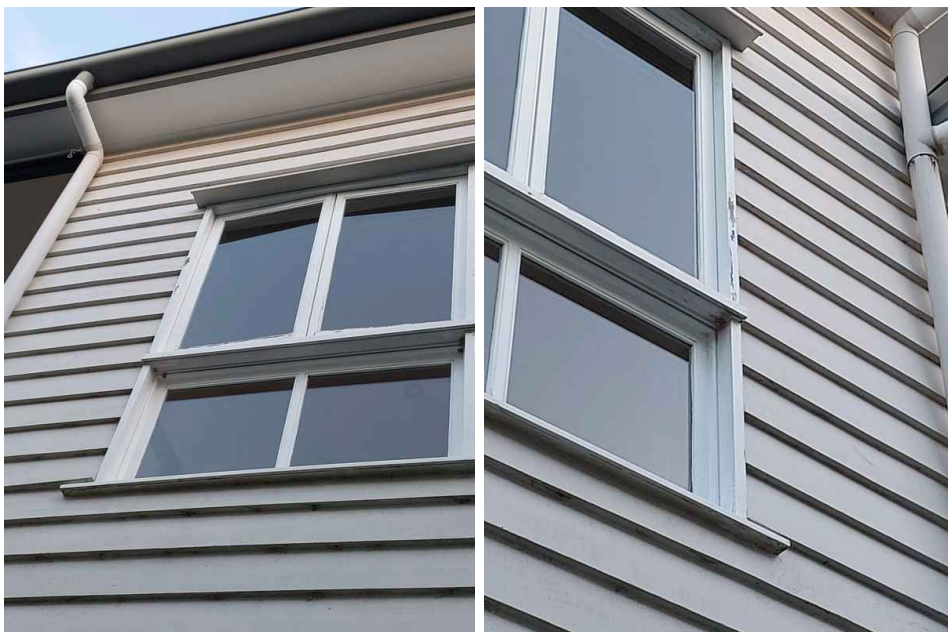
11.5.1 Exterior Joinery/Trim

MOISTURE DAMAGE. MINOR DECAY

Further evaluation and correction recommended

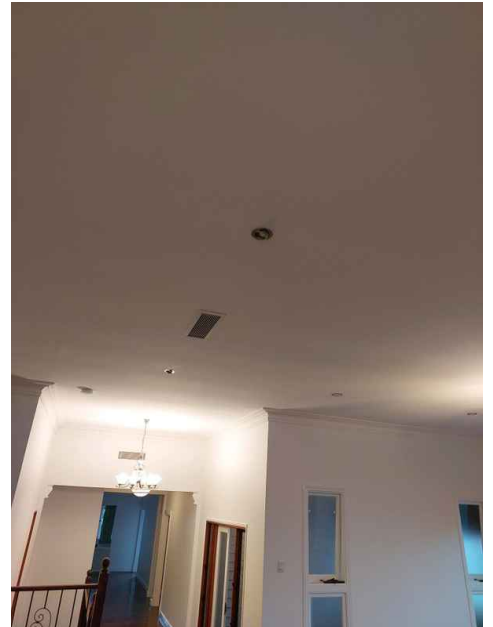
13.4.3 Ceilings

MOISTURE STAINS - NO MOISTURE DETECTED

Minor-Moderate Attention Recommended

Stains on the ceiling observed at the time of the inspection. The moisture meter showed no elevated levels of moisture present in the stained areas at the time of the inspection, indicating that the source of moisture may have been corrected, or may be intermittent.

Further evaluation and correction recommended.

Contact a qualified professional.

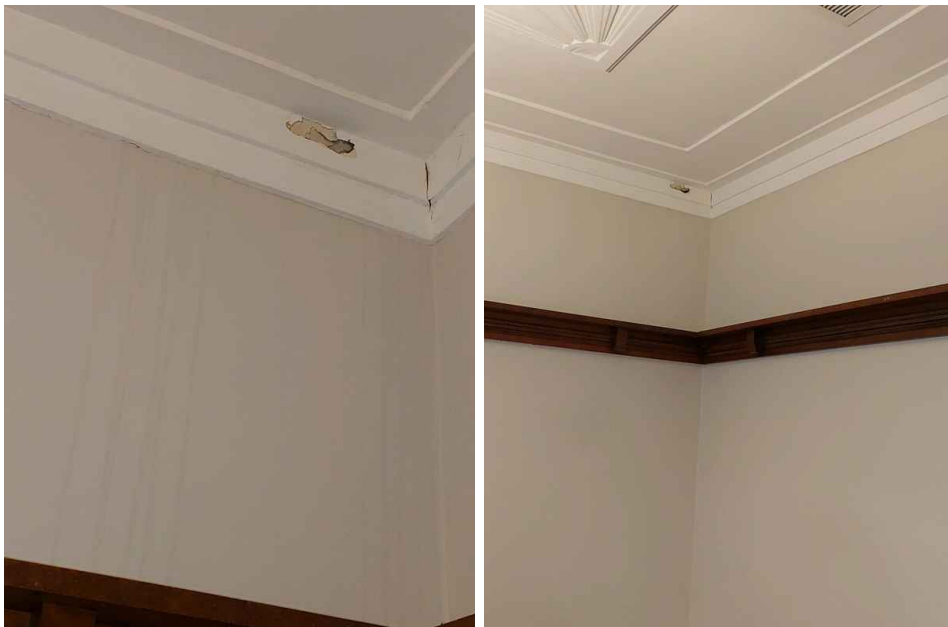
13.4.4 Ceilings

Minor-Moderate Attention Recommended**PAINT PEELING IN AREAS.**

Repainting/regular maintenance recommended

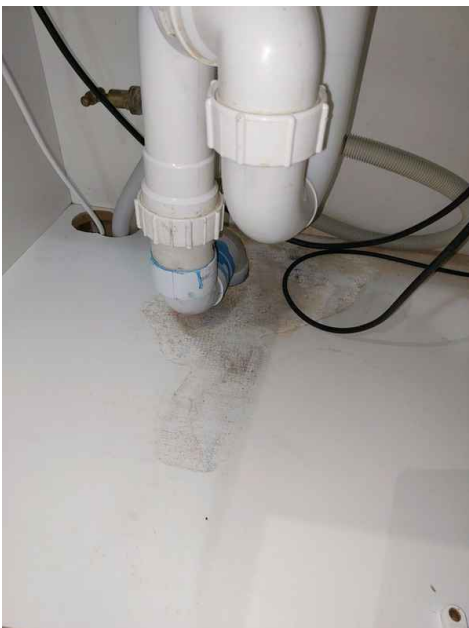
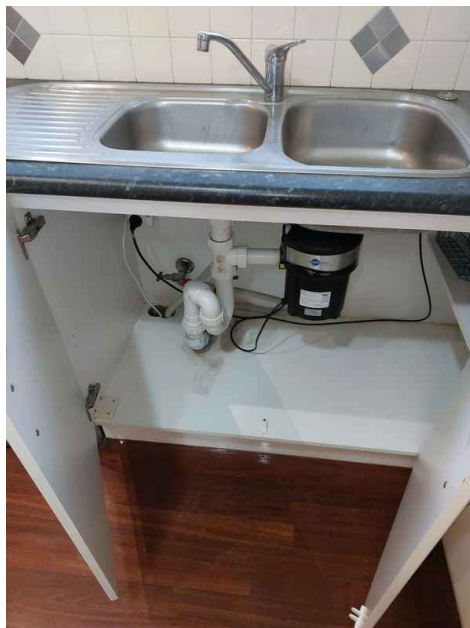
14.1.1 Cabinets

MOISTURE STAINS/DAMAGE

Minor-Moderate Attention Recommended

There were moisture stains/damage under the sink indicating a leak of some nature. No moisture was observed at the time of the inspection, though this is not a guarantee that there is not an ongoing leak, as it may be intermittent.

It would be prudent to have a plumber to test all plumbing for leaks before further use.

Contact a qualified plumbing contractor.

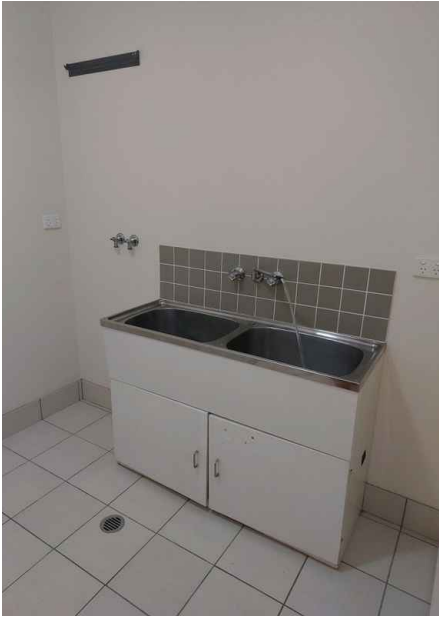
16.2.1 Plumbing

LEAK AT TAP

Minor-Moderate Attention Recommended

Further evaluation and correction recommended

Contact a qualified plumbing contractor.

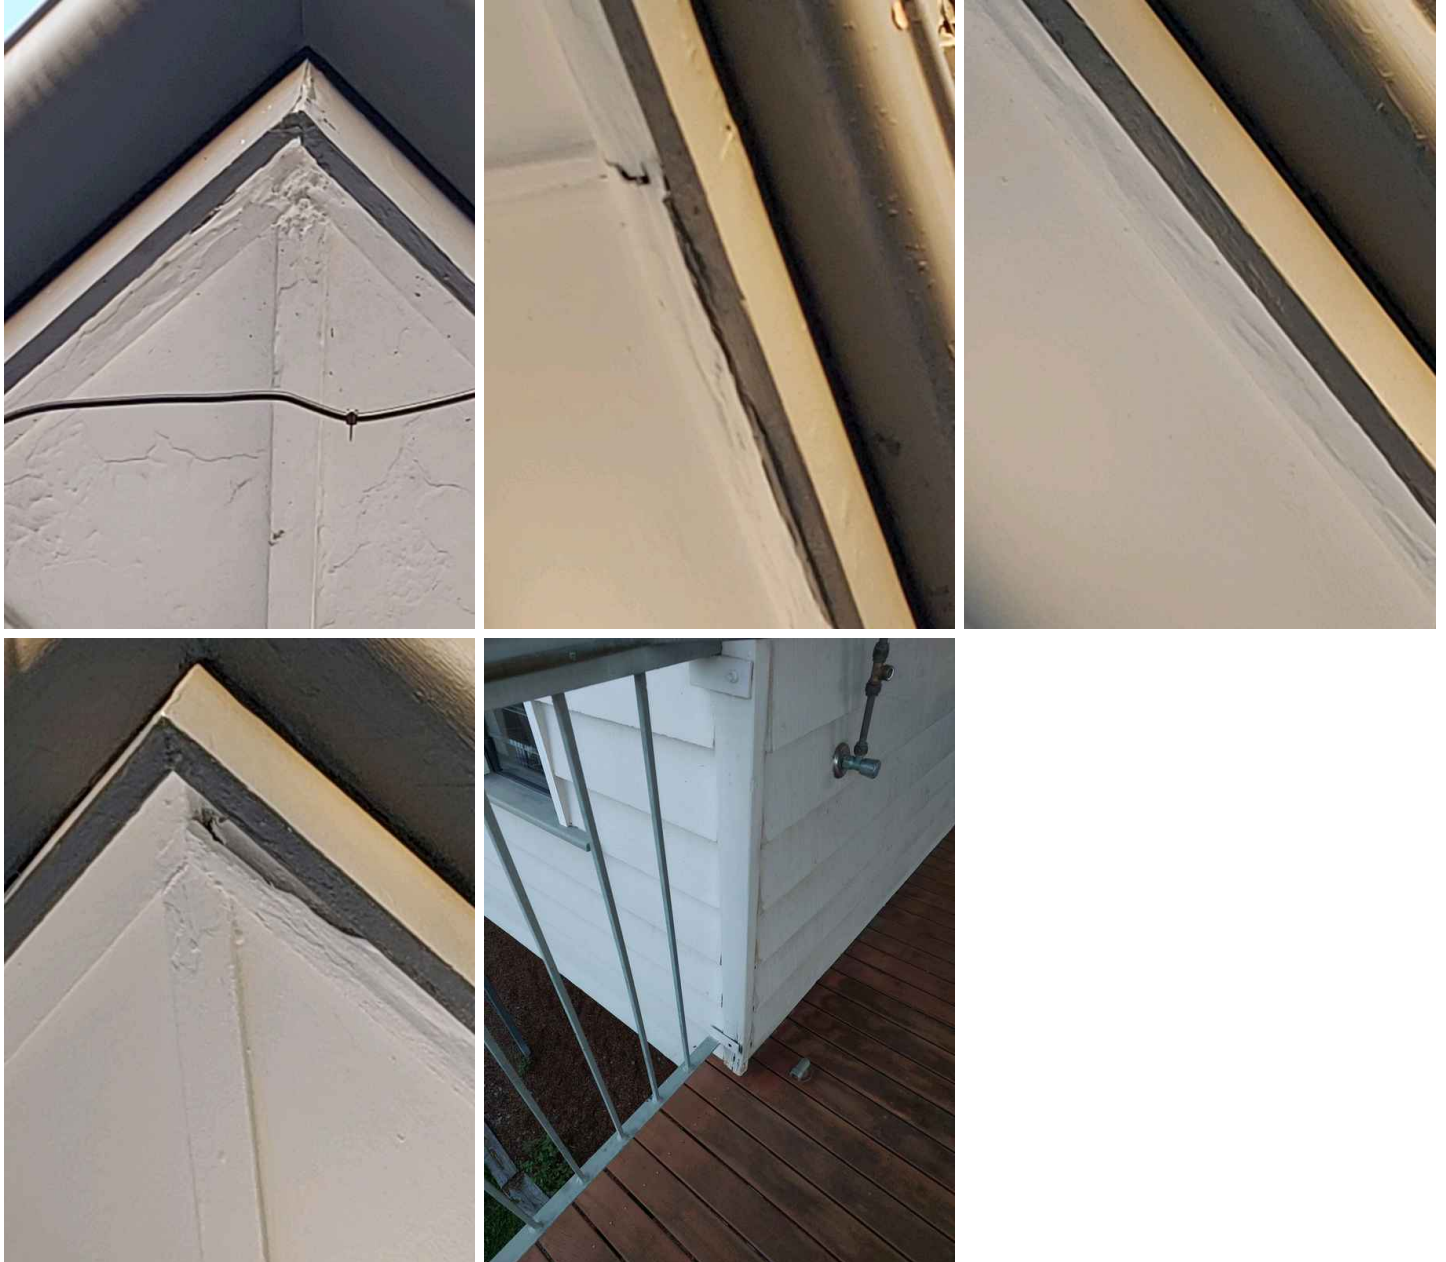
19.8.1 Fungal Decay (Wood Rot)

MINOR TO MODERATE FUNGAL DECAY DAMAGE

Minor-Moderate Attention Recommended

Minor to Moderate fungal decay damage was observed in various sections of timber, the decay did not appear to be structurally significant at time of the inspection. Further evaluation and repair or replacement recommended.

Contact a qualified professional.

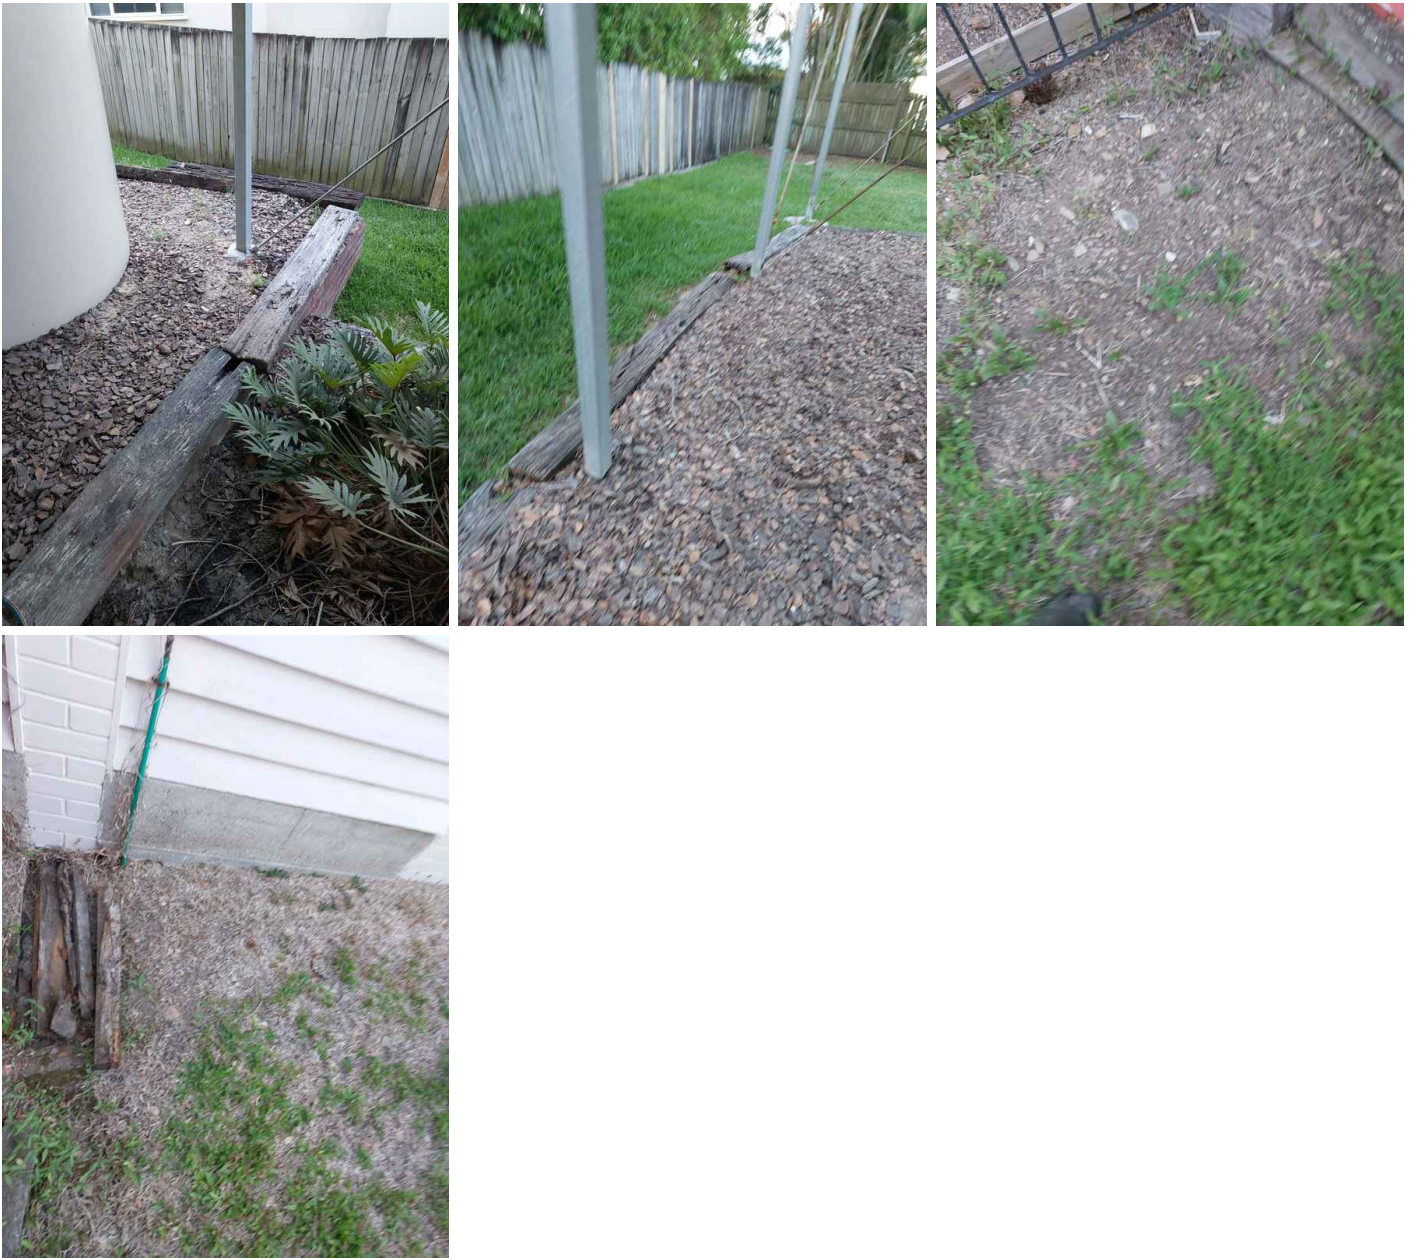
Non durable timbers generally decay quickly, and are readily available food for termites. We recommend removing or replacing with durable or treated timbers, or an alternative product.

Further evaluation and correction recommended

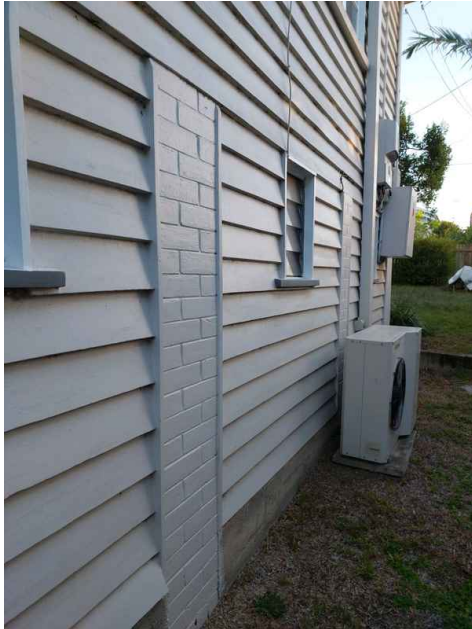
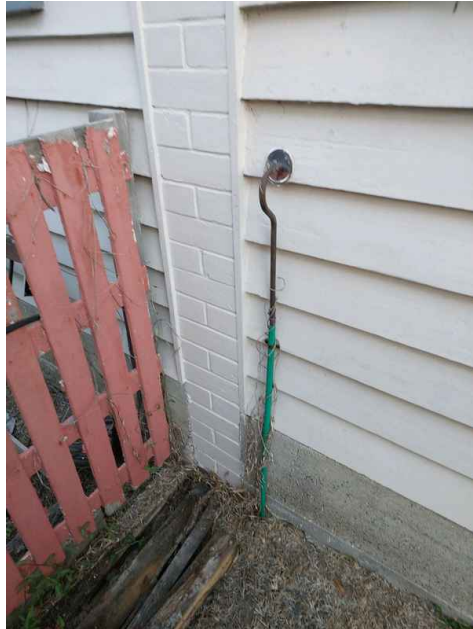
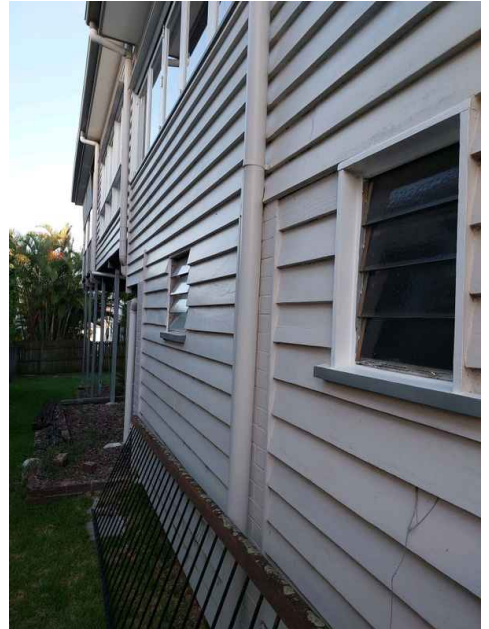
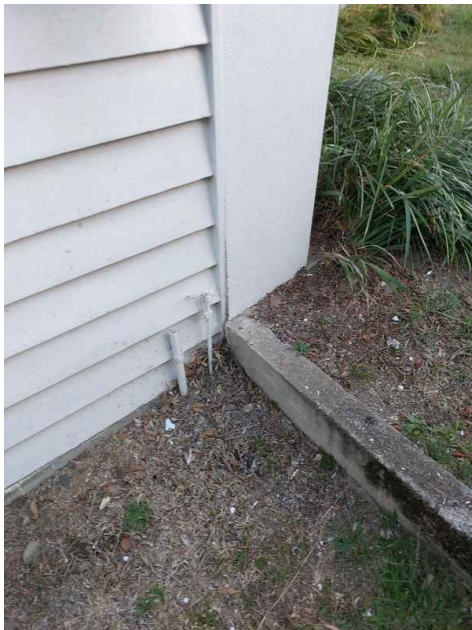
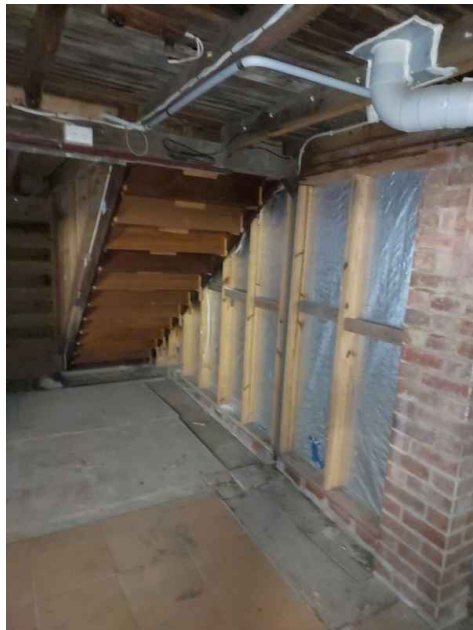
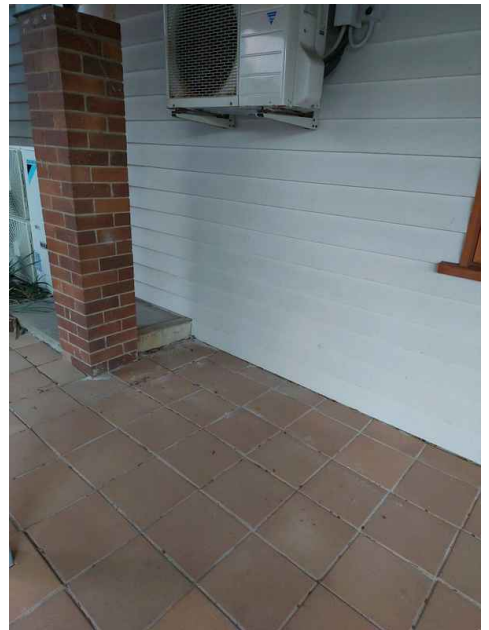
20.3.1 Presence of Excessive Moisture

EVIDENCE OF MOISTURE INTRUSION FOUND

Minor-Moderate Attention Recommended

Contact a qualified professional.
