BUILDING AND TIMBER PEST REPORT

8 Lloyd St
Camp Hill, QLD 4152

BYB (BYB)
31/10/2023

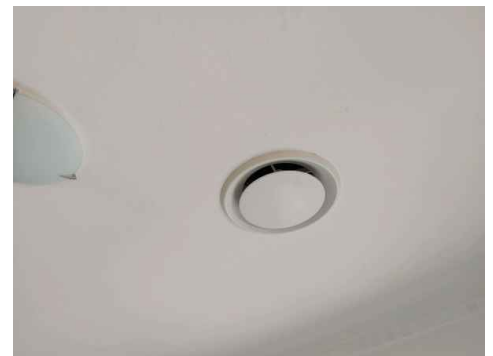
5.3.1 Air Conditioning

Type of air-condition installed is a fully ducted system. Refer to pictures in roof void section showing visible ducting.

Contact a qualified professional.

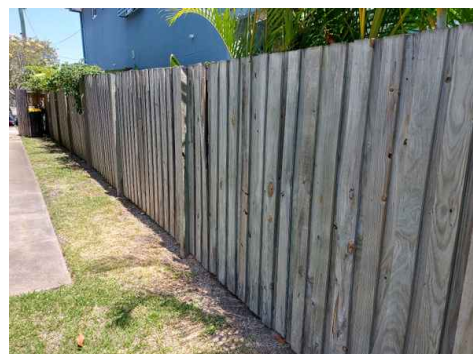
TIMBER FENCES

It should be stated that timber fences do have a finite service life. Timber and treatment to timber deteriorate over time, and require regular maintenance and replacement. Maintaining the bases of the fence posts and palings free and clear of soil, rotting leaves, and occasional treatment with a wood preservative will be most effective in prolonging service life.

Contact a qualified professional.

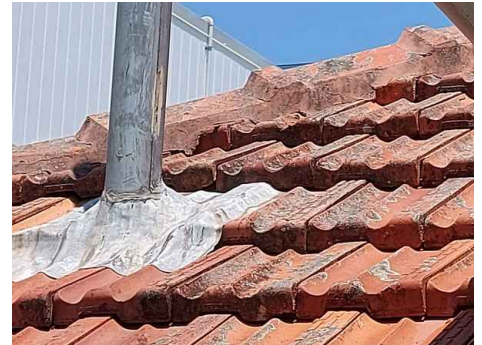
General: Primary roof-covering type:

Terracotta Tiles

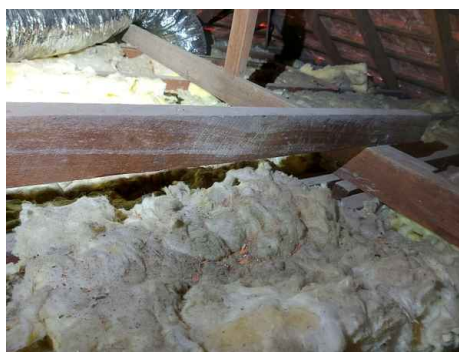
General: Roof Space thermal insulation:

Fiberglass Batt

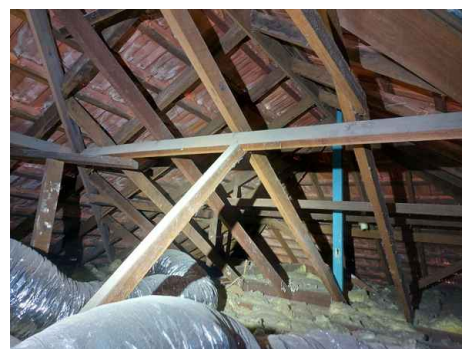
General: Roof Framing Type: Conventional Framing

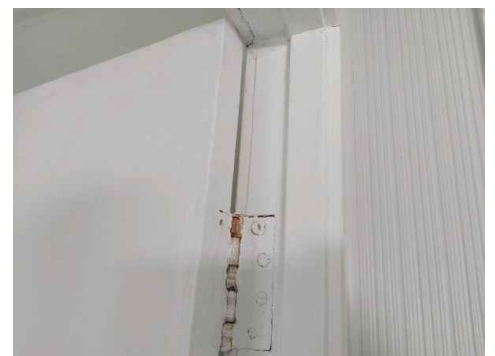
11.5.3 Doors

LATCH MISALIGNED

Further evaluation and correction recommended

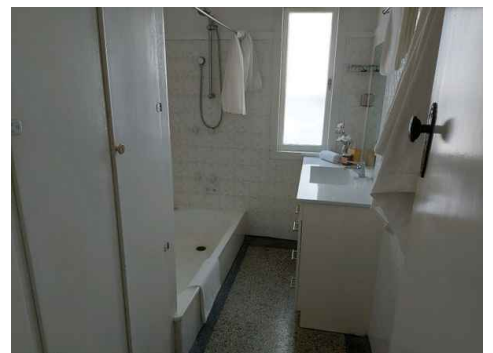
Although functioning, the bathroom/s are older and toward the end of useful life, and recommend consideration of replacement/renovation of the bathroom in the near future.

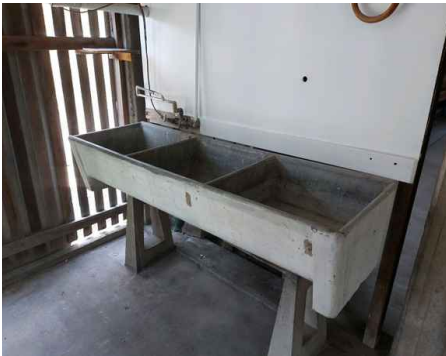
Sub Floor

It appears that the laundry facilities have been moved to the exterior of the building
