BUILDING AND TIMBER PEST REPORT

8/11 Kennington Road
Camp Hill, QLD 4152

BYB
06/03/2024

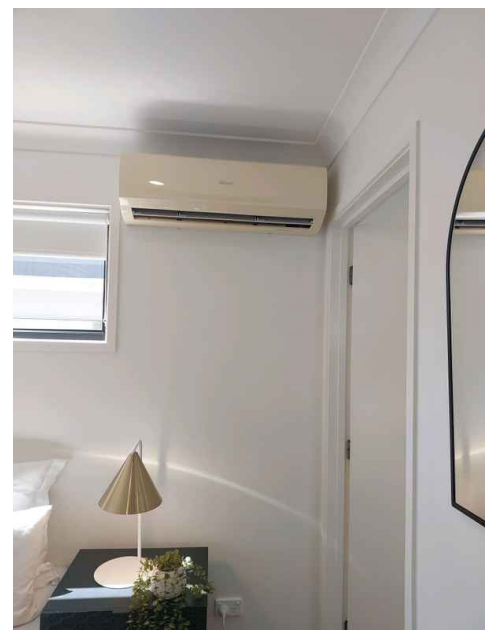
5.3.2 Air Conditioning

The air conditioning units did not appear to be functioning correctly at the time of the inspection. Further evaluation and correction recommended.

Contact a qualified HVAC professional.

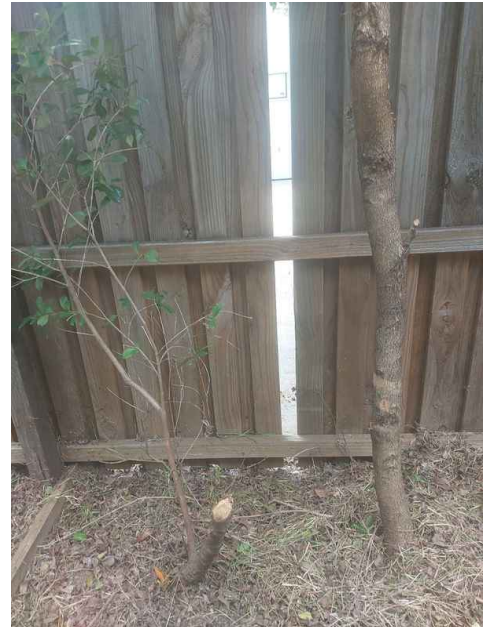
**FENCE REPAIR - MINOR**

Fences and/or gates are damaged and/or deteriorated in some areas. Make repairs or replace sections as necessary.

Contact a qualified fencing contractor

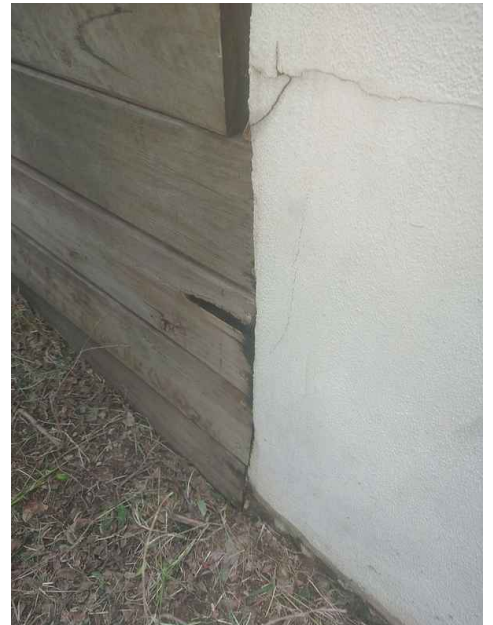
6.6.1 Retaining Walls

**RETAINING WALL CRACKS /
DETERIORATION - MONITOR**

Minor defects to the retaining walls observed. Recommend monitoring and evaluation, if the condition deteriorates, consult a structural engineer/retaining wall specialist.

Recommend monitoring.

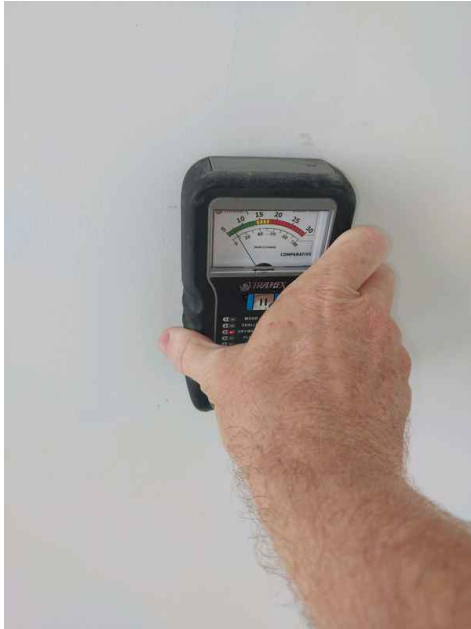
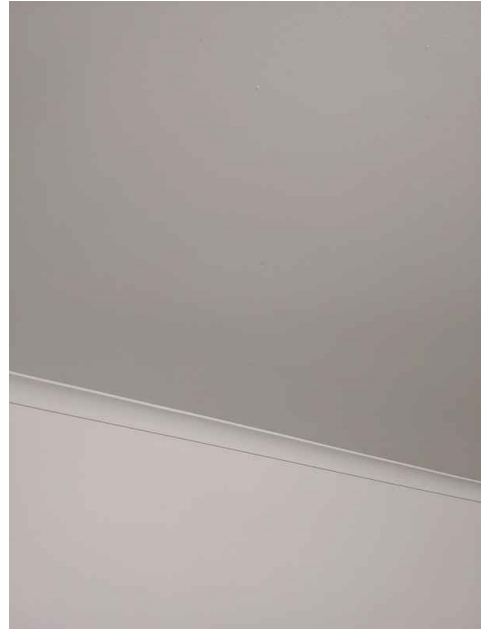
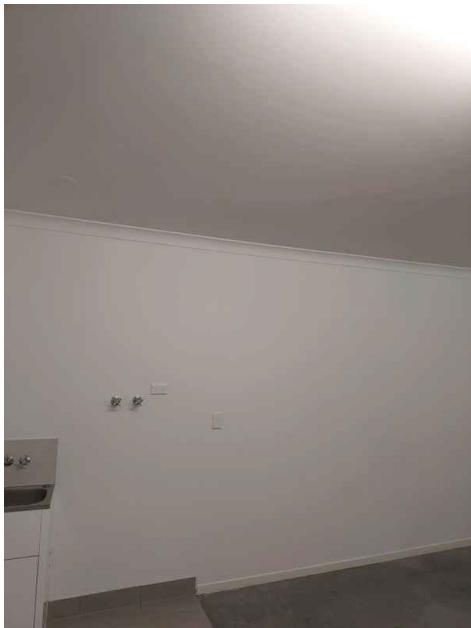
**MOISTURE STAINS - NO MOISTURE DETECTED**

Stains on the ceiling observed at the time of the inspection. The moisture meter showed no elevated levels of moisture present in the stained areas at the time of the inspection, indicating that the source of moisture may have been corrected, or may be intermittent.

Further evaluation and correction recommended.

Contact a qualified professional.

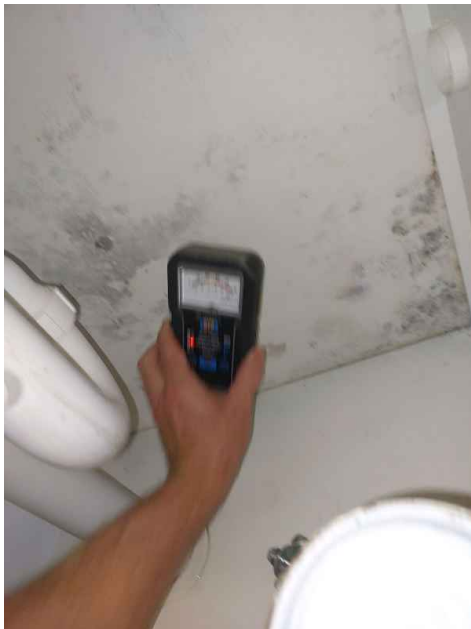
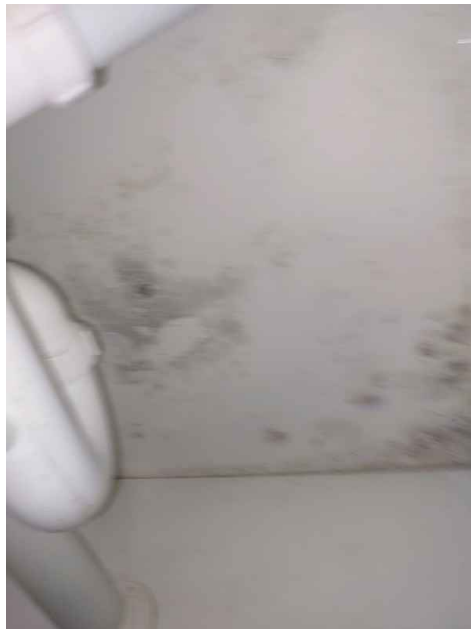
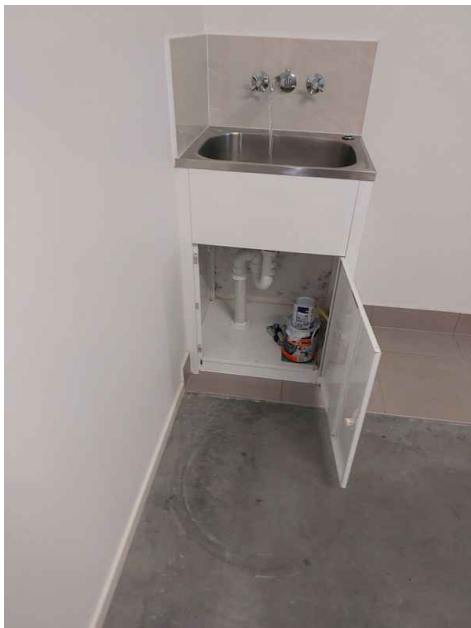
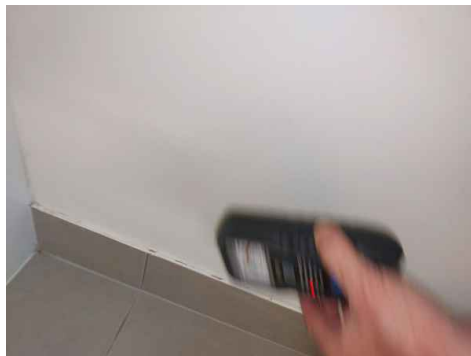
MOISTURE DAMAGE- EVIDENCE CONSISTENT WITH HIGH MOISTURE

Evidence consistent with moisture on the walls at the time of the inspection appeared to be the result of moisture intrusion. The moisture meter showed elevated moisture levels in the affected areas at the time of the inspection, indicating that the leakage has been recent. The Inspector recommends consultation with a qualified contractor to discuss options and costs for correction and repair.

Contact a qualified professional.

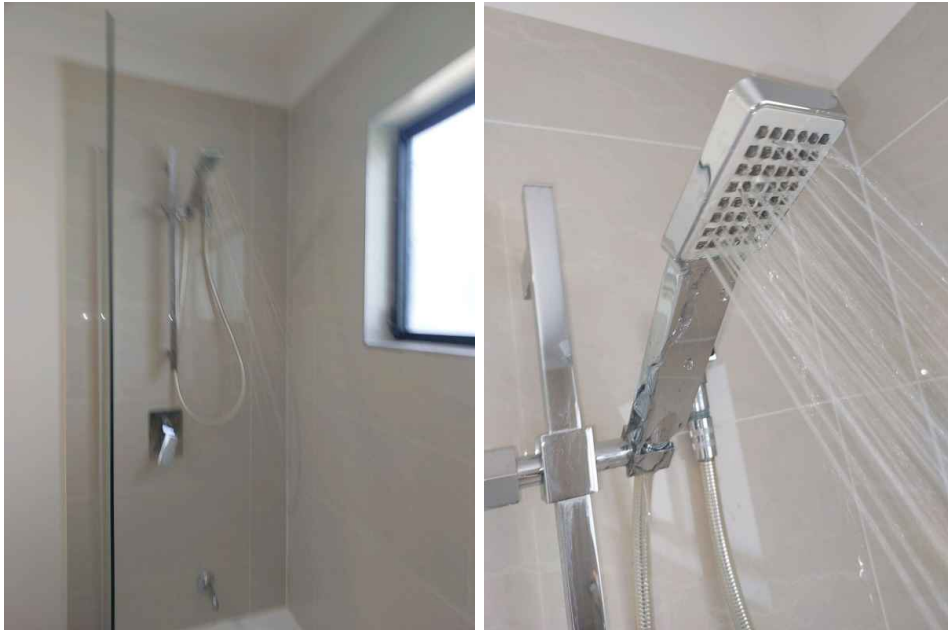
13.2.1 Shower

SHOWER HEAD/HOSE LEAKING

The shower head/ hose is leaking. This is may due to deterioration. It may simply require a new seal or tightening. Replacement is relatively inexpensive.

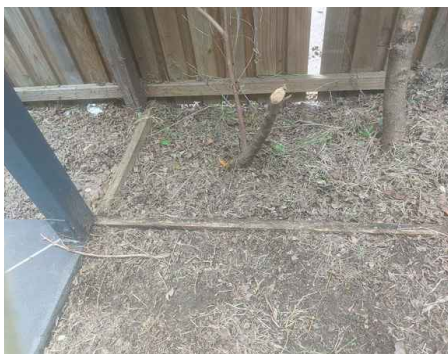
Site and Exterior: Landscaping Timbers

Timber in direct contact with the ground and or soil produces are ready food source for termites. Susceptible Timbers used in a hazardous environment are prone to fungal decay. It is recommended that you remove this condition order to prevent timber pest activity.

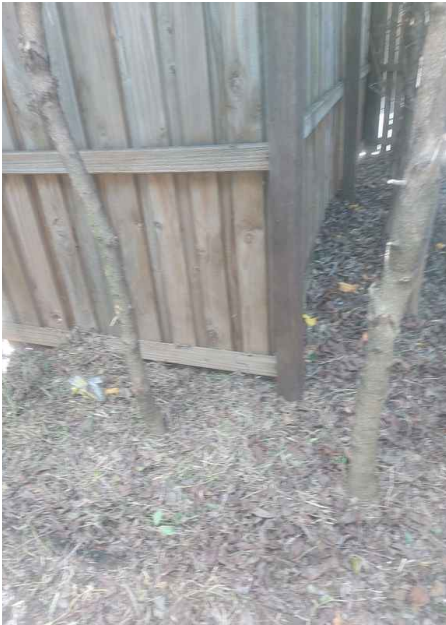
Site and Exterior: Timber in ground contact

Timber in contact with the ground will raise the moisture content of timber creating conditions conducive to fungal decay. Action is required to remove this condition in order to prevent timber pest activity and structural damage occurring.

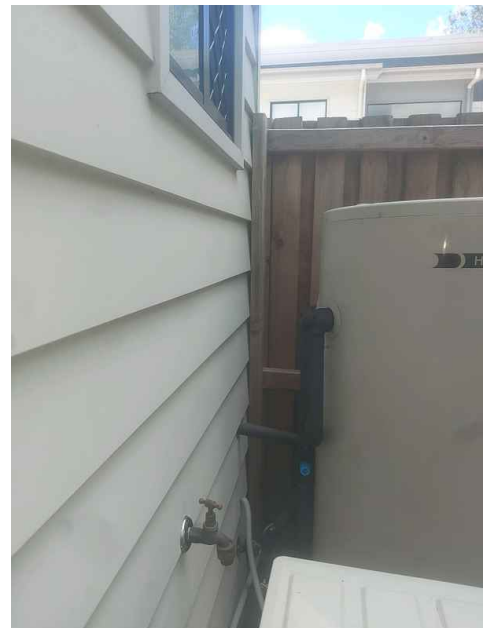
18.4.1 Bridging and Breaching of Termite Barriers and Inspection Zones

INADEQUATE CLEARANCE FROM GROUND

Inadequate clearance can allow hidden termite entry and moisture problems. Further evaluation and correction recommended.

Contact a qualified professional.
