## BUILDING AND TIMBER PEST REPORT

20 Brinawa St  
Camp Hill, QLD 4152

BYB (BYB)  
26/10/2023

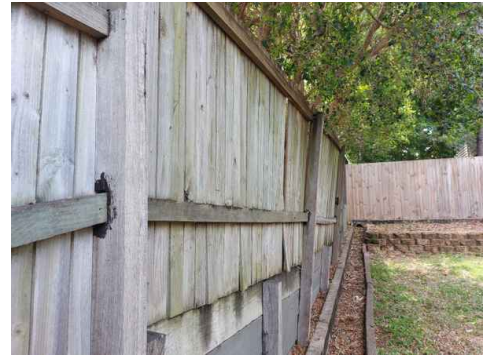
Fence leaning in areas. A qualified contractor should evaluate and make repairs or replace sections as necessary.

Contact a qualified fencing contractor

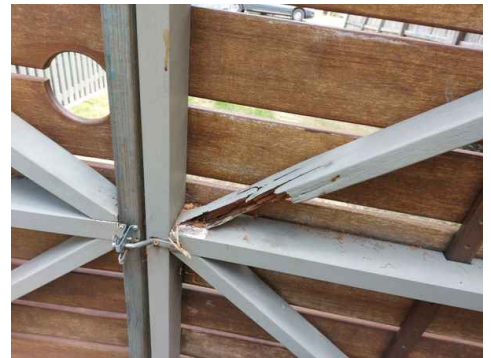
## 6.4.3 Fences/Gates

**GATE REPAIR - MINOR**

One or more gates had some damage and/or deterioration. Recommend repairs made.

Contact a handyman or DIY project

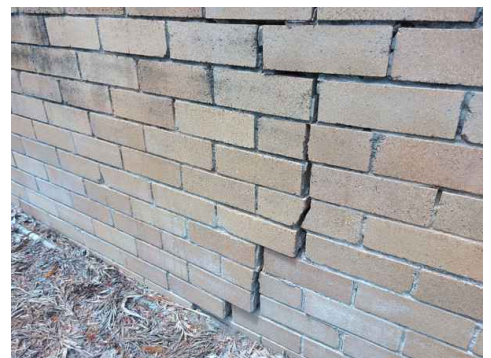
## 6.5.1 Retaining Walls

**RETAINING WALL  
CRACKS / DETERIORATION - REPAIR**

Significant cracks, deterioration, leaning and/or bowing were found in one or more retaining walls. Recommend that a qualified contractor evaluate and repair or replace sections as necessary. Note that some retaining walls, based on their height or size, may require evaluation by a structural engineer.

Contact a qualified general contractor.

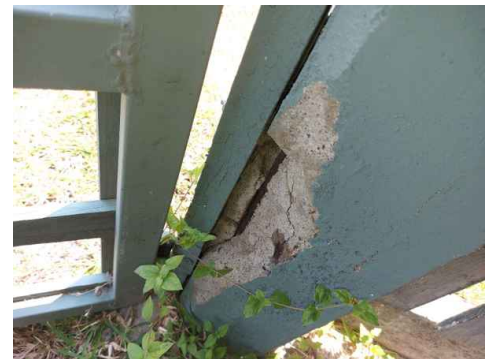
### 7.2.1 Stumps/Posts/Piers

### CRACKED CONCRETE PIERS

Cracks/repairs to concrete pier/s were observed. This is often caused by corrosion of steel reinforcement, but may be caused by other factors.

Note: Corrosion of steel reinforcement is informally known as concrete cancer. Steel reinforcement corrodes when it is too close to the external surface of a concrete pier or brick pier. The effect is similar in both cases. The products of corrosion, rust, have a greater volume than the original steel. The steel grows in volume and pushes outwards. This causes the concrete or brickwork to crack. The cracks allow more air and more moisture into the pier. The corrosion process continues and accelerates.

Consult a structural engineer or qualified Re-stumper to determine any repairs or replacement required.

Contact a qualified structural engineer.

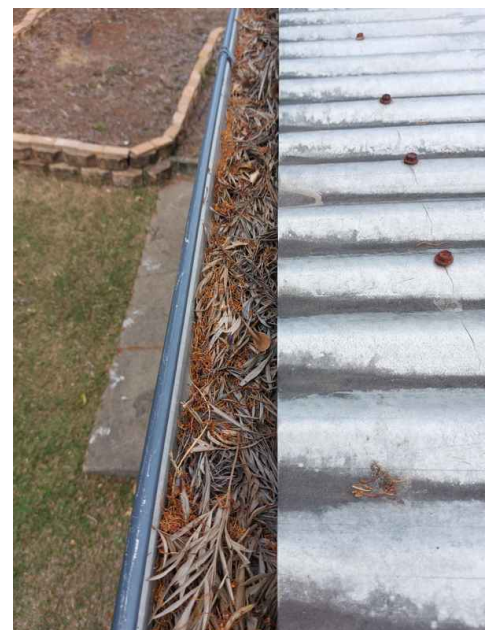
Debris has accumulated in one or more gutters or downpipes. Gutters can overflow and cause water to come in contact with the building exterior, interior or water can accumulate around the foundation. This can encourage timber pests and cause building damage. Recommend cleaning gutters and downspouts now and as necessary in the future.

Contact a handyman or DIY project

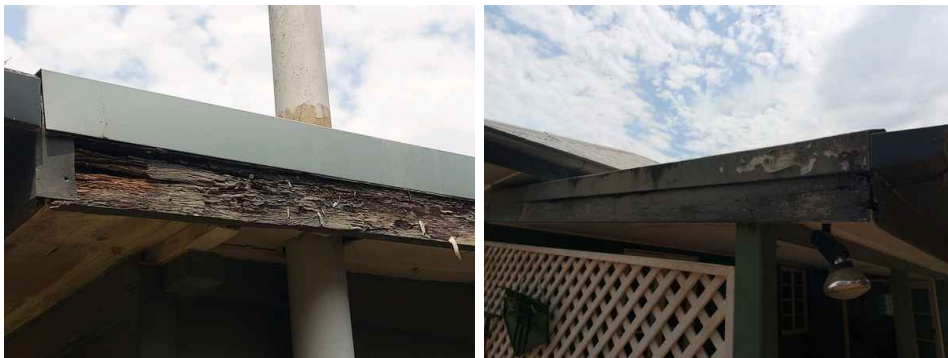
**DECAYED TIMBER**

Fungal Decay (rot) damage to timbers was observed. This is classed as a timber pest. Recommend replacement of damaged timbers, and identify and correct moisture intrusion.

Further evaluation and correction recommended

Contact a qualified professional.

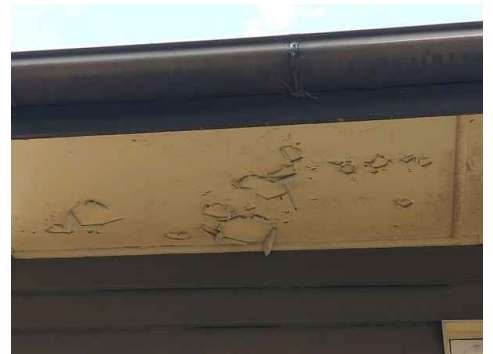
## 10.4.1 Eaves/Soffits

**BLISTERING/PEELING PAINT**

The paint work to the eaves is deteriorating. Repair as required.

Note: This damage may be due to moisture. The source of moisture should be identified and corrected.

Contact a qualified professional.

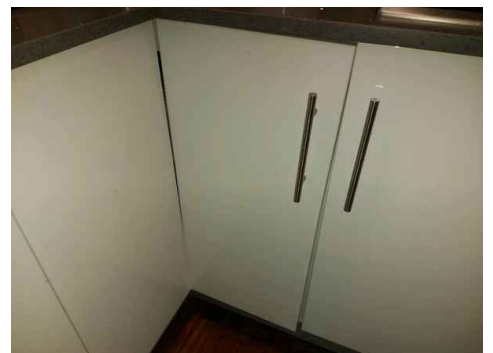
## 12.1.1 Cabinets

**ADJUSTMENTS RECOMMENDED**

Doors/drawers require adjustment of hinges, latches, and/or runners for smoother operation/prevent damage.

Contact a qualified professional.
