## BUILDING AND TIMBER PEST REPORT

14 Lloyd St  
Camp Hill, QLD 4152

BYB  
04/04/2024

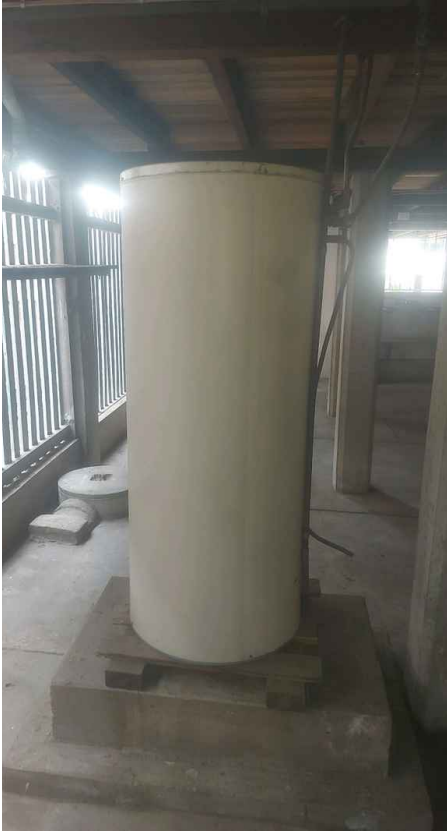
#### Hot Water Service: Hot water provided by:

Electric Water Heater (Tank)

No specific tests were carried out. No determination has been made as to the compliance, suitability or adequacy of the hot water system in relation to capacity, function or lifespan.

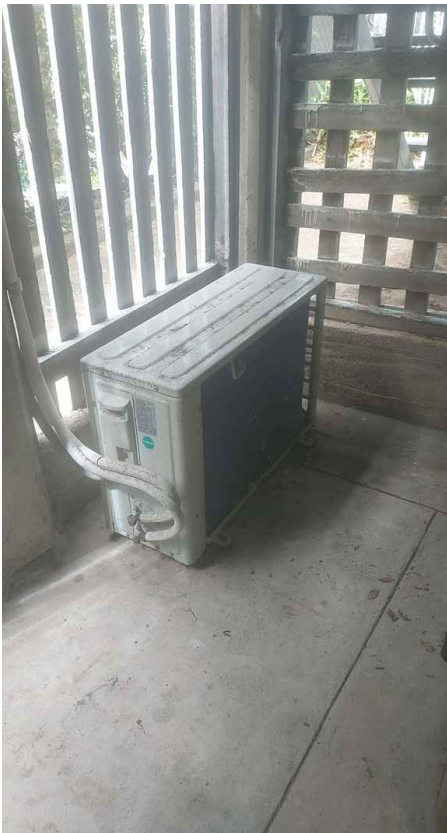
**Air Conditioning: Air Conditioning Installed**

Air-conditioning is installed to the property but has not been tested/inspected. We recommend a licensed air conditioning specialist to determine the status of the units.

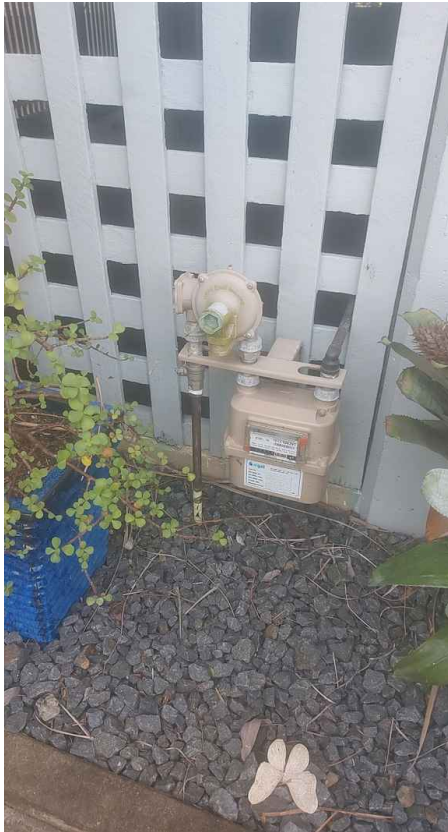
#### Reticulated Gas (Underground Lines)

A gas system was installed at the Property but was not inspected, tested, or checked for compliance. We recommend testing and inspection by a qualified Gas Plumber prior to use

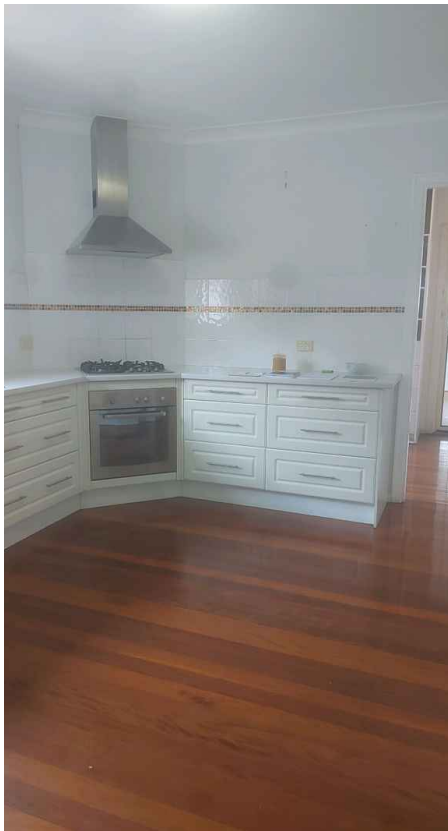
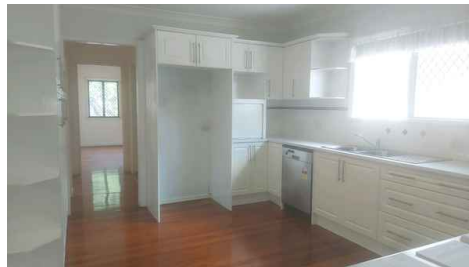
**Cabinets: Serviceable condition**

The Inspector observed no major deficiencies at the time of the inspection.

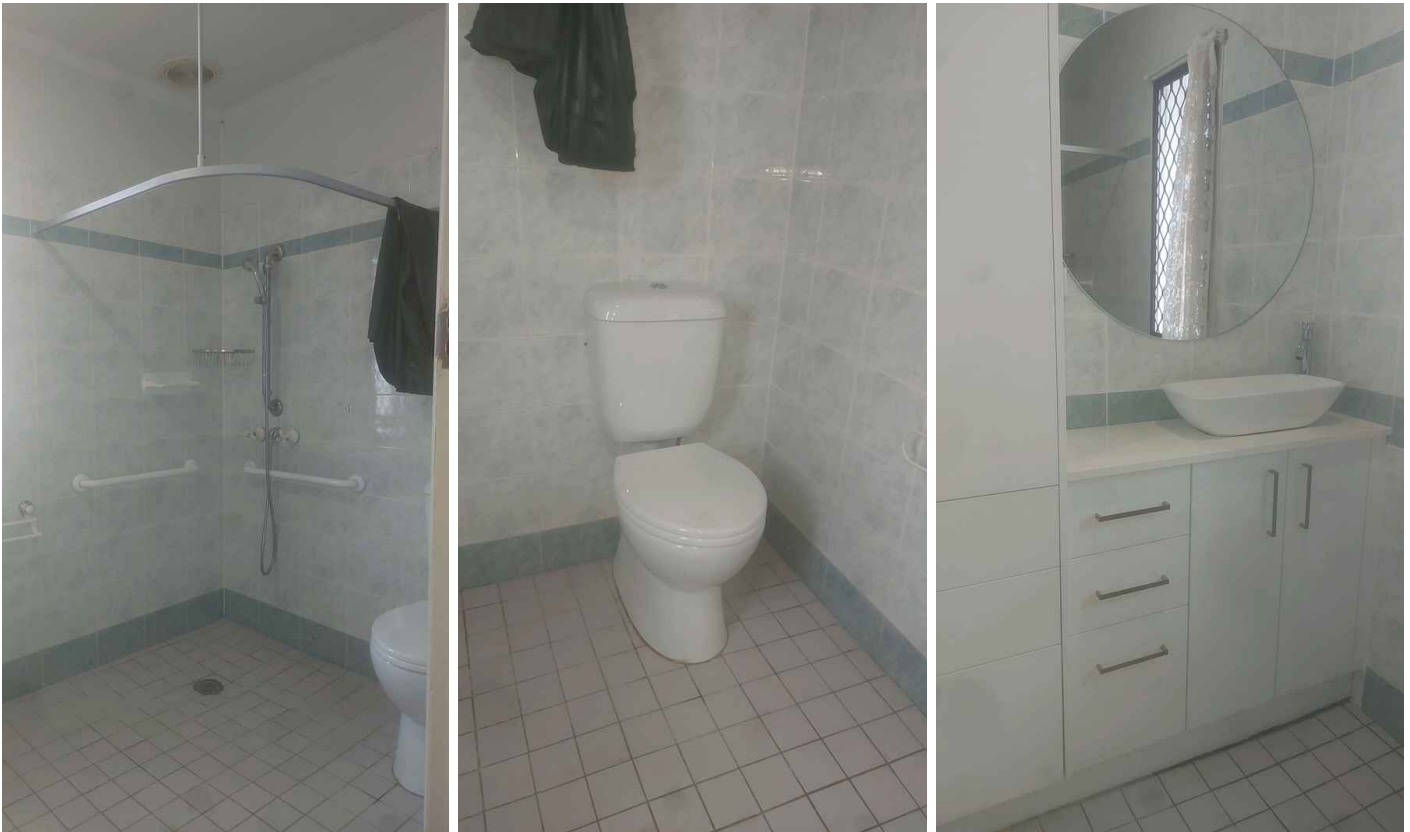
**General: Overall serviceable condition**

No Major Defects Were Observed. Normal ongoing maintenance is required.

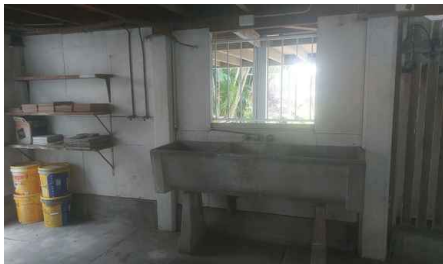
**General: Laundry Area**  
**Serviceable**

The Inspector observed no major deficiencies at the time of the inspection.
