BUILDING AND PEST XL2

24 Fryar St
Camp Hill, QLD 4152

Before You Bid (BYB)
10/11/2023

Pre-Purchase Inspection - Residential Building Report

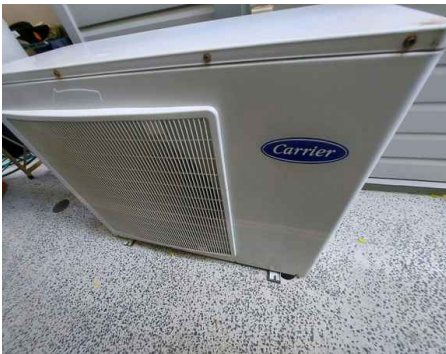
Air Conditioning: Air Conditioning Installed

Air-conditioning is installed to the property but has not been tested/inspected. We recommend a licensed air conditioning specialist to determine the status of the units.

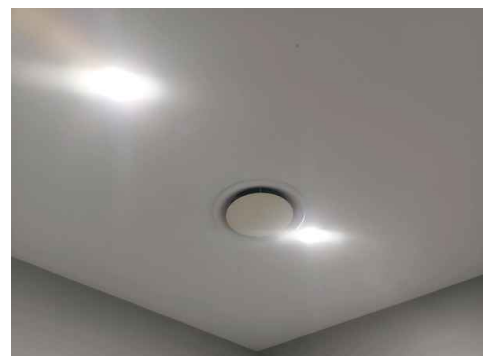
5.3.1 Air Conditioning

Type of air-condition installed is a fully ducted system. Refer to pictures in roof void section showing visible ducting.

Contact a qualified professional.

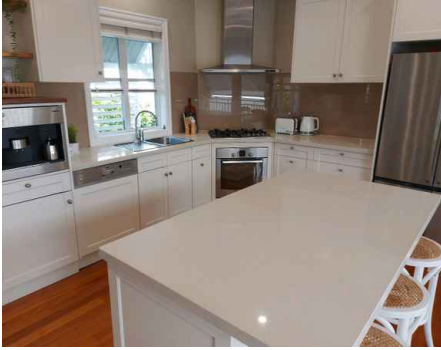
Cabinets: Good condition

The Inspector observed no major deficiencies at the time of the inspection.

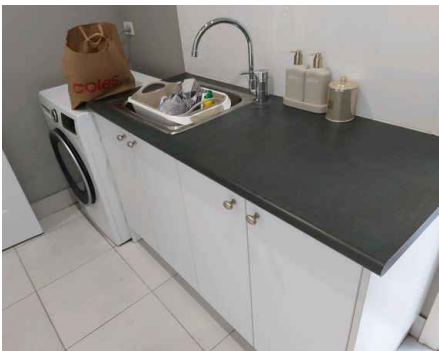
General: Good Condition

The Inspector observed no major deficiencies at the time of the inspection.
