BUILDING AND TIMBER PEST REPORT

24 Goulburn St
Hawthorne, QLD 4171

BYB
28/03/2024

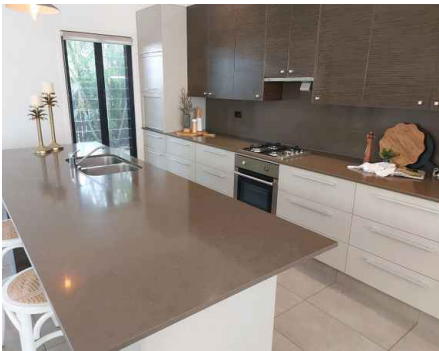
12.1.1 Cabinets

Cabinets: Good condition

The Inspector observed no major deficiencies at the time of the inspection.

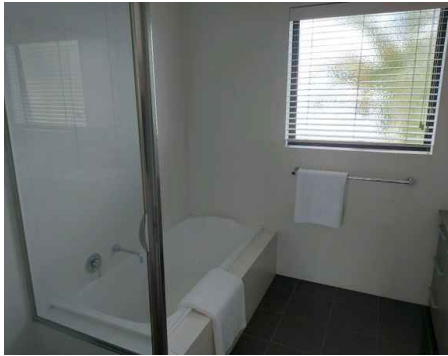
1st Floor Bathroom

General: Overall Good Condition

No Major Defects Were Observed. Normal ongoing maintenance is required.

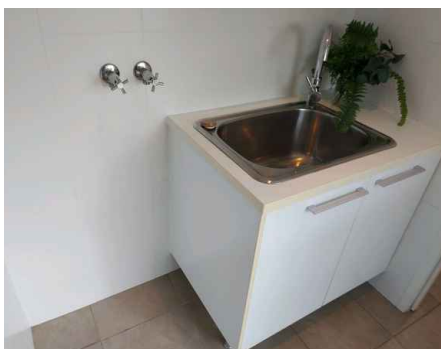
Serviceable

The Inspector observed no major deficiencies at the time of the inspection.

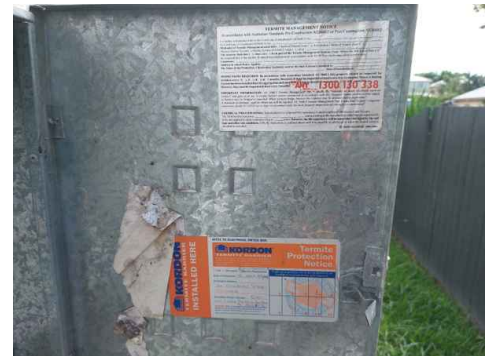
17.3.1 Termite Management Systems

KORDON

Recommendation

Contact a qualified professional.
