BUILDING AND TIMBER PEST REPORT

4/47 East St
Camp Hill, QLD 4152

BYB
04/04/2024

Pre-Purchase Inspection - Residential Building Report

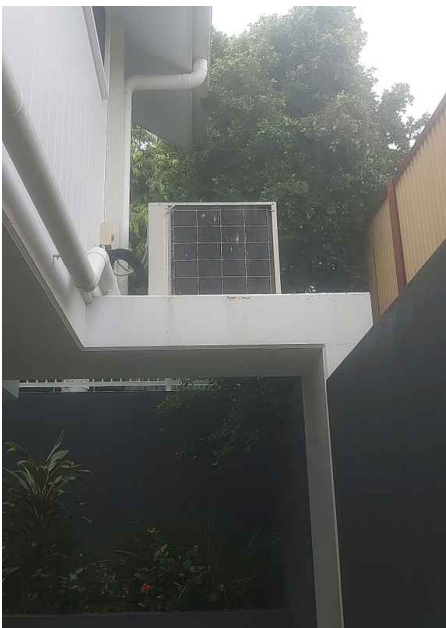
Air-conditioning is installed to the property but has not been tested/inspected. We recommend a licensed air conditioning specialist to determine the status of the units.

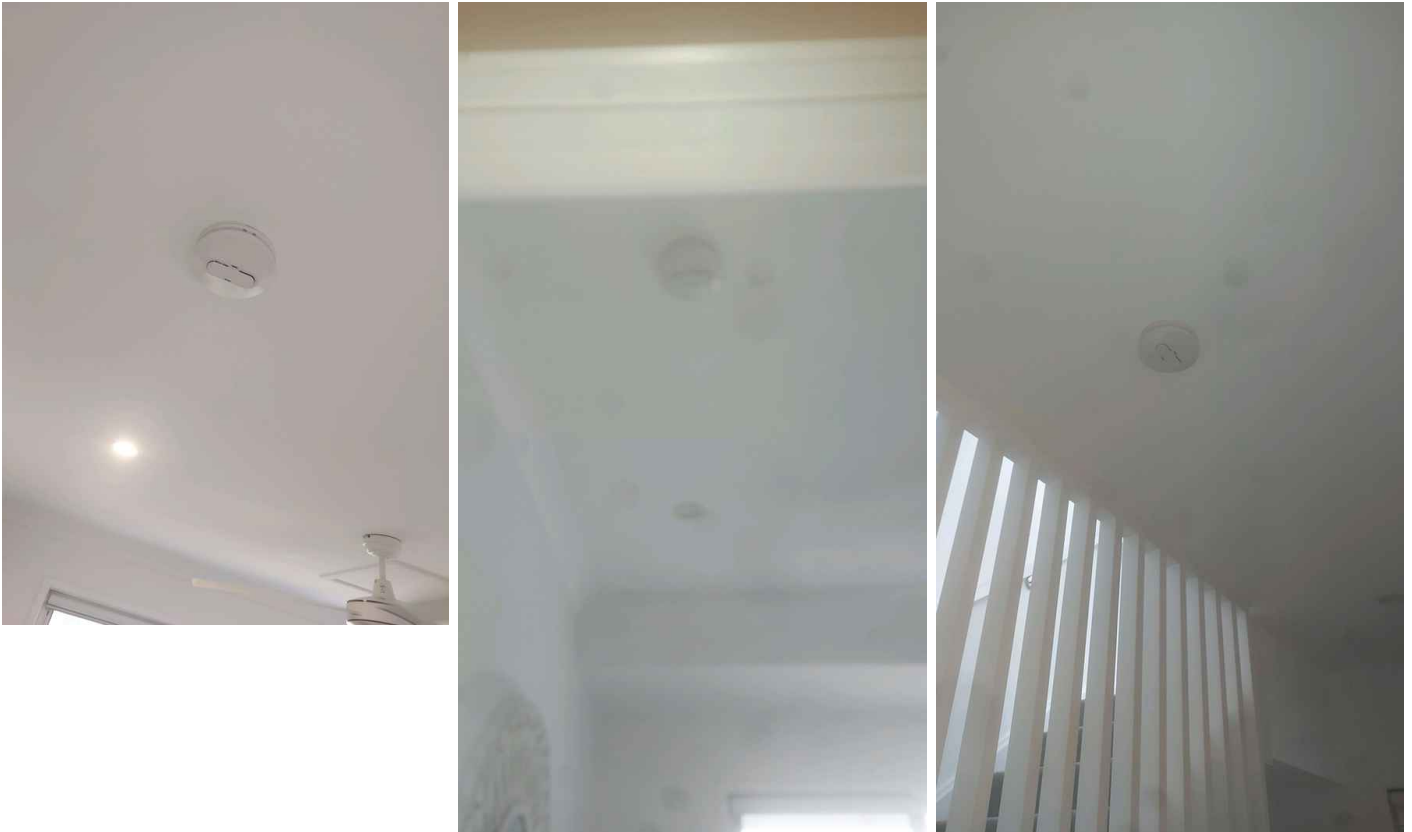
Smoke alarm(s) are fitted however the operation or adequacy was not tested and is not commented on.

IMPORTANT NOTE. The Consultant cannot comment on the installation/testing requirements of smoke detectors as this is a specialist safety-critical task that is not within the scope of this inspection and report. It is strongly recommended that the Client obtains advice from a suitably qualified person to either install the adequate amount of smoke detectors and/or ensure existing smoke detectors are of the required type and are installed and maintained correctly.

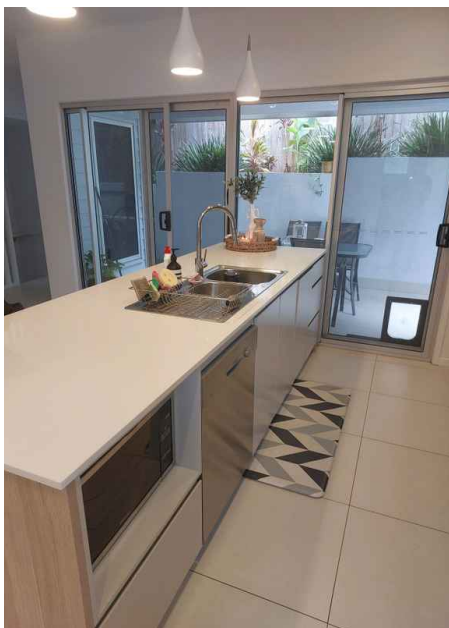
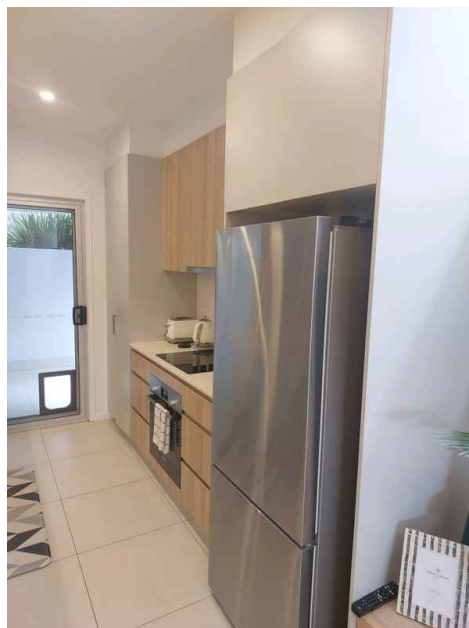
Cabinets: Good condition

The Inspector observed no major deficiencies at the time of the inspection.

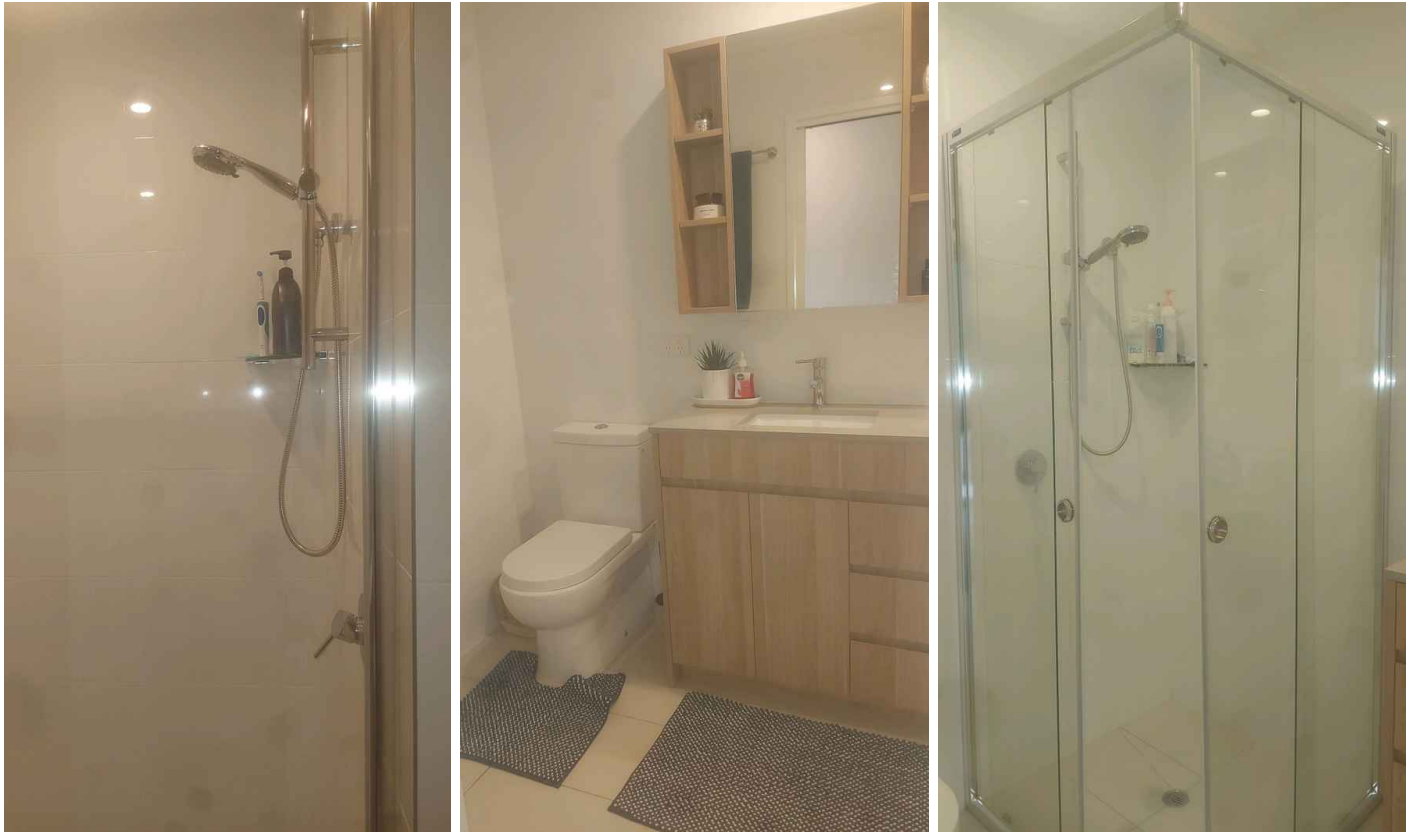
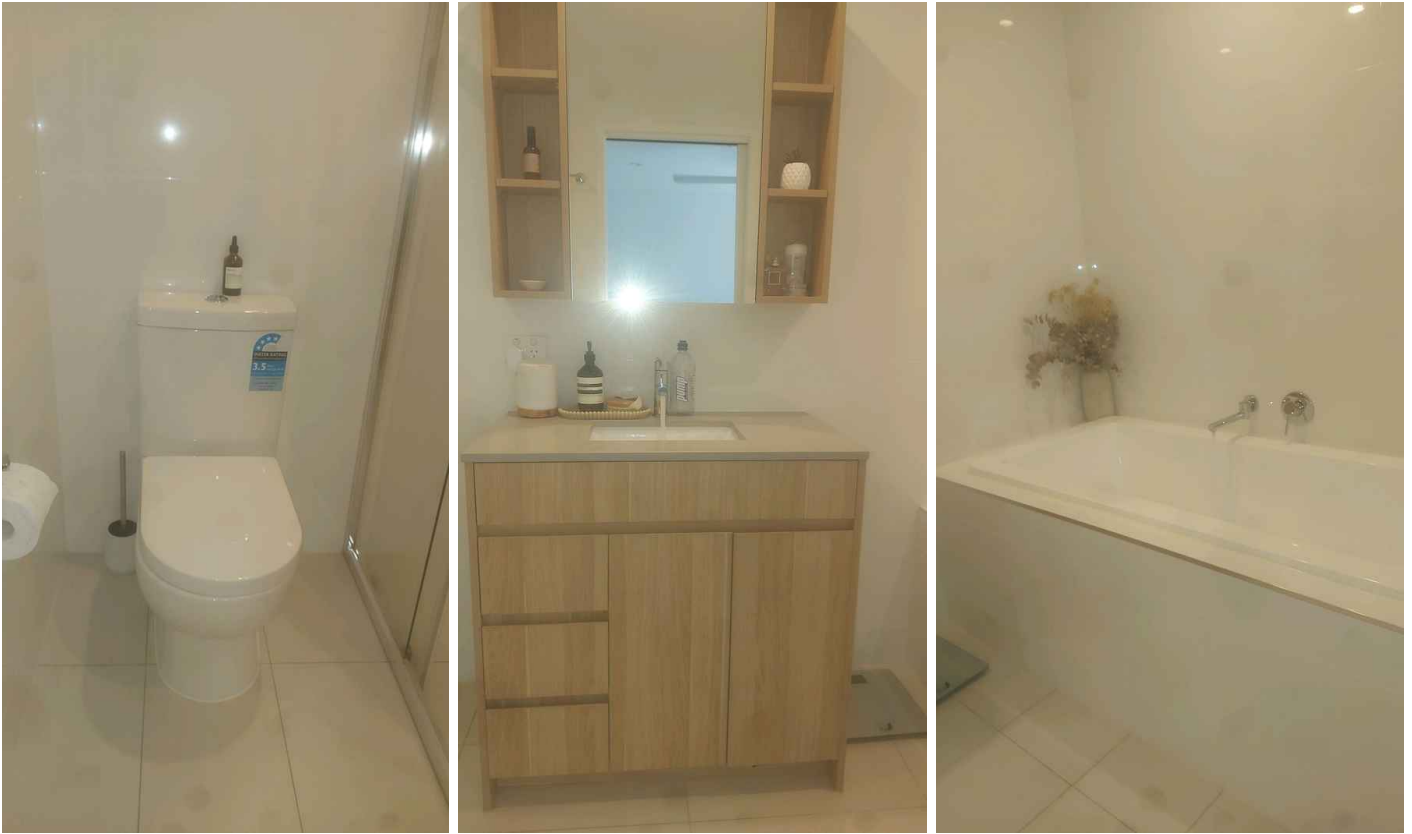
General: Overall serviceable condition

No Major Defects Were Observed. Normal ongoing maintenance is required.

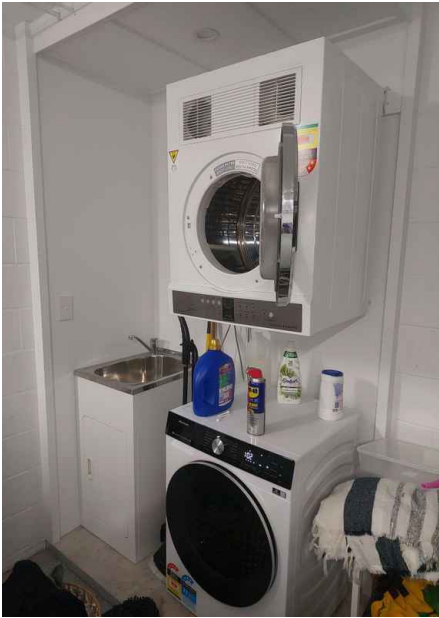
General: Laundry Area **Serviceable**

The Inspector observed no major deficiencies at the time of the inspection.

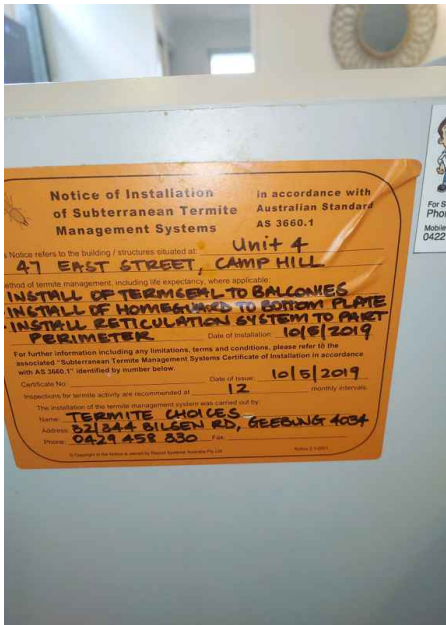
Durable Notices: Durable Notices (Termite Management Notice)

This firm can give no assurances with regard to work that may have been previously performed by other firms. You should obtain copies of all paperwork and make your own inquiries as to the quality of the treatment, when it was carried out and warranty information. In most cases you should arrange for a treatment in accord with "Australian Standard 3660" be carried out to reduce the risk of further attack.
