BUILDING AND TIMBER PEST REPORT

**58 Arrol Street
Camp Hill, QLD 4152**

Before You Bid (BYB)

15/03/2024

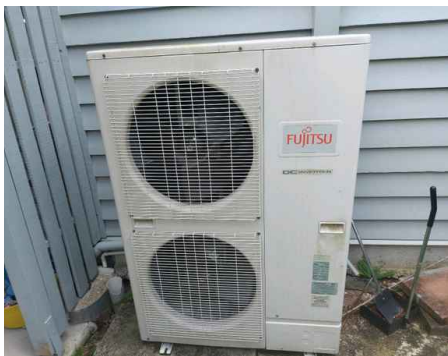
Air Conditioning: Air Conditioning Installed

Air-conditioning is installed to the property but has not been tested/inspected. We recommend a licensed air conditioning specialist to determine the status of the units.

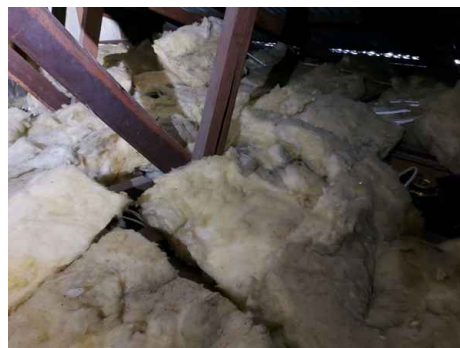
General: Roof Space inspected from:
 Limited - Access hatch only, Partial Inspection

General: Roof Space thermal insulation:
 Fiberglass Batt

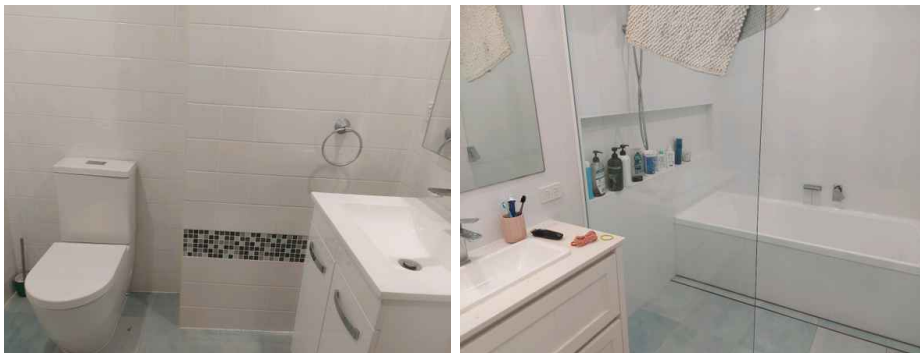
General: Overall serviceable condition

No Major Defects Were Observed. Normal ongoing maintenance is required.

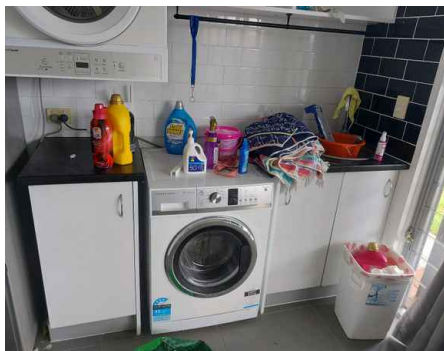
General: Laundry Area Serviceable

The Inspector observed no major deficiencies at the time of the inspection.
