## BUILDING AND TIMBER PEST REPORT

**58 Capella St  
Coorparoo, QLD 4151**

Before You Bid (BYB)  
10/04/2024

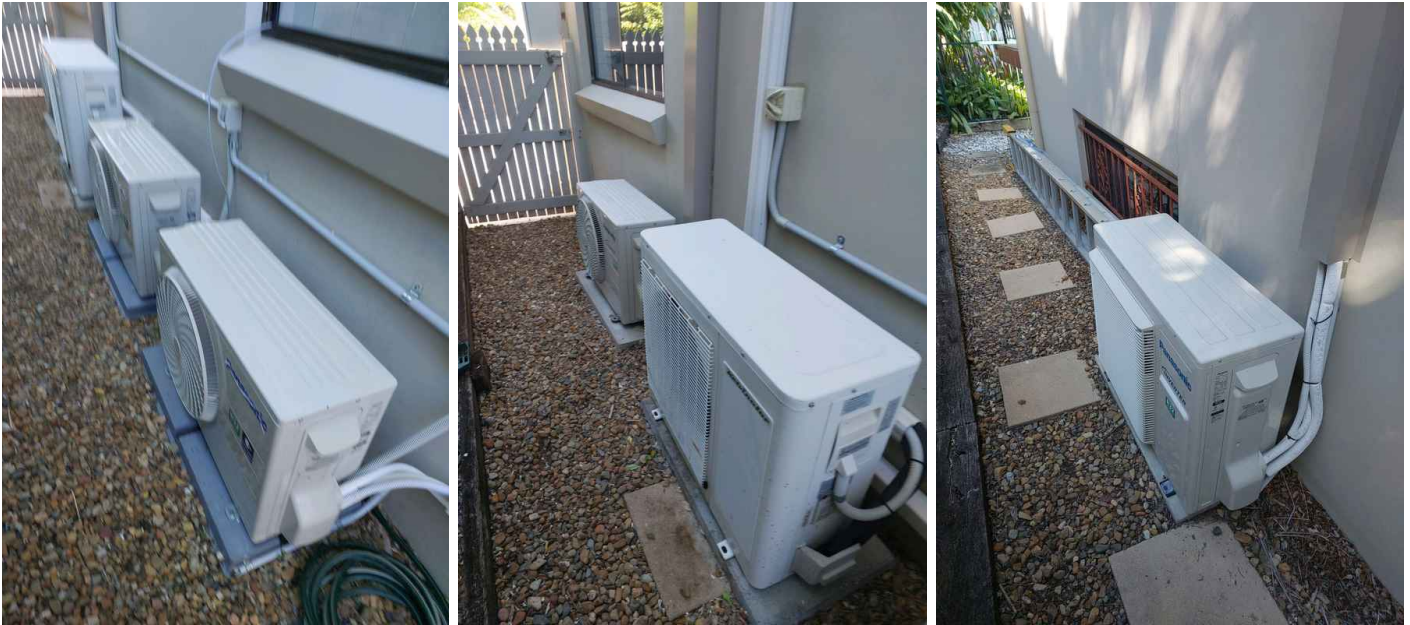
**Air Conditioning: Air Conditioning Installed**

Air-conditioning is installed to the property but has not been tested/inspected. We recommend a licensed air conditioning specialist to determine the status of the units.

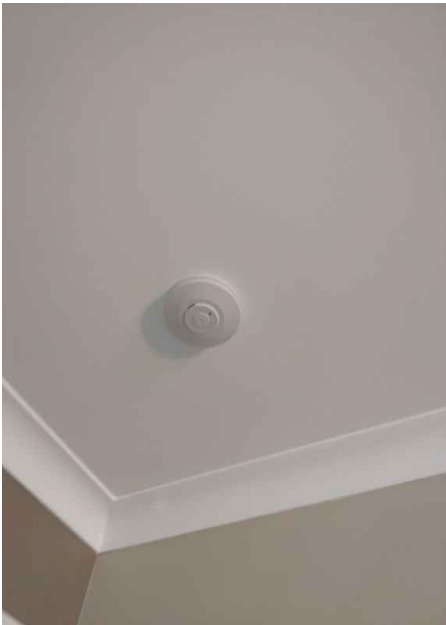
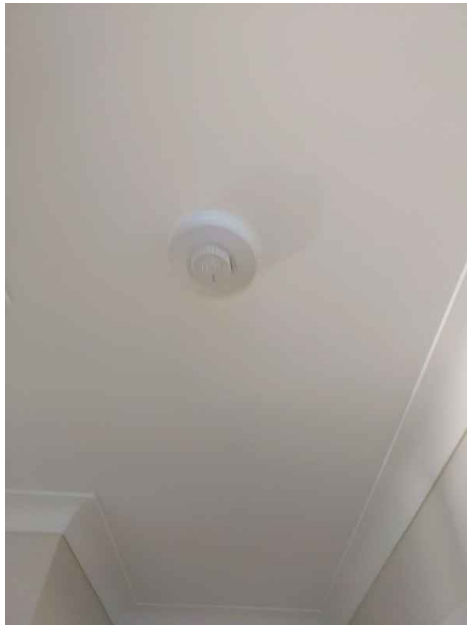
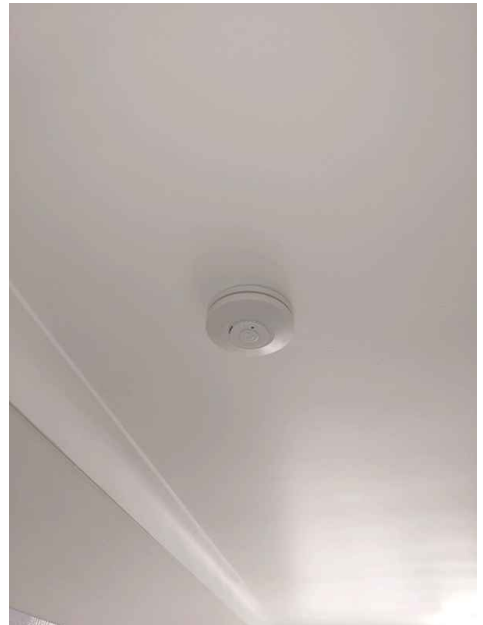
Smoke alarm(s) are fitted however the operation or adequacy was not tested and is not commented on.

**IMPORTANT NOTE.** The Consultant cannot comment on the installation/testing requirements of smoke detectors as this is a specialist safety-critical task that is not within the scope of this inspection and report. It is strongly recommended that the Client obtains advice from a suitably qualified person to either install the adequate amount of smoke detectors and/or ensure existing smoke detectors are of the required type and are installed and maintained correctly.

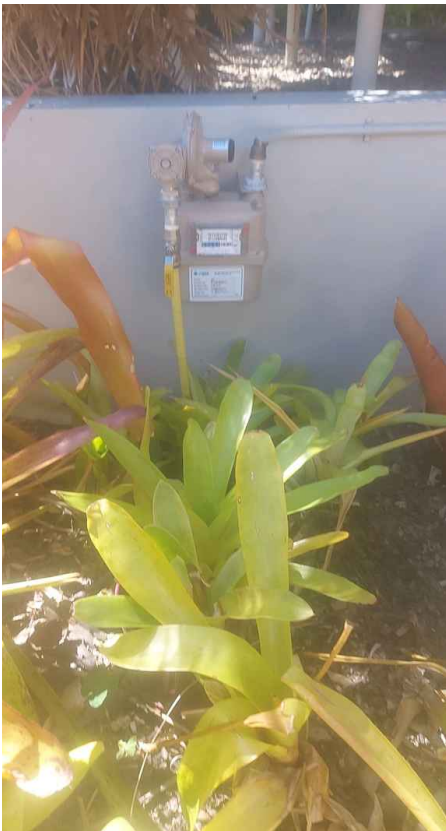
### **Gas : Gas system installed**

Reticulated Gas (Underground Lines)

A gas system was installed at the Property but was not inspected, tested, or checked for compliance. We recommend testing and inspection by a qualified Gas Plumber prior to use

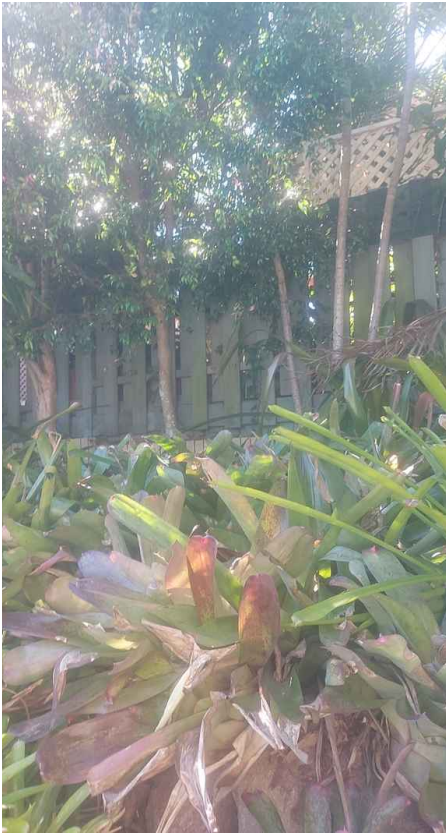
#### **Access, Restrictions And Limitations: Timber Posts Base Not Visible**

The base of some Timber posts are below ground level or not visible. Access and inspection of any posts is recommended.

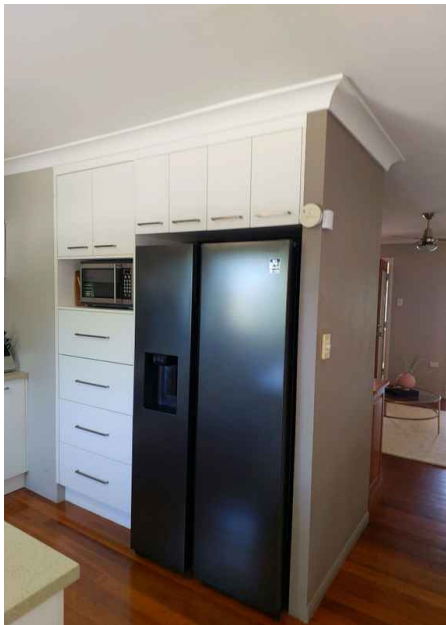
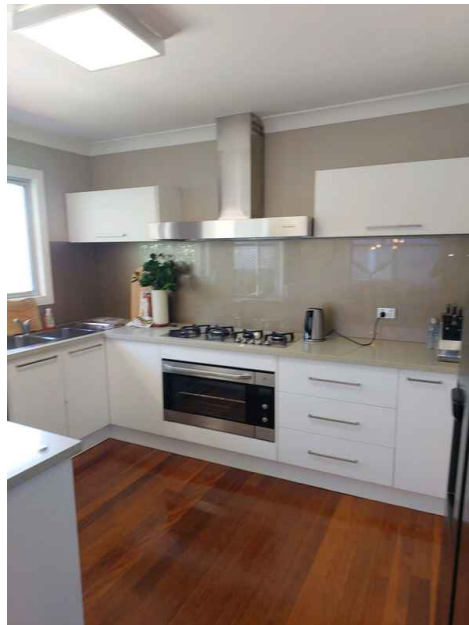
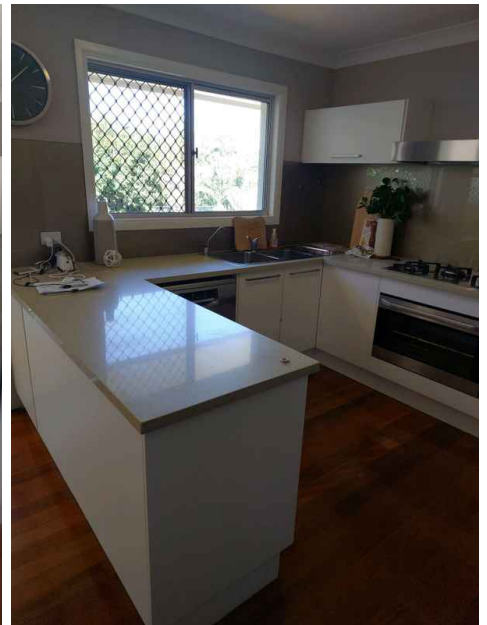
**Cabinets: Serviceable condition**

The Inspector observed no major deficiencies at the time of the inspection.

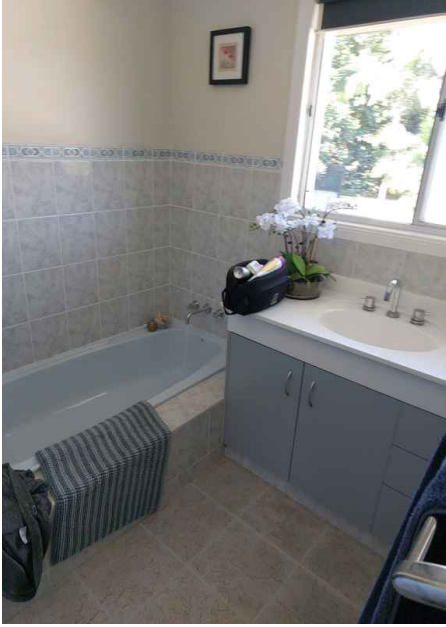
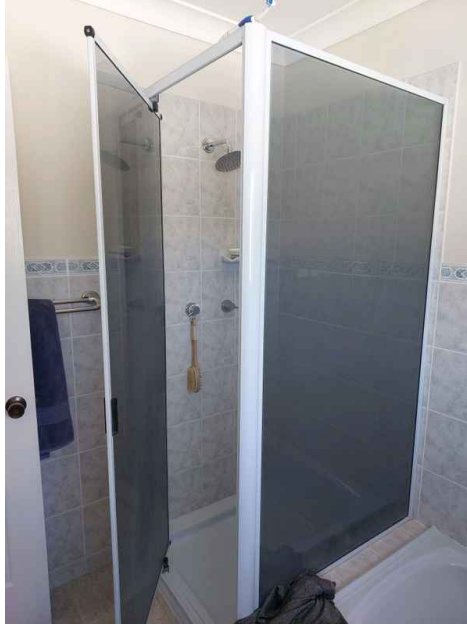
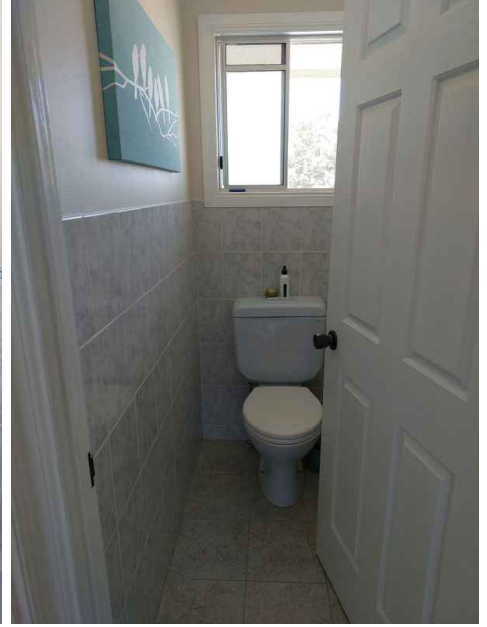
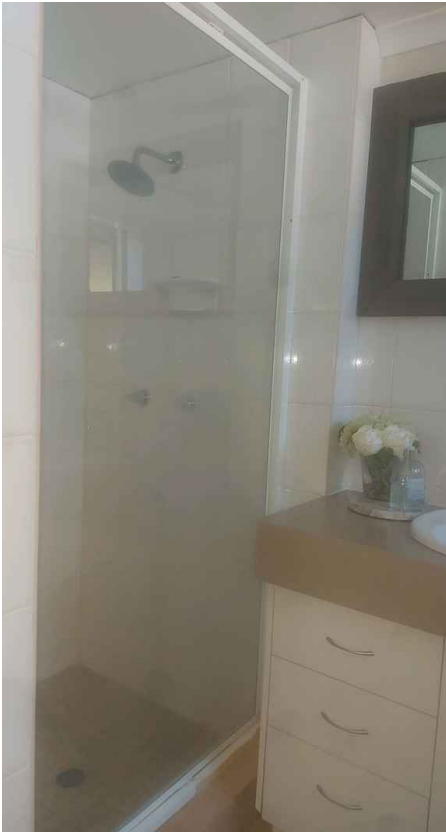
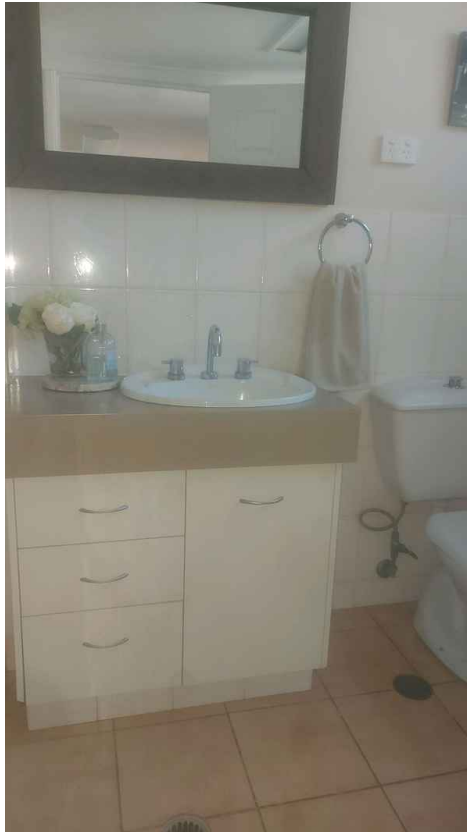
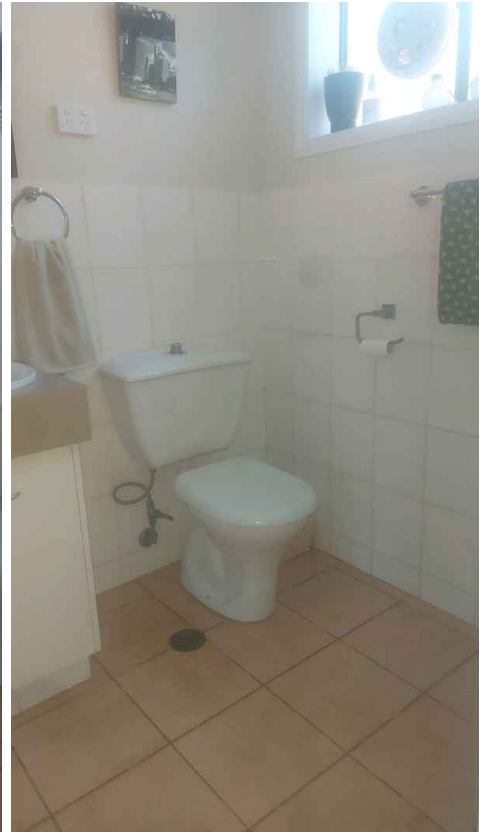
### General: Overall serviceable condition

No Major Defects Were Observed. Normal ongoing maintenance is required.

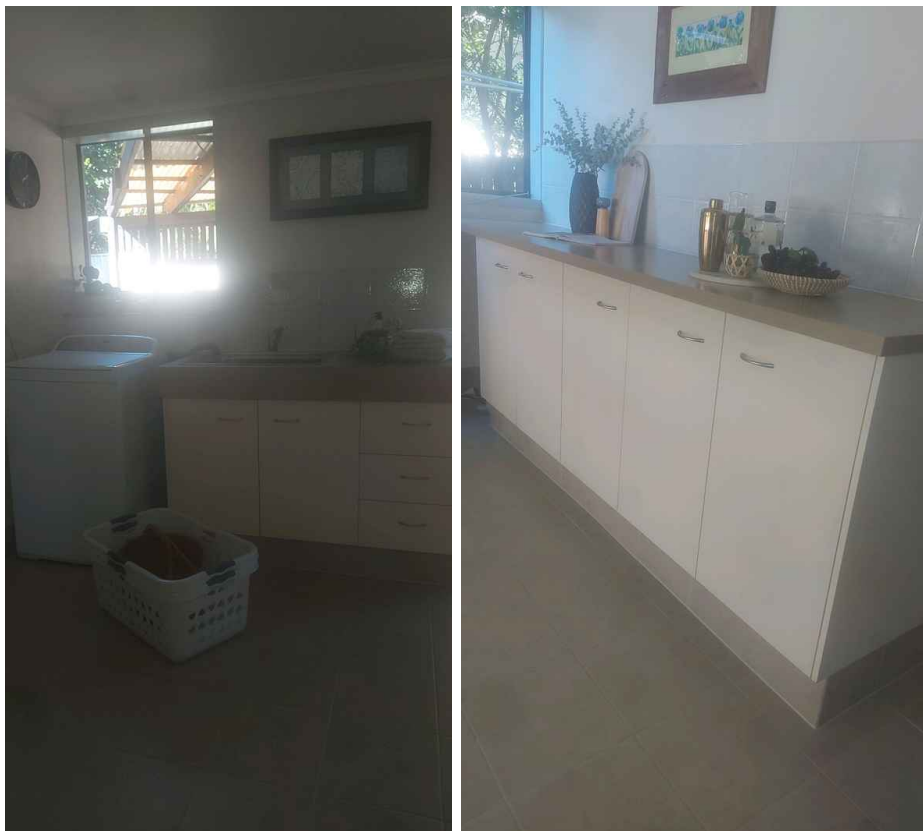
**General: Laundry Area Serviceable**

The Inspector observed no major deficiencies at the time of the inspection.
