BUILDING AND TIMBER PEST REPORT

**64 Halland Terrace
Camp Hill, QLD 4152**

11/12/2023

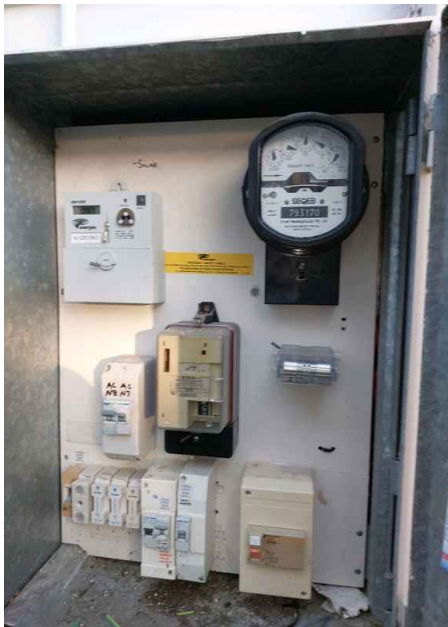
Electrical : Safety Switch Observed

A safety switch was observed, but not tested. It is recommended that the electrical system is fully inspected by a qualified electrician prior to use

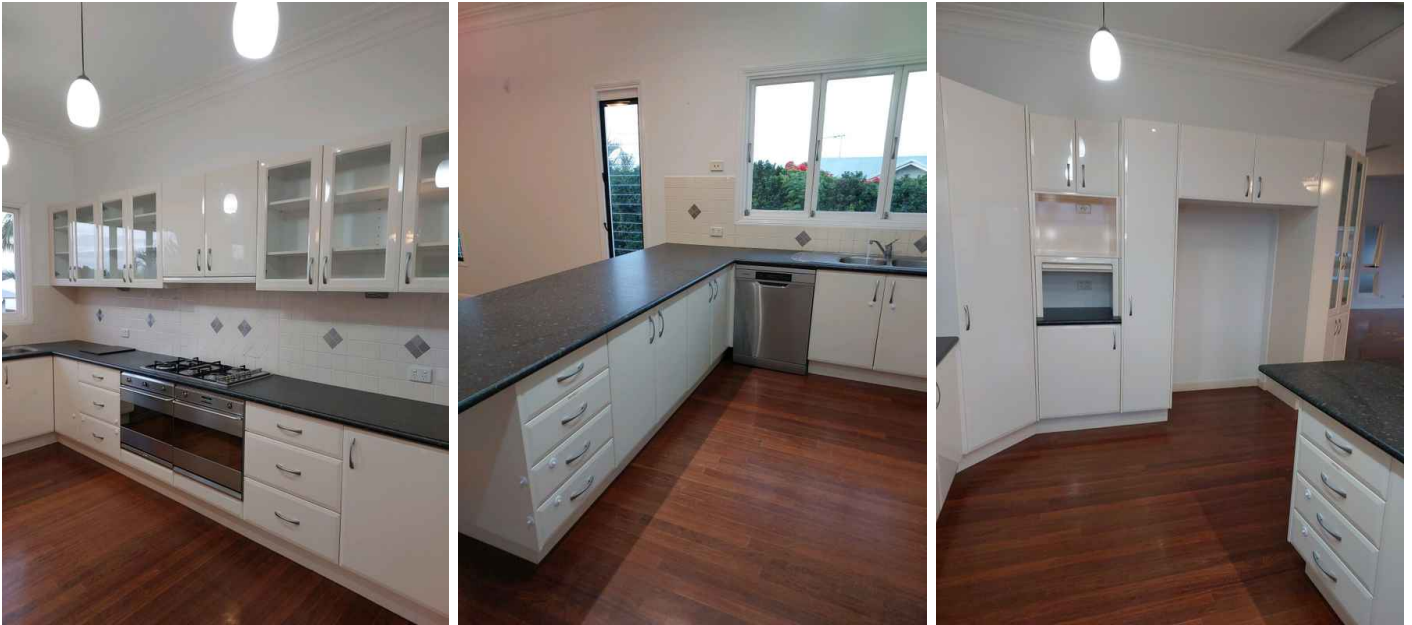
Cabinets: Serviceable condition

The Inspector observed no major deficiencies at the time of the inspection.
