BUILDING AND TIMBER PEST REPORT

8/11 Kennington Road
Camp Hill, QLD 4152

BYB
06/03/2024

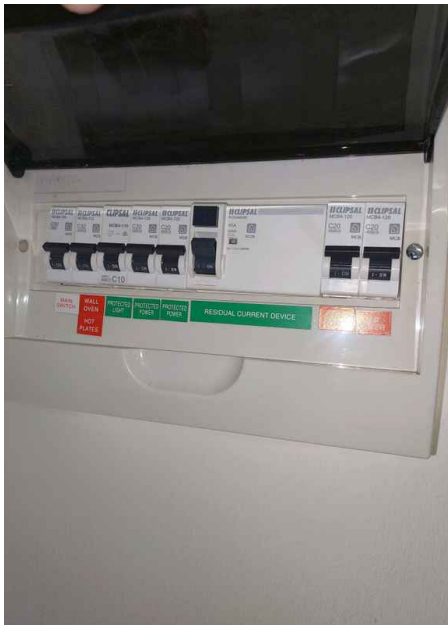
It is prudent to have these systems checked by a qualified Licenced Electrician.

Any notes regarding these systems included in this report are informational only and should be verified and evaluated by an electrician.

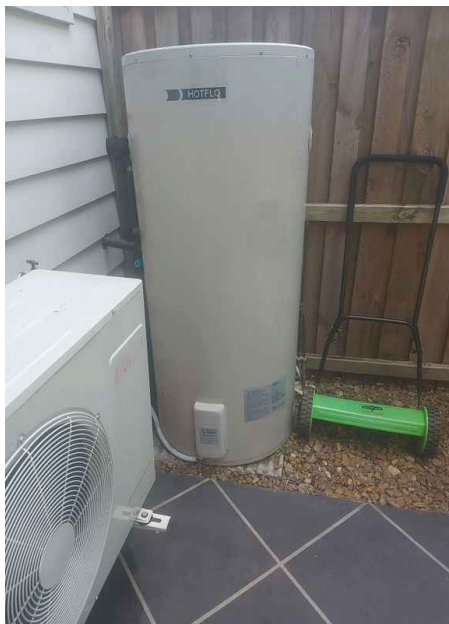
Hot Water Service: Hot water provided by:

Electric Water Heater (Tank)

No specific tests were carried out. No determination has been made as to the compliance, suitability or adequacy of the hot water system in relation to capacity, function or lifespan.

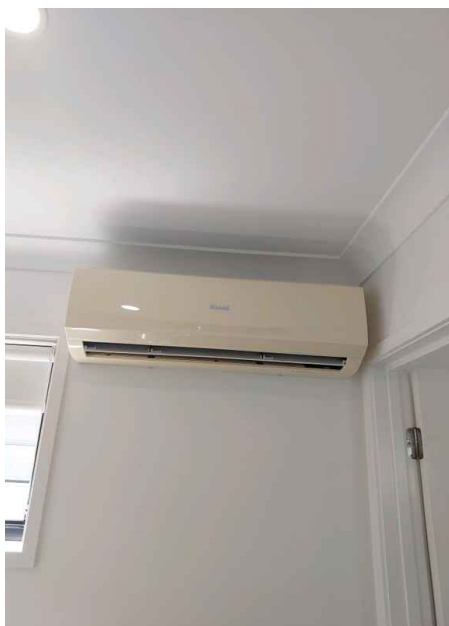
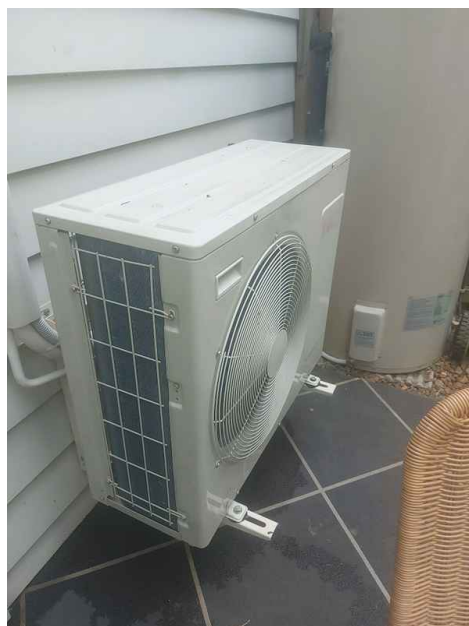
Air Conditioning: Air Conditioning Installed

Air-conditioning is installed to the property but has not been tested/inspected. We recommend a licensed air conditioning specialist to determine the status of the units.

OLD AIR CONDITIONING SYSTEM

Although Air conditioners are excluded from the inspection, air conditioners observed appeared old.

Recommend further evaluation by an air conditioning specialist.

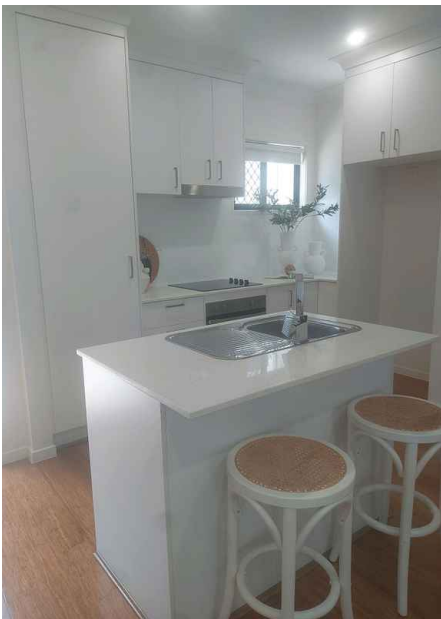
Cabinets: Serviceable condition

The Inspector observed no major deficiencies at the time of the inspection.

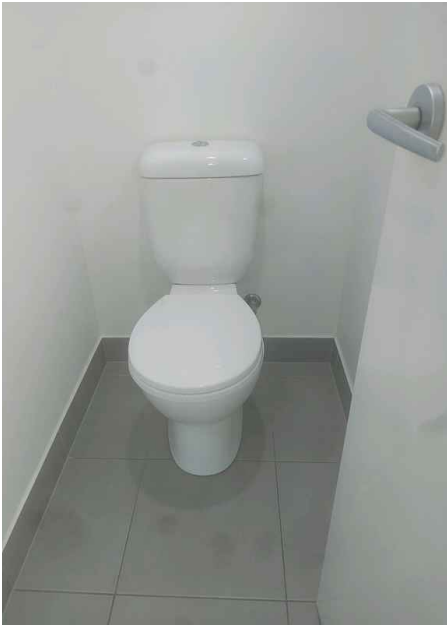
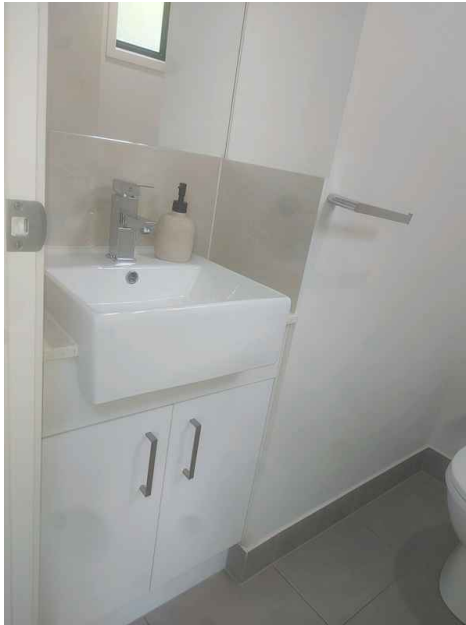
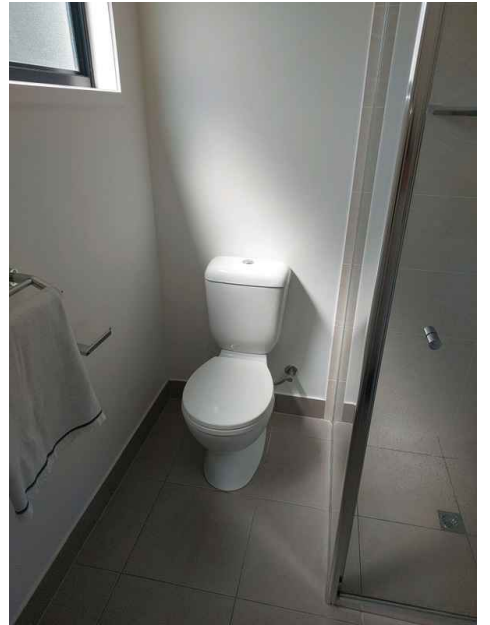
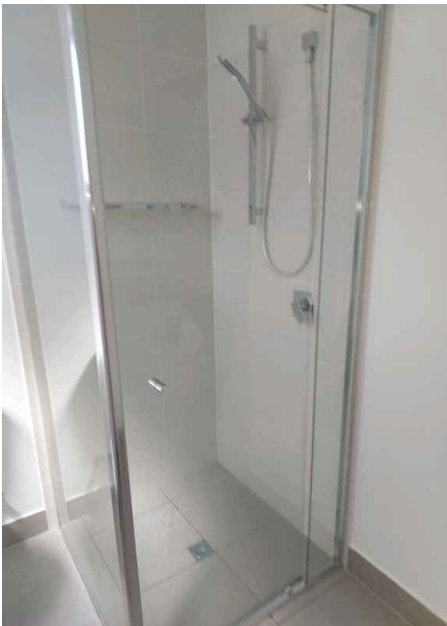
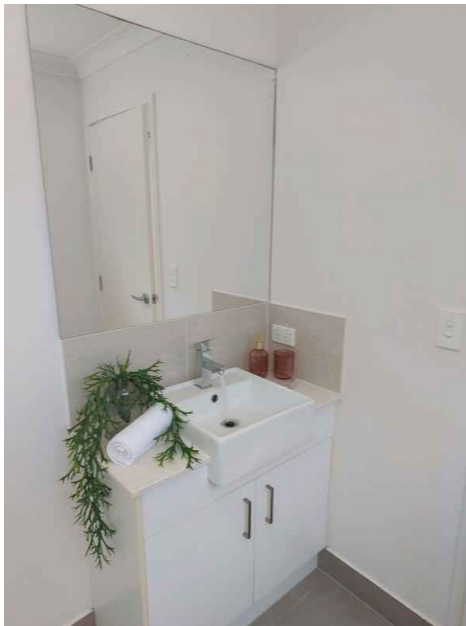
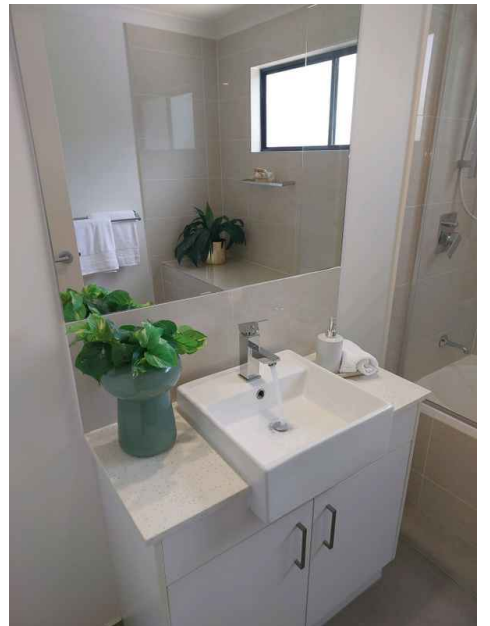
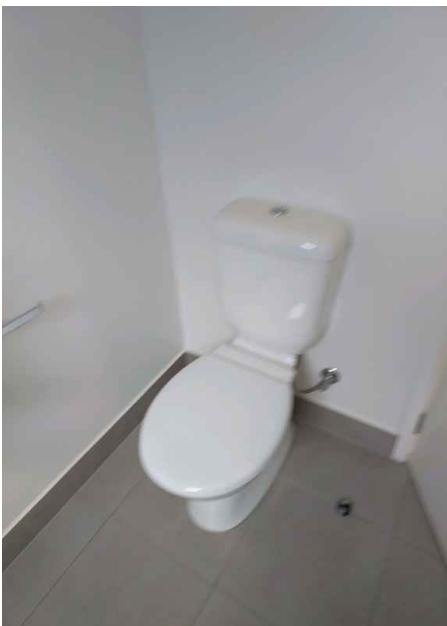
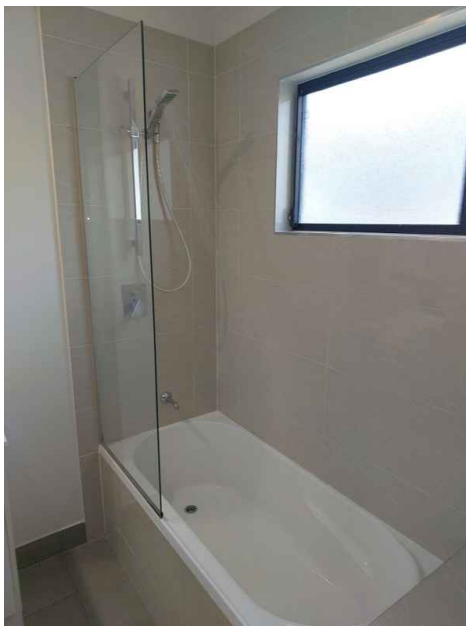
General: Overall serviceable condition

No Major Defects Were Observed. Normal ongoing maintenance is required.

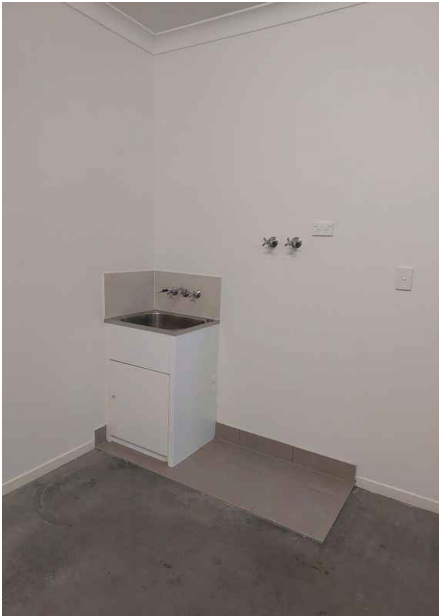
Garage

The Inspector observed no major deficiencies at the time of the inspection.

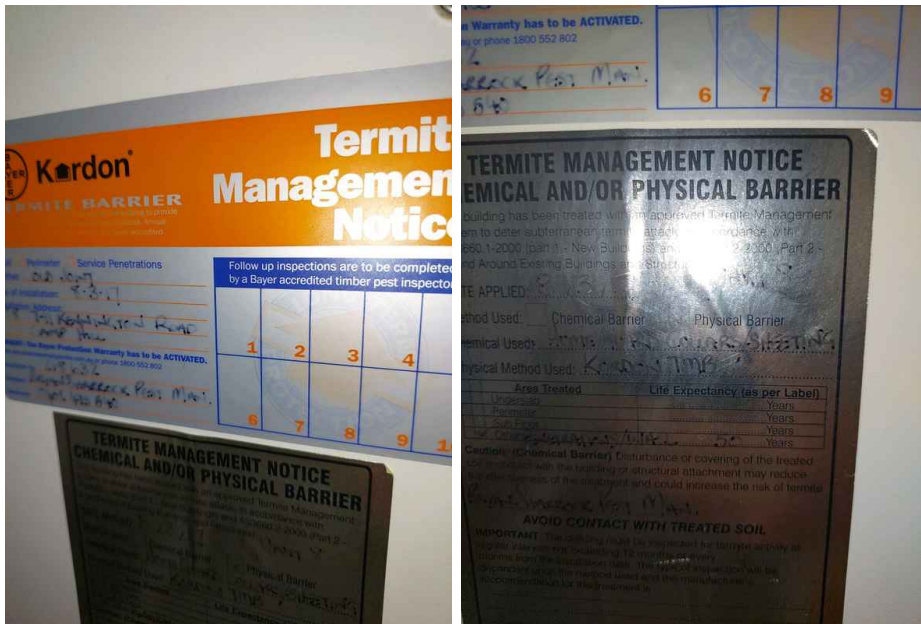
Durable Notices: Durable Notices (Termite Management Notice)

This firm can give no assurances with regard to work that may have been previously performed by other firms. You should obtain copies of all paperwork and make your own inquiries as to the quality of the treatment, when it was carried out and warranty information. In most cases you should arrange for a treatment in accord with "Australian Standard 3660" be carried out to reduce the risk of further attack.
